AAIB Bulletin

10/2021

Published 14 October 2021

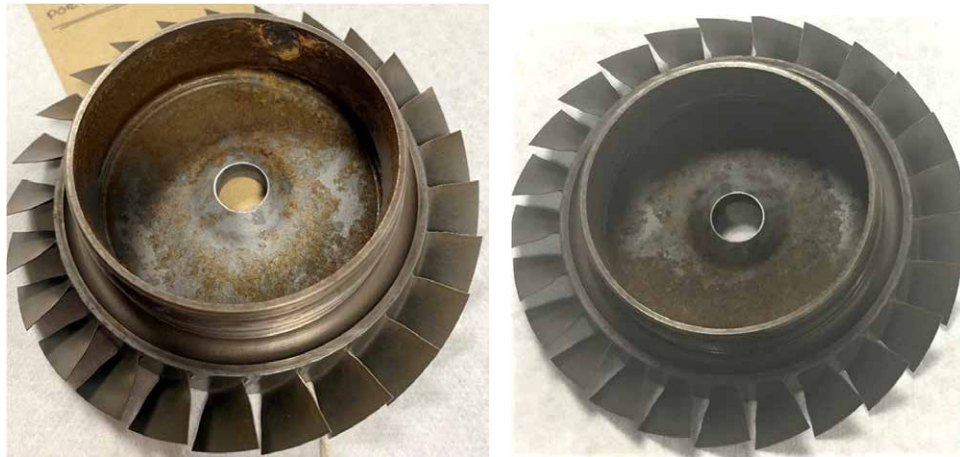
Figure 4

Some of the corrosion found on the left engine axial compressor wheel hubs

Further detailed examination of the left engine's rotor wheels showed there was heavy corrosion present on their hubs (Figure 4). Despite these issues, there was no damage that could be attributed to ice ingress, a potential overspeed or overheat event during the roll-back and shutdown of the engines.

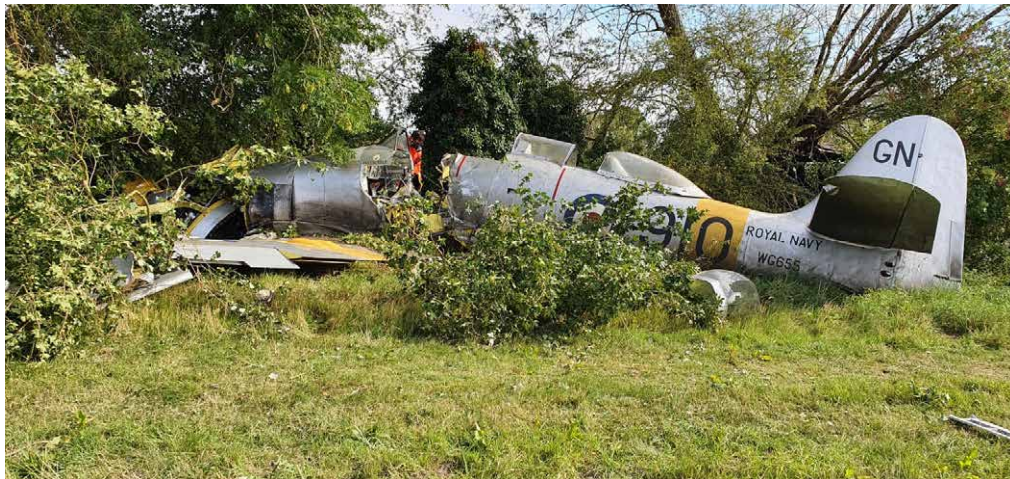
Figure 3

Nearing the ground, the pilot flared the aircraft to reduce the rate of descent but did not hold it off. The aircraft hit the ground and bounced, then hit again and skidded across the field. The aircraft slid into a tree on the far side of the field, which spun it around, and it came to rest in a hedgerow (Figure 3).

G-INVN after the accident

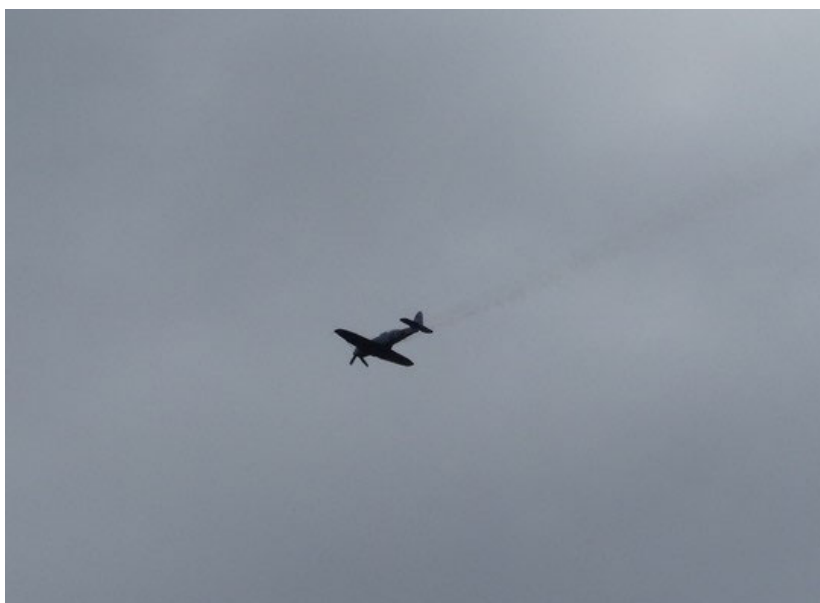
Figure 4

Several people in villages near the accident site reported hearing and seeing the aircraft before the accident. They reported hearing a rough running engine and seeing smoke coming from the aircraft. Several of them heard the engine stop. Video footage and several still photographs supplied to the AAIB showed a smoke trail coming from the aircraft (Figure 4). A witness who was close to the accident site saw the aircraft flying towards him. He described seeing “thick black smoke coming from both sides” and that “the propeller was rotating but then stopped and the nose dropped”.

G-INVN in flight just prior to the accident with smoke trail visible
(Photograph used with permission)

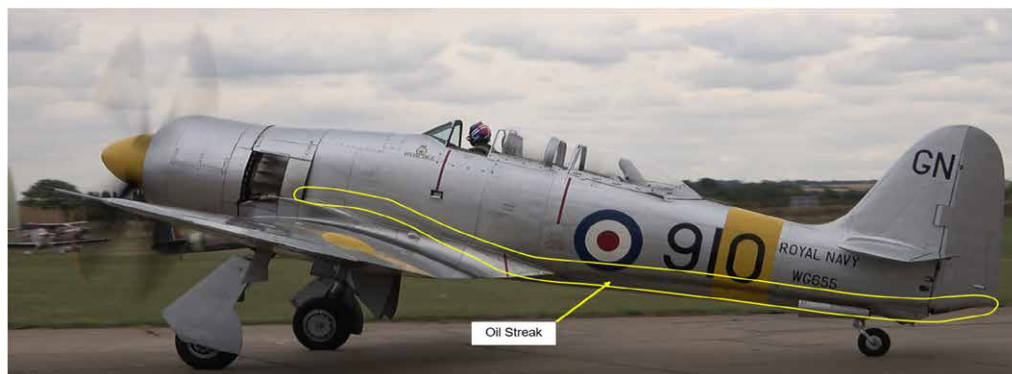
The image in Figure 6 was taken after the flight and showed an oil streak along the left side of the aircraft. The oil streak appeared to emerge from the crankcase breather duct positioned beside the cowling flaps.

Figure 6
G-INVN after the first flight showing an oil streak on the left side
(Still photograph taken from video used with permission - Sky High Films)

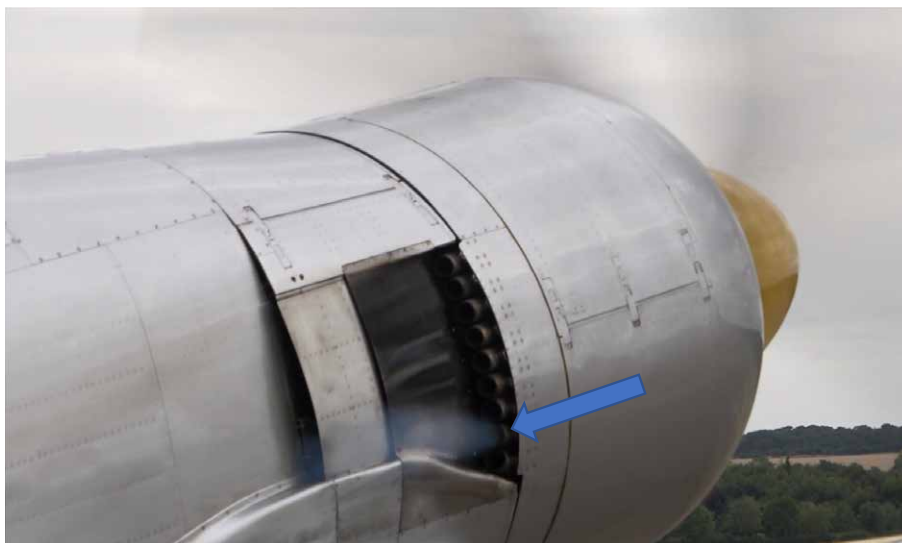
Further video footage showed the start-up, taxi and takeoff of the accident flight. During the pre-flight checks, smoke could be seen coming from the exhaust for the No 9 cylinder (rear bank, master cylinder) (Figure 7). No smoke was observed coming from any other exhaust. The footage also showed a smoke trail during the takeoff, and there appeared to be more smoke than was visible on the first flight.

G-INVN before the accident flight showing smoke from No 9 exhaust
(Still photograph taken from video. Image used with permission)

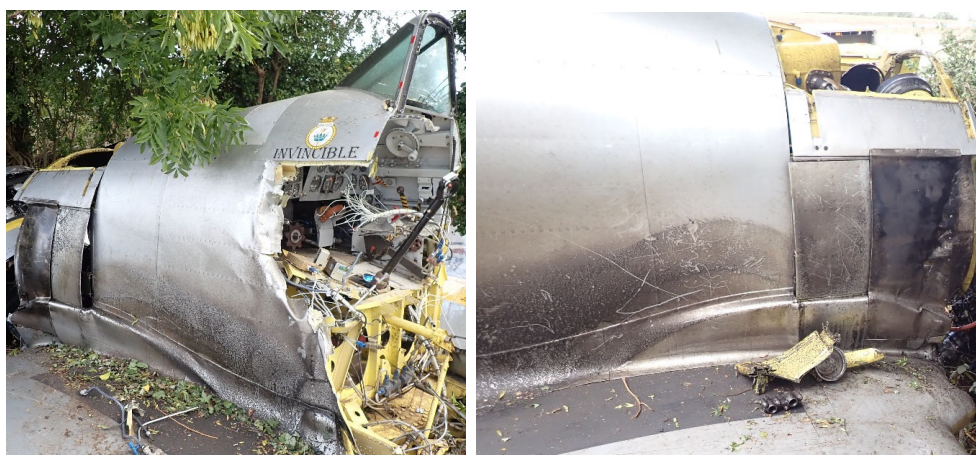
Figure 14

The fuselage had split to the rear of the windscreen and the gap between the two sections was approximately one metre. The sheet metal on the left side of the break showed signs of compression buckling and tearing in tension whereas the right side showed only tearing in tension. The cockpit instrument panels were largely intact, but the transponder had become dislodged and was found several metres to the right of the fuselage. All the CBs were closed (in) except the 'OIL CLR' and 'OIL TMP'. There was evidence of oil streaking along the side of the fuselage from each of the crankcase breather ducts (Figure 14).

Oil streak from crankcase breather ducts

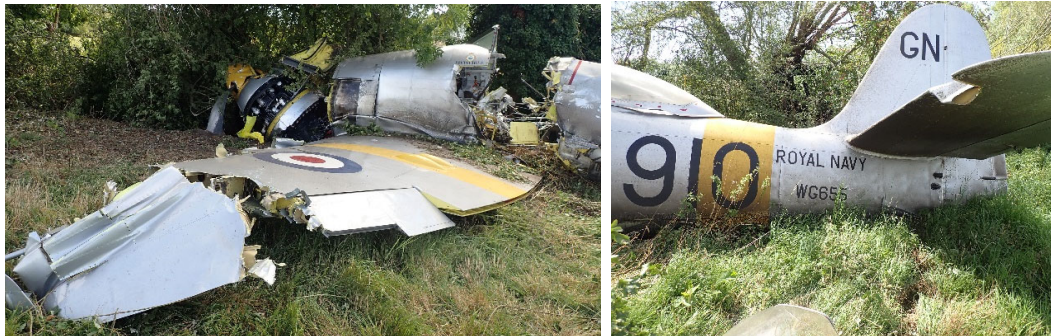
Figure 15

The left wing was significantly damaged by the impact with the hedge, with multiple tears, and the tip structure had detached (Figure 15 left). The right aileron was significantly damaged and was deformed by a large tree. The flap lever was in the fully DOWN position and the flaps had partially deployed. The landing gear lever was in the UP position with the landing gear retracted, but the landing gear was not locked and the legs extended freely during the recovery. The tail structure was intact and the right tailplane had dug into the ground. The partially deployed tail wheel had scribed an arc in the grass (Figure 15 right).

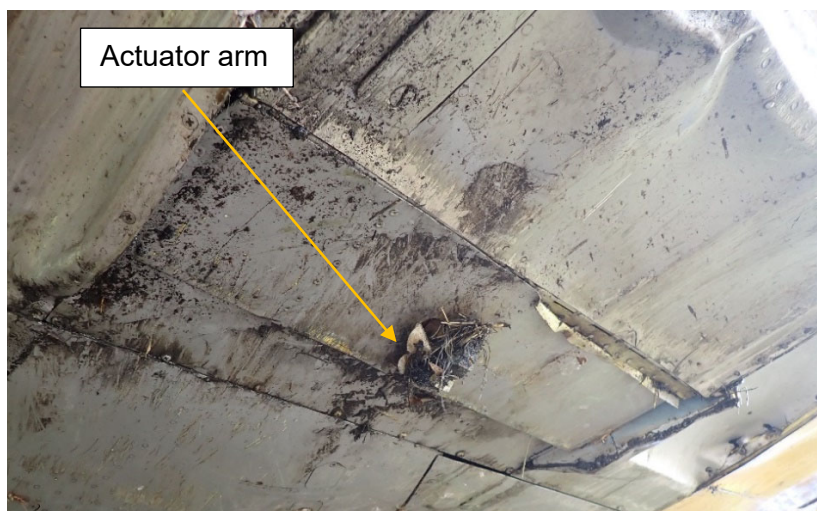
Figure 16

The oil cooler inlet cowling was deformed and the front of the cooler was clogged with earth. The outlet flap was closed but the actuator arm had penetrated through the surface, indicating that the flap had been at least been partially open and was forced closed during the ground slide (Figure 16).

Oil cooler outlet flap

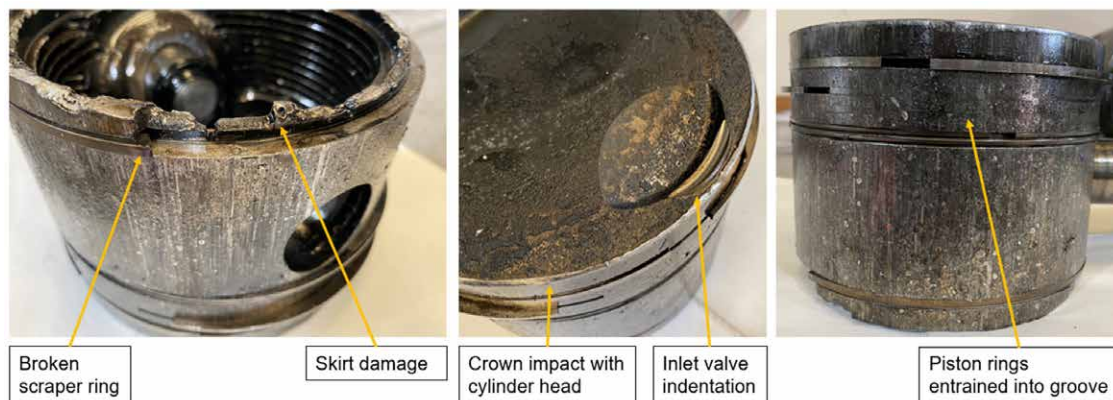
Figure 17

The engine had seized with the No 1 piston (rear bank) at or near top dead centre (TDC). Correspondingly the No 10 piston (front bank) was also at or near TDC. All the rear bank pistons were damaged below the scraper ring groove and the scraper rings were partially lost (Figure 17 left). Around the periphery of the piston crown it was evident that some pistons had struck the top of their cylinders (Figure 17 centre) and there were indentations from the inlet valves in all the piston crowns. The side of all pistons showed evidence of abrasion and the compression rings were entrained in the grooves of the master piston (Figure 17 right).

Rear bank piston damage (Piston No 9 shown)

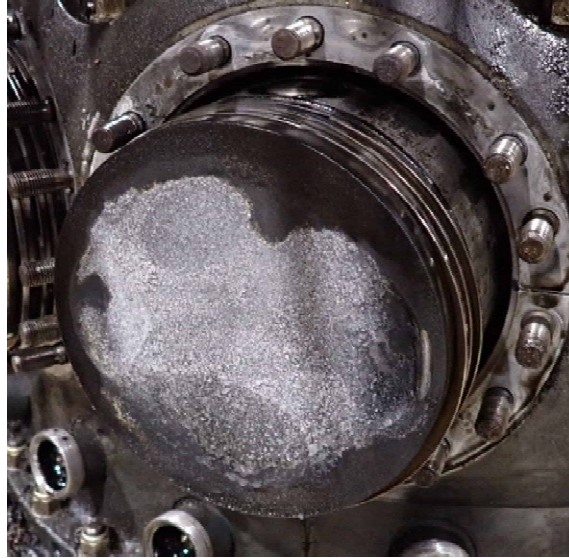
Figure 18

There was considerably less damage to the front bank pistons, with only abrasion damage to the skirts and some pistons retaining metal fragments inside the rear of the piston. There was evidence on some piston crowns, in each bank, of a grey powder deposit (Figure 18). A sample was removed, analysed, and found to contain aluminium, carbon, oxygen, lead and bromine.

Piston crown deposit (piston No 13 shown)

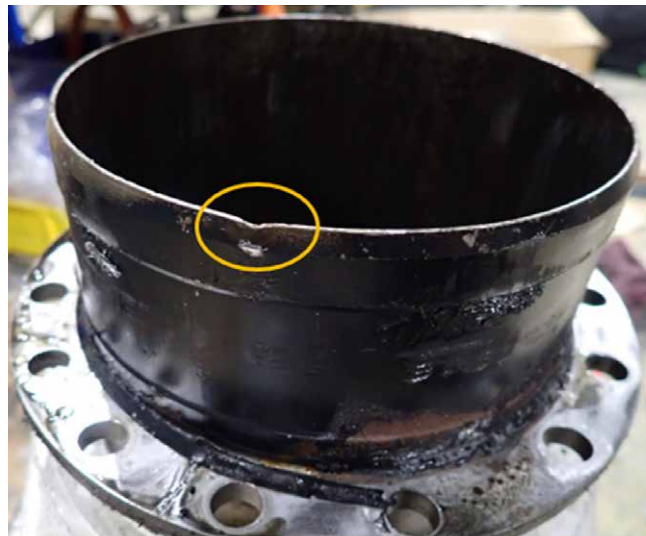
Figure 19

Some cylinder barrels had impact damage to the flange which engages inside the crankcase. The shape and size of the damage was inconsistent: whilst most flared outwards (Figure 19), one cylinder was flared inwards.

Cylinder flange impact damage (cylinder No 15 shown)

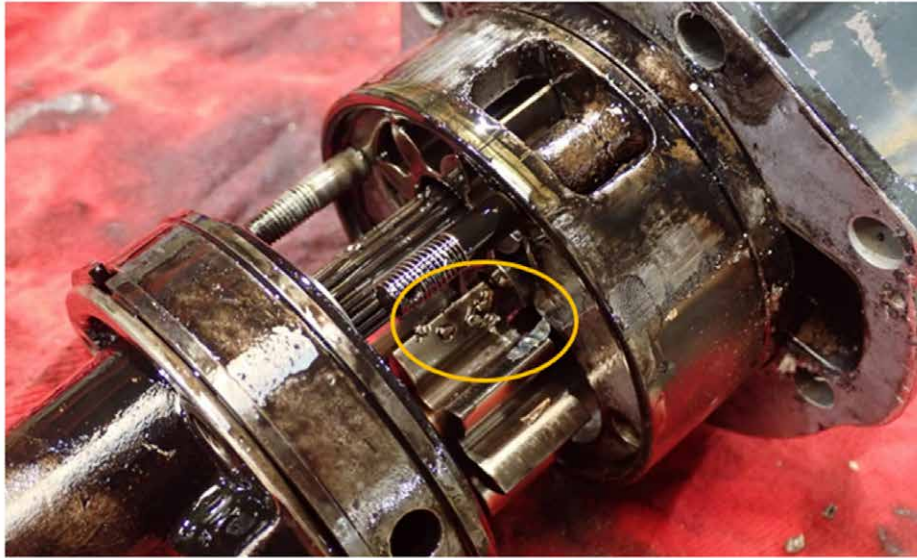
**Figure 20**

The pressure oil pump was removed and could be turned by hand. There was evidence of fine metallic debris in the oil passageways. The front scavenge pump would not turn by hand but there was no evidence of damage to the drive gears. The pump was disassembled, and metallic debris was found within the gears, preventing them from turning (Figure 20). No other damage was observed.

Front oil scavenge pump

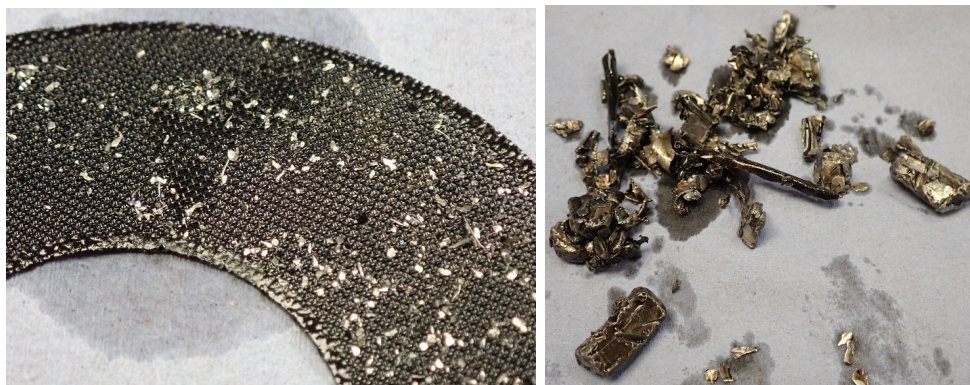
**Figure 21**

The two engine oil filters and the Cuno filter were removed and their contents examined. The metal mesh filters contained a large amount of fine metallic debris whereas the rear case screen contained a quantity of large metallic fragments (Figure 21). These fragments were identified as broken pieces of piston skirt and piston ring. The fine metallic debris was analysed and was found to be silver, iron, aluminium and copper.

Left – pressure oil strainer. Right – debris from rear case drain screen

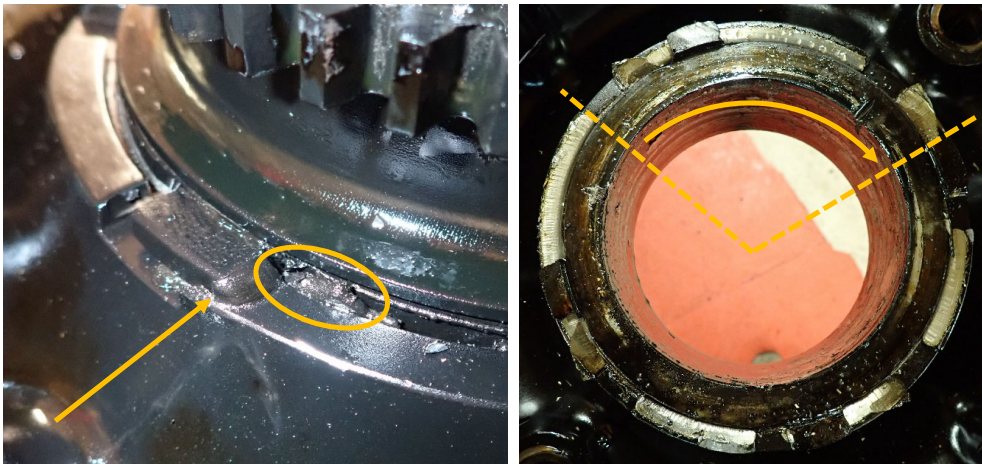
Figure 22

An inspection of the front and rear crankcases revealed evidence that the front and rear crankshaft journal bearings had rotated in the crankcase. The locking tabs of both bearings had dragged in the casing (Figure 22) with the front bearing having rotated approximately three to four degrees. The rotation of the rear bearing was at least 120° as there was continuous mechanical damage between the locking tab slots. It was not possible to determine if the bearing had rotated more than 120°. The bearing surfaces were heavily scored (Figure 23) and there was evidence that the silver had melted and solidified. The centre crankshaft bearing showed no evidence of rotation but some evidence of scoring. The silver bearing material was largely intact.

Left – Detail of front bearing rotation (arrowed) and molten metal (circled).
Right – Detail of rear bearing rotation

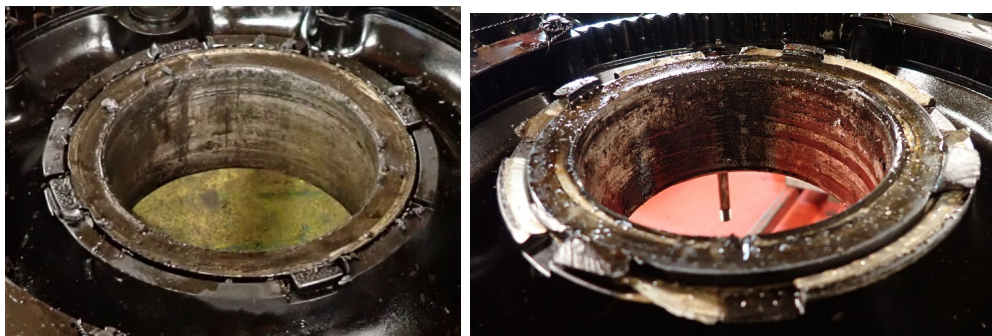
Figure 23

Left – Front crankshaft journal bearing
Right – Rear crankshaft journal bearing

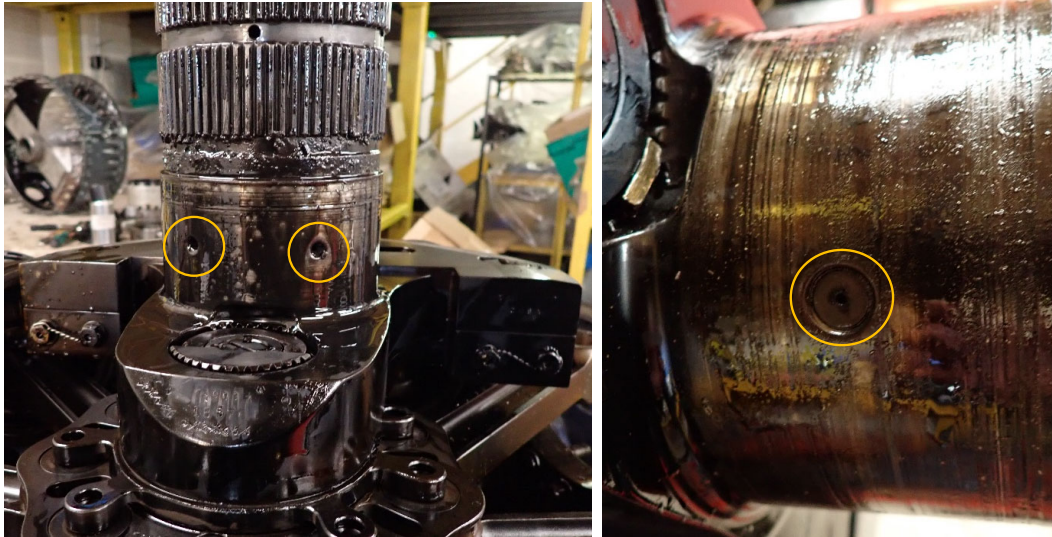
Figure 24

blocked and the rear secondary counterweight bearing showed evidence of running without lubrication. The front journal bearing hole was partially blocked restricting the supply of oil to the bearing.

Left - Front crankshaft journal (oil holes circled)
Right - Rear crankshaft journal (oil hole circled)

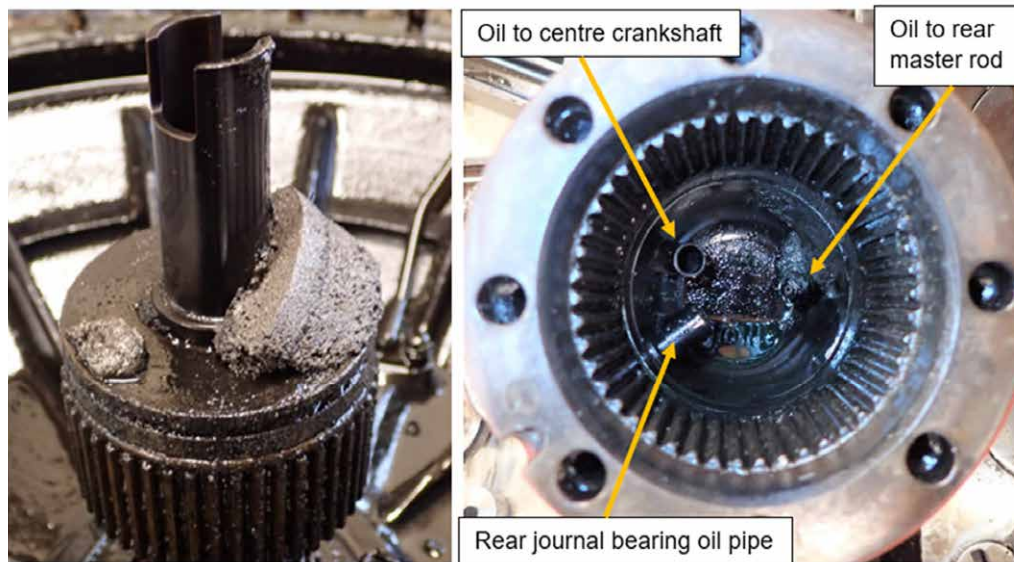
Figure 25

Metallic particles filling the rear of the crankshaft
Supercharger output shaft – Left. Crankshaft pocket – Right

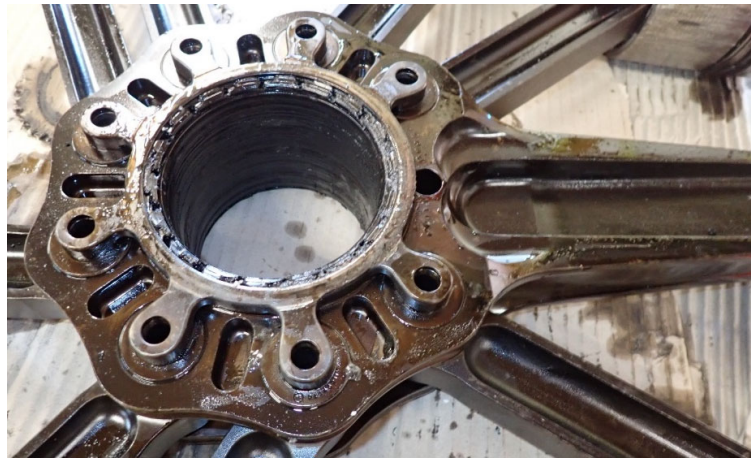
Figure 28

The rear master rod assembly also showed evidence of heavy scoring with very little of the bearing material remaining (Figure 28). There were also substantial amounts of loose, metallic particles on the bearing face. The castellations on both ends of the bearing had been significantly damaged along with the corresponding castellations of the retaining plate. The castellations had become swaged together and had to be cut away to enable the bearing to be pressed from the master rod. No defects or bending were found on the link rods of either master rod assembly.

Rear master rod showing bearing damage

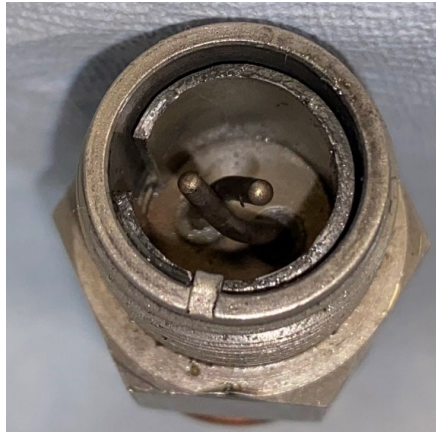
Figure 29

The two temperature sensors were examined and subjected to an electrical continuity test. No defects were found with the sensor removed from the rear accessory case (rear cockpit) but the sensor providing indications in the front cockpit was damaged. The electrical connector was disconnected from the sensor and it was found that the pins had become twisted together (Figure 29).

Oil temperature sensor electrical connection pins

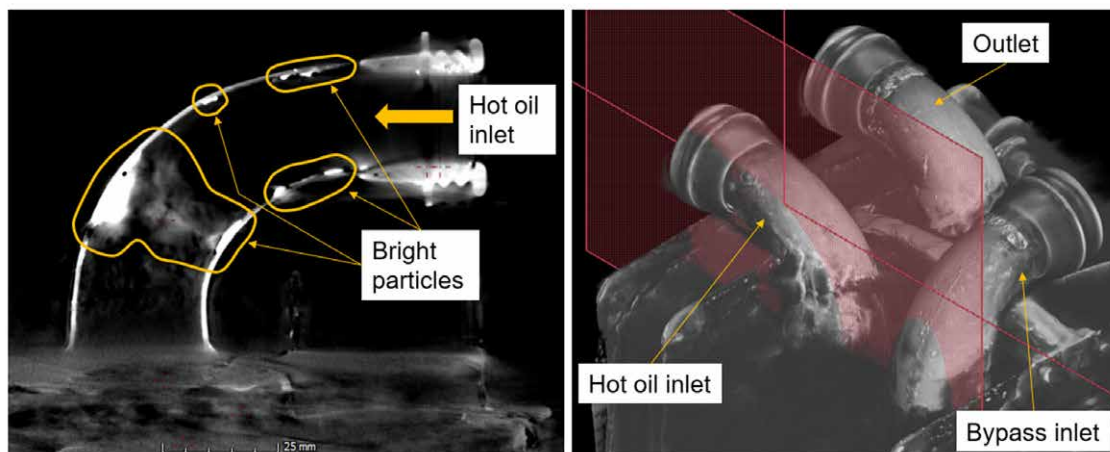
Figure 30

The oil cooler was scanned using computerised tomography (CT), which showed many metallic particles within the cooler. Several large bright particles were visible in the hot oil inlet which were determined to be silver (Figure 30). Multiple bright particles were identified throughout the core of the cooler, with a higher concentration towards the inlet end (examples circled in Figure 31). Other particles, probably of aluminium, were also identified throughout the inlet and the core. It was not possible to perform a detailed analysis of the inlet pathway, from the inlet pipe to the first core pack, because the X-rays did not penetrate the multiple layers of brass and steel.

Section view through the oil cooler - hot oil inlet

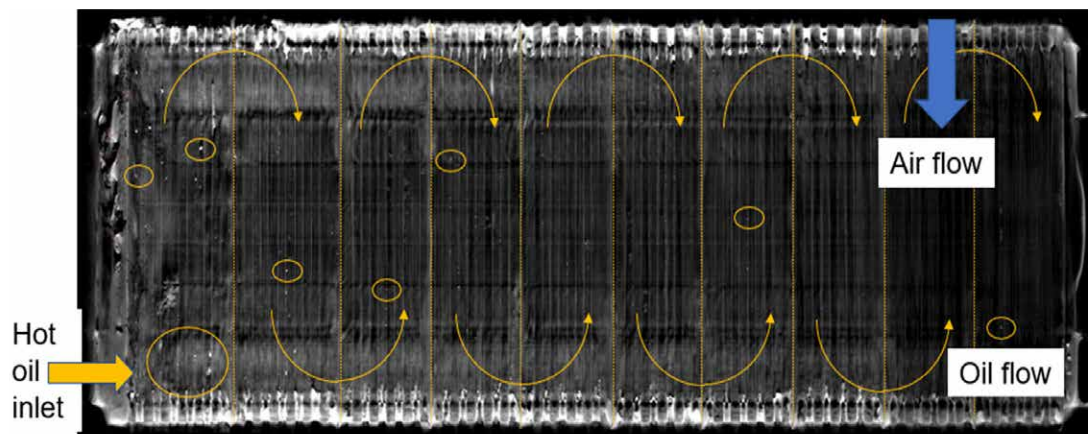
Figure 31

Oil cooler core. Some particles highlighted

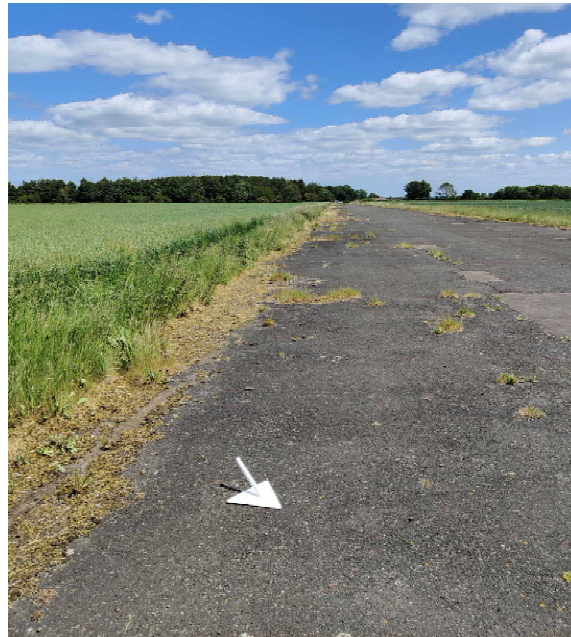
The pilot identified several contributory causes of this accident. The runway is narrow, 15 m wide, and has crops growing at its edges. Figure 1 shows the proximity of the crops. He normally configures the aircraft with a slipstream to improve forward visibility during landing but on this occasion, slipstream was not used. He described how he failed to observe the extent of the drift and when he realised and attempted to correct it, it was too late. He believed that, had he initiated an immediate go-around, it is likely the accident would have been averted.

Proximity of the crop to runway
(the object on the runway is a detached aileron spade)

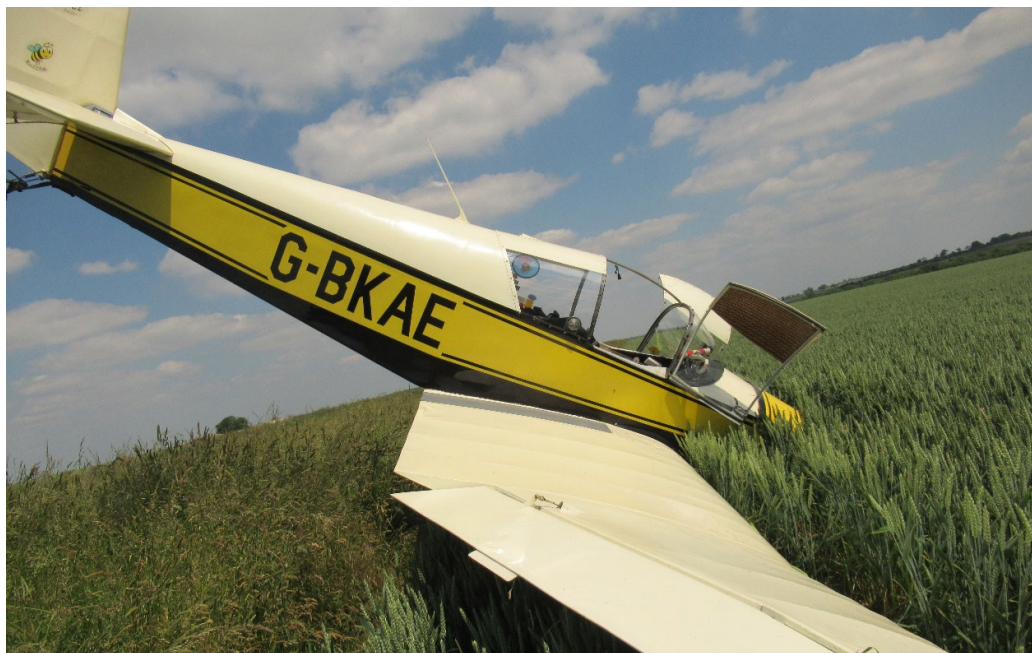
Figure 1
G-BKAE after the accident
