AAIB Bulletin S3/2021

SPECIAL

ACCIDENT

Aircraft Type and Registration:	Escapade, G-CGNV	
No & Type of Engines:	1 Rotax 912-UL piston engine	
Year of Manufacture:	2011 (Serial no: LAA 345-14901)	
Date & Time (UTC):	14 November 2021 at 1204 hrs	
Location:	Brighton Airfield, East Riding of Yorkshire	
Type of Flight:	Private	
Persons on Board:	Crew - 1	Passengers - None
Injuries:	Crew - 1 (Fatal)	Passengers - N/A
Nature of Damage:	Aircraft destroyed	
Commander's Licence:	Private Pilot's Licence (Aeroplanes)	
Commander's Age:	66 years	
Commander's Flying Experience:	945 hours (of which 4 were on type) Last 90 days - 9 hours Last 28 days - 3 hours	
Information Source:	AAIB Field Investigation

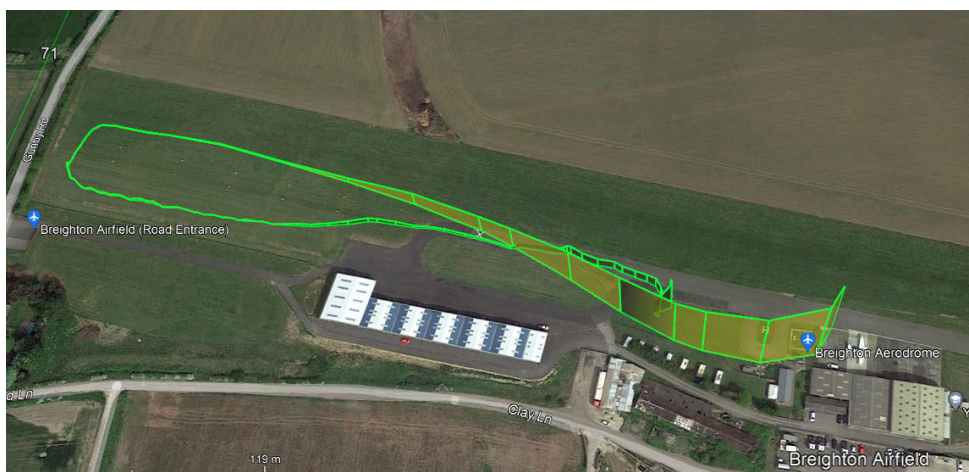
Figure 1

The aircraft was seen to takeoff and climb steeply while appearing to sideslip and drift off the runway centreline. It climbed to approximately 180 ft agl at which point the left wing dropped, the aircraft departed from controlled flight and it descended rapidly to the ground. The pilot was fatally injured. The evidence indicates that the seat moved rearwards leading to the pilot losing control of the aircraft. The cause of the seat movement is under investigation. Three Safety Recommendations are made.

Track of G-CGNV using PilotAware ATOM GRID Network data
(Satellite imagery courtesy of Google Earth)

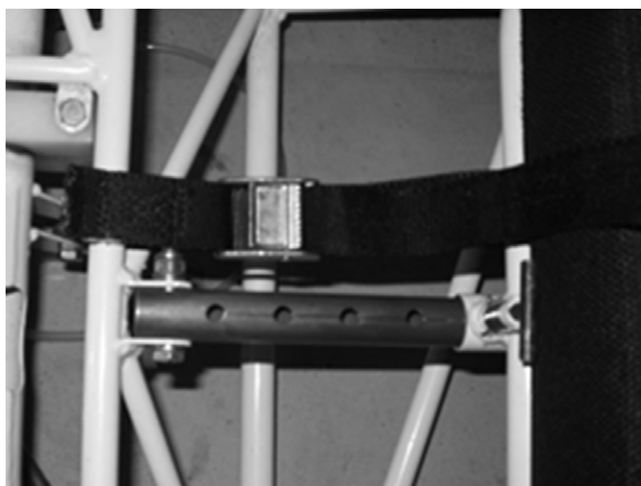
Figure 4

Witness evidence also indicated that the pilot had found the seat adjuster backup straps “fiddly” to use. The pilot’s strap was found to be set at a length that would have allowed the seat to have travelled rearwards to around the full length of its travel, and therefore would not have secured the seat in the fully forward position as required by this pilot.

The evidence indicates that the seat adjustment pin was not correctly located in one of the holes in the adjustment rail and therefore the seat was not locked in the fully forward position required by the pilot. Additionally, the seat adjuster backup strap, intended to prevent rearwards seat movement in case of pin failure, appears not to have been tightened.

- ensure that the seat pin is correctly locking the seat in position, and
- set the seat adjuster backup strap after the desired seat position has been selected.

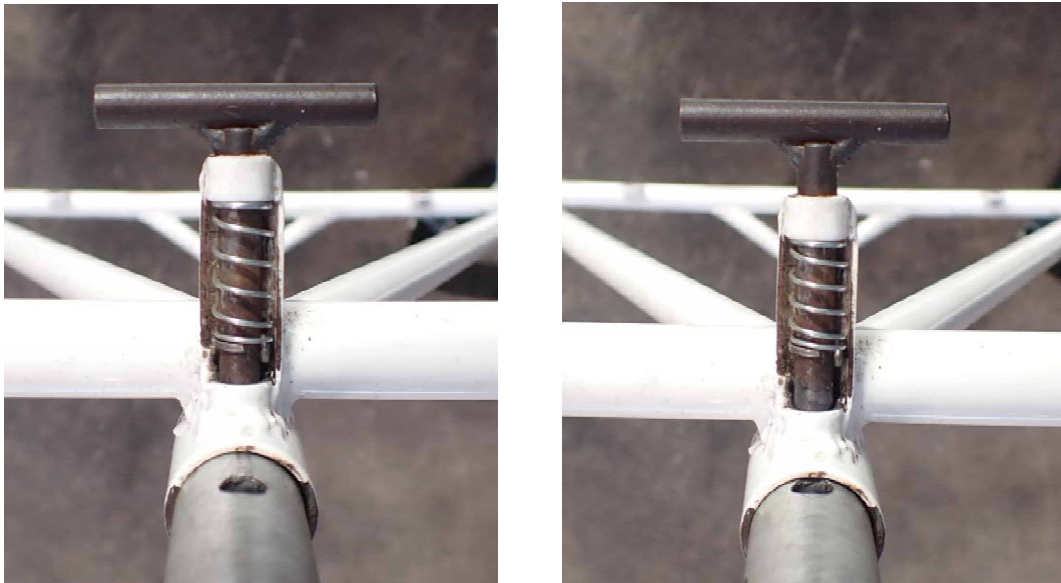
Witness evidence indicated that other users of the aircraft had previously experienced difficulty locating the pins for both left and right seats in an appropriate hole in the adjustment rail to lock the seats. Figure 5 shows a comparison between the correct and incorrect location of the seat adjustment pin. While sitting in the seat the occupant is not afforded the same view as in Figure 5.

Seat adjustment pin correctly located in one of the holes in the adjustment rail (left) and incorrectly located sitting on top of the adjustment rail (right).

Post-accident examination of the pilot's seat assembly showed that the seat pin was not correctly located in a hole in the adjustment rail. The damage and distortion to the adjustment rail was consistent with the seat being towards the rearmost extent of its travel when the aircraft struck the ground. Marks on the damaged adjustment rail showed that the seat adjustment pin and holes were slightly misaligned, with their centrelines offset (Figure 6), making it difficult for the pin to locate correctly.

It is recommended that the Light Aircraft Association remind owners of this aircraft type of the necessity, after every seat position adjustment, to:

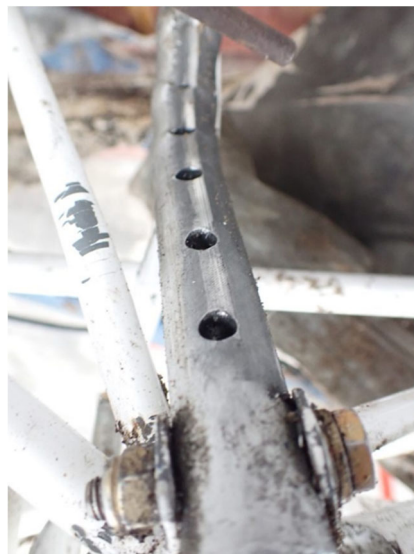
Figure 6

Marks created on the pilot's seat adjustment rail by the pin
