ACCIDENT

Aircraft Type and Registration:	Grob G102 Astir CS, G-CJSK	
No & Type of Engines:	None	
Year of Manufacture:	1977 (Serial no: 1521)	
Date & Time (UTC):	23 June 2021 at 1337 hrs	
Location:	Gibett Hill, Brentor, near Tavistock, Devon	
Type of Flight:	Private	
Persons on Board:	Crew - 1	Passengers - None
Injuries:	Crew - 1 (Minor)	Passengers - N/A
Nature of Damage:	Aircraft destroyed	
Commander's Licence:	Other	
Commander's Age:	65 years	
Commander's Flying Experience:	229 hours (of which 69 were on type) Last 90 days - 13 hours Last 28 days - 5 hours	
Information Source:	Aircraft Accident Report Form submitted by the pilot

Synopsis

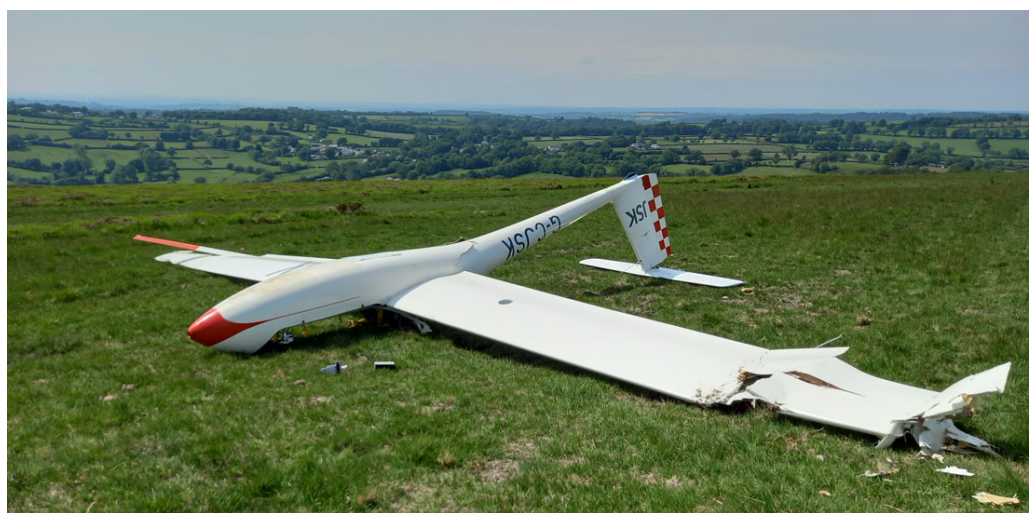
Figure 1
Accident site

The glider came to rest in an area of open ground approximately 1 nm NNE from Brentor^a Airfield in an inverted attitude (Figure 1).

All components of the glider were present at the accident site apart from the canopy, which had been jettisoned in flight and was recovered a short distance from the aircraft wreckage.

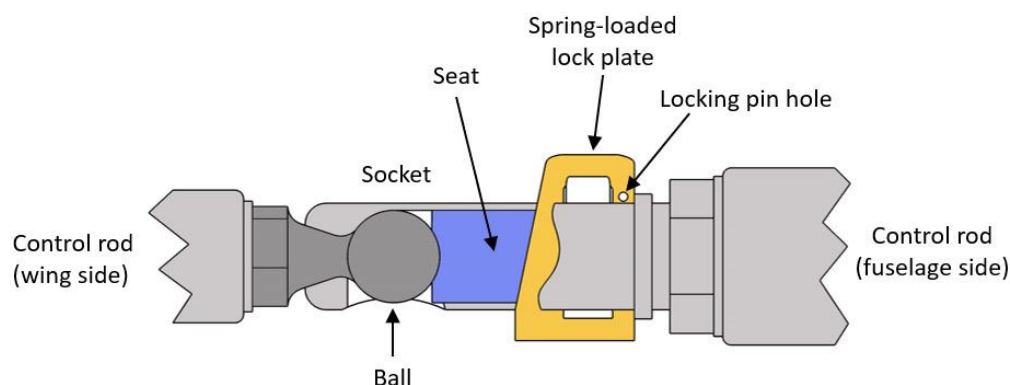
**Figure 3**

The aileron and airbrake control connections in the fuselage were of the L'Hotellier type, in which a ball on the wing pushrod end engages with a socket in the L'Hotellier fitting at the end of the fuselage pushrod (Figure 3). A spring-loaded lock plate is pressed downwards during assembly of the connection, which allows a seat to move away from the socket such that the ball may enter the socket. The ball is locked into the socket when the lock plate moves to its upward position, under spring loading, allowing the seat to contact the ball.

L'Hotellier control connection components

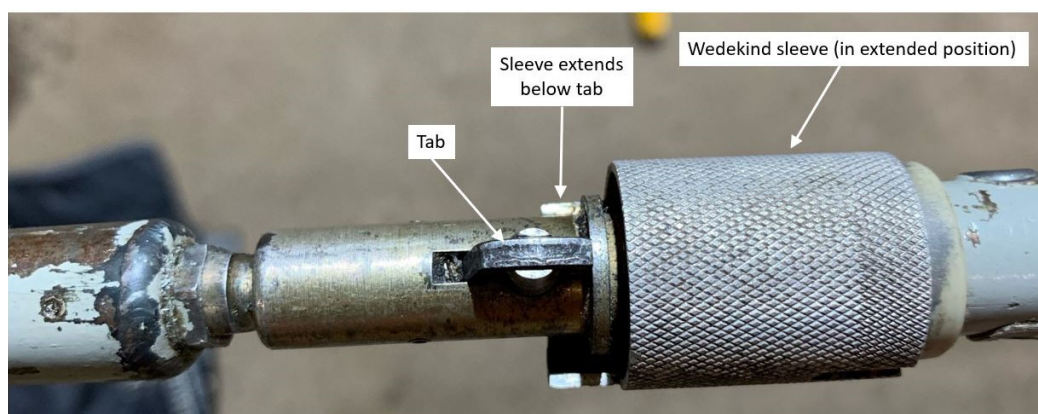
An alternative method of compliance was the installation of a Wedekind sleeve, which introduced a spring-loaded collar between the end of the pushrod and L'Hotellier fitting (Figure 4). The sleeve pushes away from the L'Hotellier fitting to permit assembly of the control connection, and extends by spring action when released to prevent the L'Hotellier lock plate from moving downwards, providing the secondary locking function. G-CJSK had Wedekind sleeves fitted to the airbrake and aileron control connections within the fuselage.

**Figure 4**L'Hotellier control connection with Wedekind sleeve correctly fitted
(image courtesy of the BGA)
