Rail Accident Investigation Branch

Rail Accident Report

Runaway and derailment of wagons at Toton, Nottinghamshire 17 January 2021

Report 09/2021
December 2021

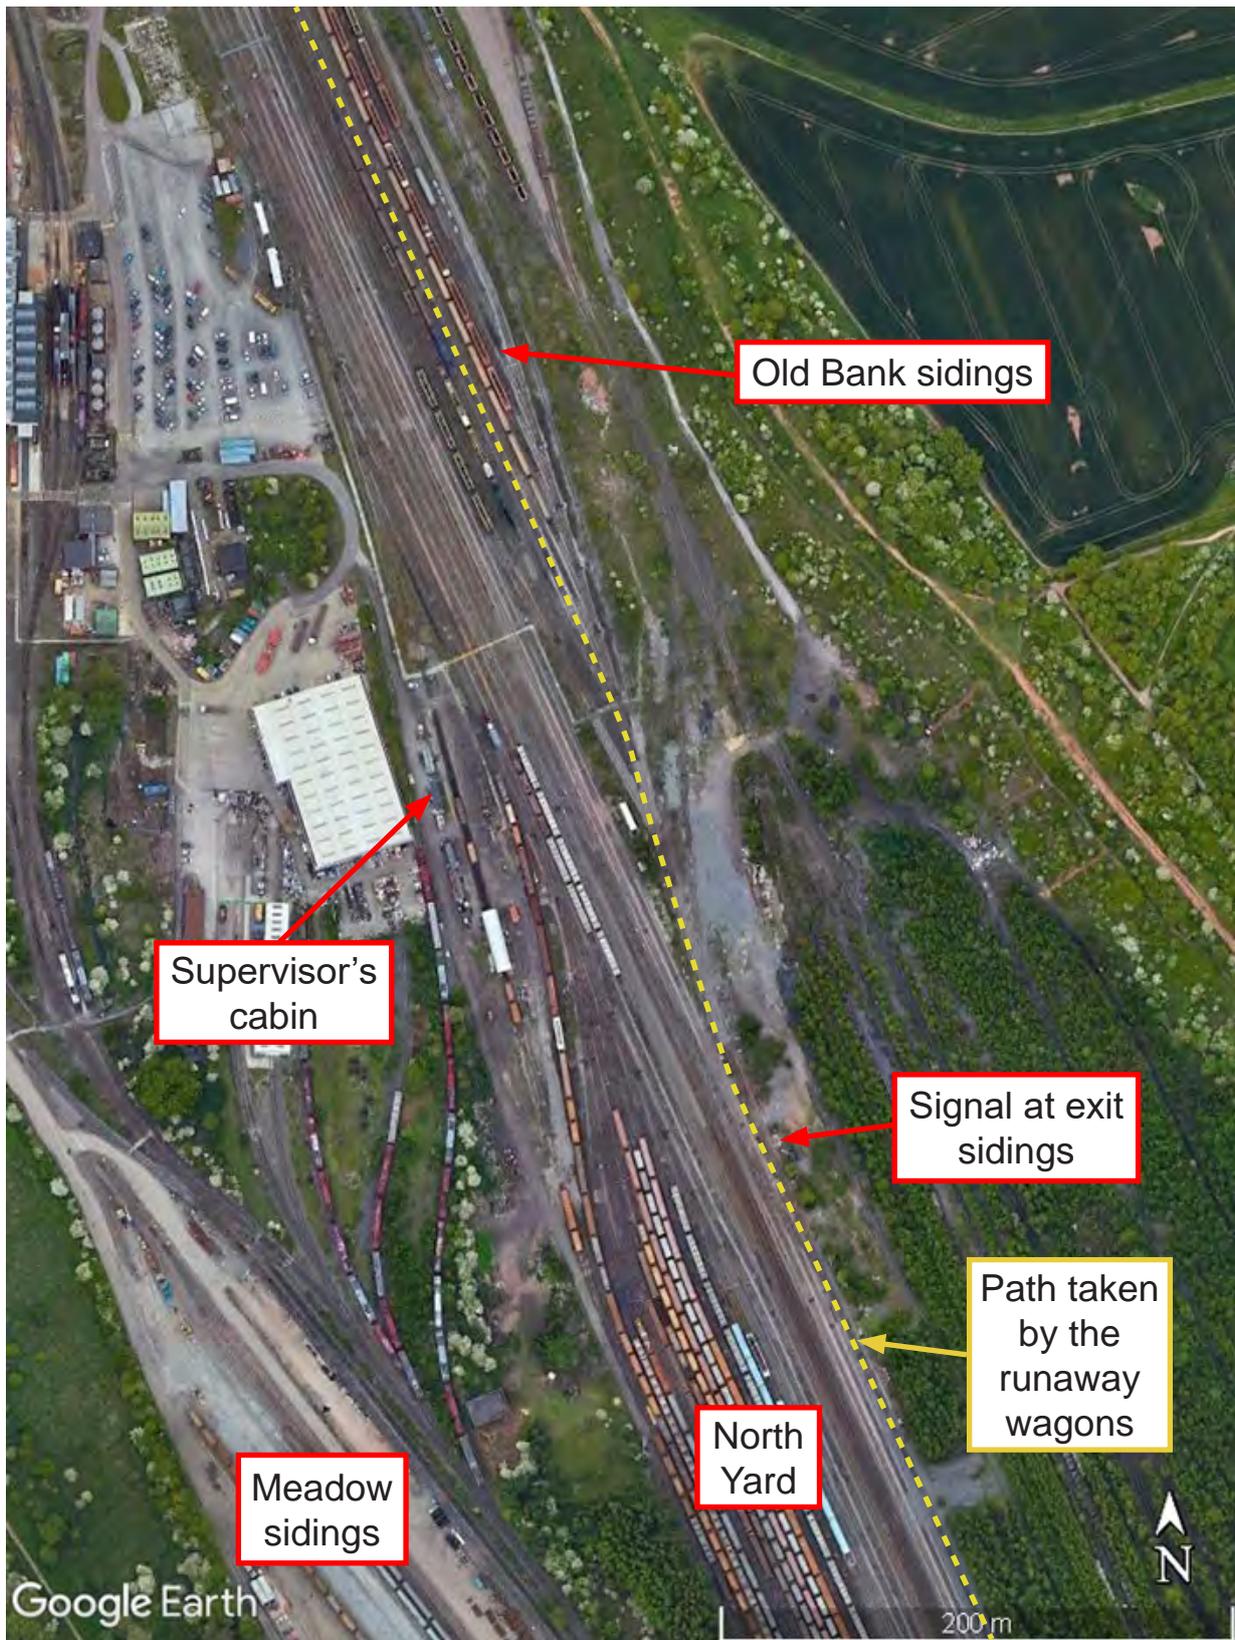
Figure 2: Google Earth view of the path taken by the runaway wagons out of Old Bank sidings

- 4 After exiting Old Bank sidings, the rake passed a signal displaying a red aspect, which generated an alarm on a signaller's workstation.¹ This alerted the signaller, who could see that track sections² along the line leading away from the sidings were being occupied (figure 2).
- 5 The rake then passed a second signal displaying a red aspect and, a short distance later, the leading four wagons derailed at the end of the run-out rails associated with a set of trap points. The trap points worked as intended to derail the unauthorised movement (figure 3). The leading two derailed wagons stopped foul of the adjacent running line (figure 4), although no trains were nearby when the derailment occurred. The rake of wagons travelled a total distance of about 0.6 miles (1.0 km) during the runaway.

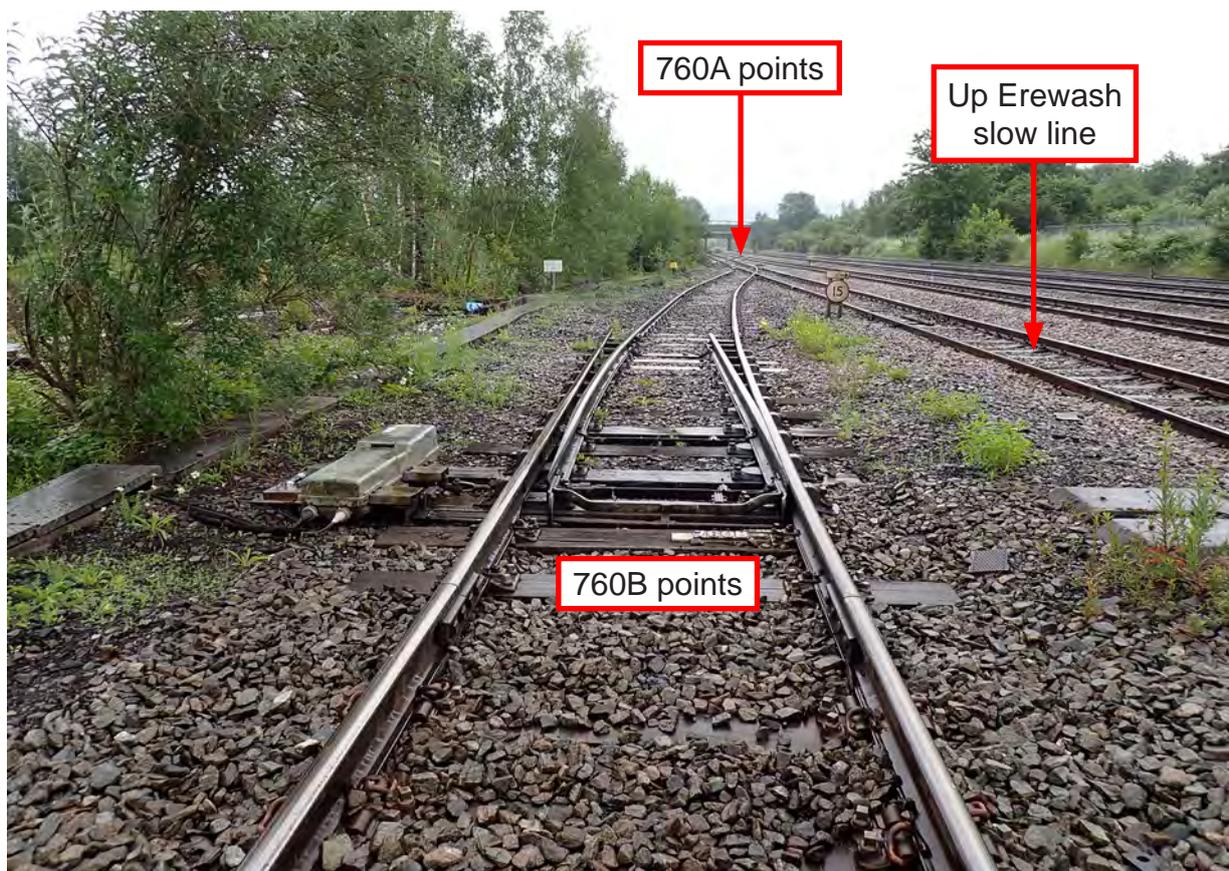
Figure 3: The trap points

- 38 The rake then continued for a short distance before it derailed on the run-out rails of 760B trap points. The rake eventually came to a stop with the leading two wagons obstructing the up Erewash slow line at Toton South Junction. Track section PJN on the up Erewash slow line showed as occupied at 04:45:59 hrs, due to the wheels of the derailed wagons damaging axle counter equipment.

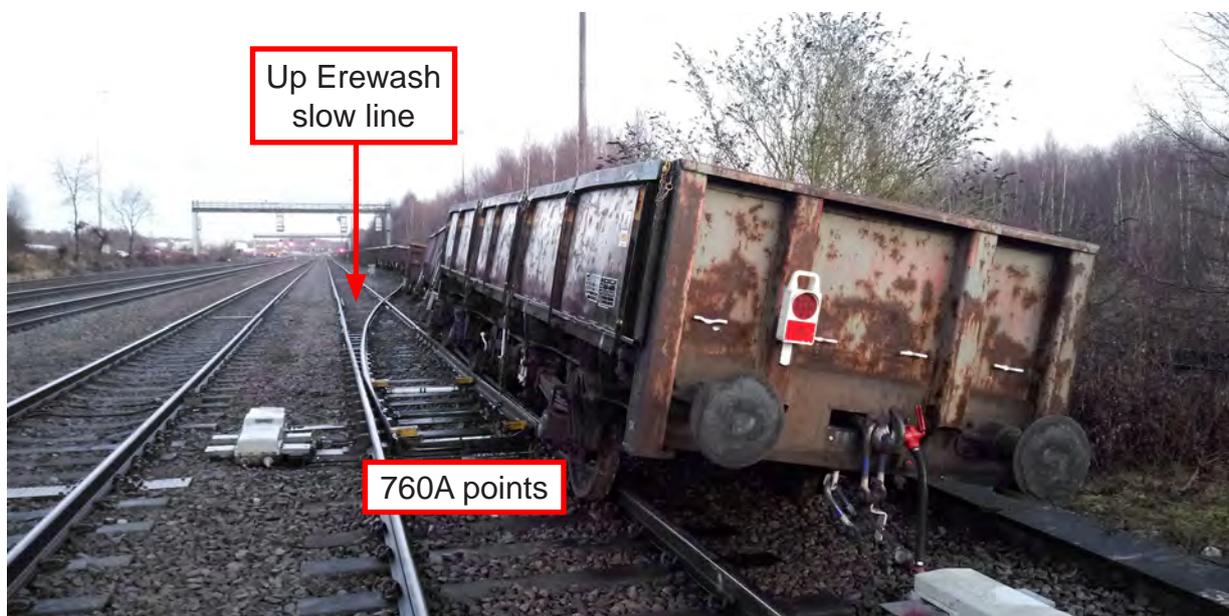
Figure 4: The derailed wagons (courtesy of DB Cargo)

- 6 The derailed wagons sustained some damage during the derailment and were uncoupled from the rest of the rake, which was pulled back into Old Bank sidings on 17 January. The derailed wagons were subsequently recovered by 13:30 hrs on 19 January. Track and signalling equipment where the wagons ran derailed also sustained damage. Repairs to this infrastructure were completed by 09:00 hrs on 21 January.

108 A factor that exacerbated the consequences of the event was that once derailed by the trap points, the leading two wagons stopped foul of the adjacent running line (paragraph 88, **Recommendation 4, Learning point 2**).

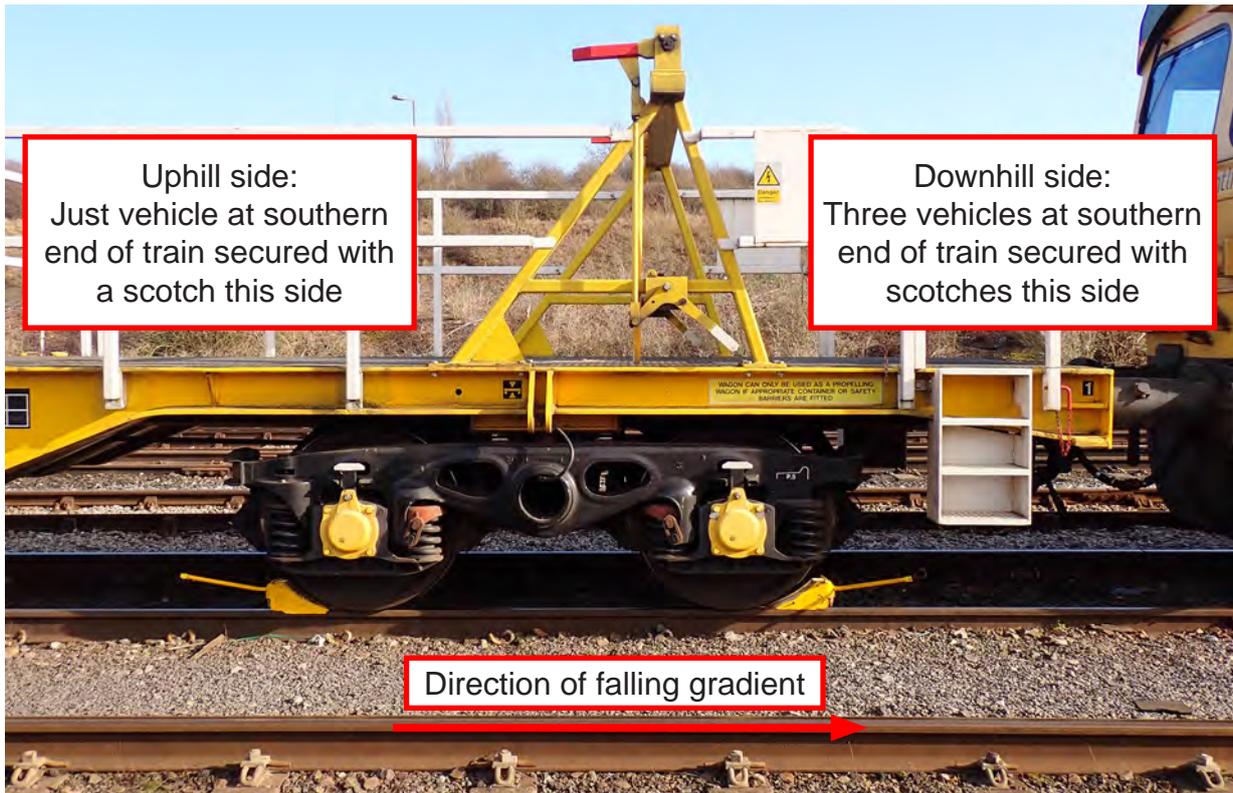
Figure 10: How vehicles should be secured in Old Bank sidings (courtesy of DB Cargo)

Location

- a. The rake of wagons ran away as no one had secured it after it was stabled in Old Bank sidings (paragraph 45). This causal factor arose due to a combination of the following:
 - i. The train was not secured before its locomotive was uncoupled from the wagons (paragraph 59, **Recommendation 1, Learning point 1**).
 - ii. There was miscommunication between the yard staff on duty about who would secure the train after its arrival at Old Bank sidings (paragraph 66, **Recommendation 2**).

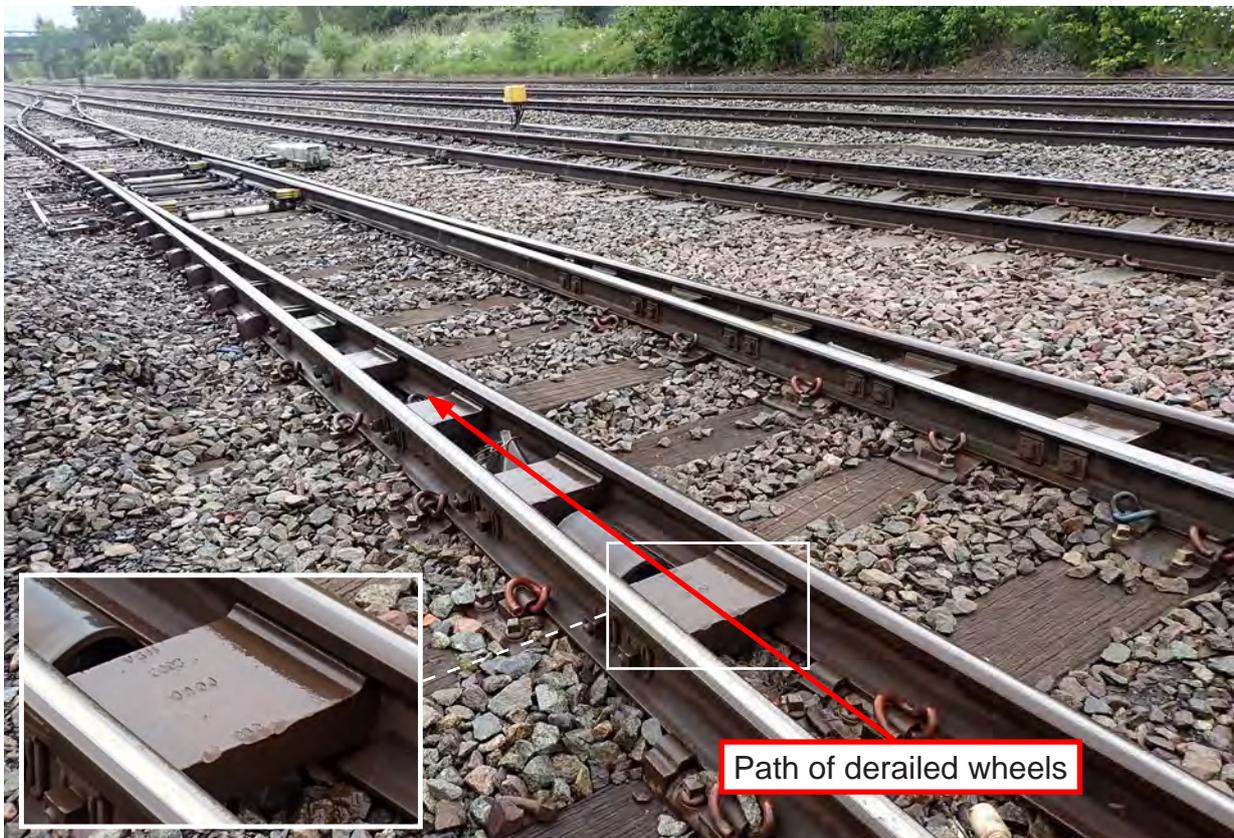
Figure 12: Impact marks on 760A points

91 The leading wagon travelled 75 metres while running derailed to reach 760A points. One reason the rake of wagons had travelled this far was because all but one of the wagons were loaded. This increased the mass of the rake from 606 tonnes (unladen) to a reported 1869 tonnes (paragraph 15). Based on the speed that the rake was travelling just before it derailed (paragraph 37), it possessed about 10.8 MJ of kinetic energy. This compares to about 3.5 MJ for a rake of unladen wagons, a ratio of around 3:1. However, the wheels of laden wagons are likely to dig into ballast more deeply than empty wagons when running derailed, so the drag forces will be higher than those applied to an unladen rake. Based on the distance travelled by the wagons, and accounting for the amount of kinetic energy and likely drag forces, analysis undertaken by RAIB suggests that a rake of empty wagons is likely to have travelled about 30 metres after derailling on the trap points. This would mean its leading wagon would have stopped short of fouling the adjacent line.
