**SERIOUS INCIDENT**

<b>Aircraft Type and Registration:</b>	Evolve Dynamics Sky Mantis	
<b>No &amp; Type of Engines:</b>	4 Electric Motor Engines	
<b>Year of Manufacture:</b>	2020 (Serial no: LINC S 2)	
<b>Date &amp; Time (UTC):</b>	1) 14 January 2021 at 1100 hrs 2) 17 February 2021 at 0930 hrs	
<b>Location:</b>	1) Skegness, Lincolnshire 2) Skegness, Lincolnshire	
<b>Type of Flight:</b>	Commercial Operations	
<b>Persons on Board:</b>	Crew - None	Passengers - None
<b>Injuries:</b>	Crew - N/A	Passengers - N/A
<b>Nature of Damage:</b>	1) Moderate damage to landing gear, fuselage and a motor. One blade missing  2) Moderate damage to landing gear and propellers. One blade missing	
<b>Commander's Licence:</b>	1) Other 2) Other	
<b>Commander's Age:</b>	1) 38 years 2) Unknown	
<b>Commander's Flying Experience:</b>	1) 14 hours (of which 2 were on type) Last 90 days - 5 hours Last 28 days - 5 hours  2) 9 hours (of which 2 were on type) Last 90 days - 2 hours Last 28 days - 2 hours

**Synopsis**

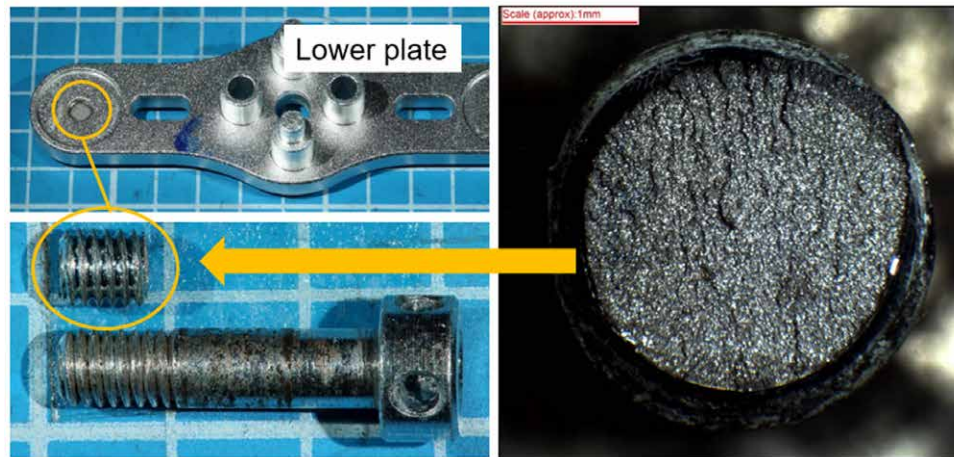
**Figure 4**

The screw had failed at the second thread from the plain diameter, (Figure 4) and the cut thread profile showed no material defects which would have initiated the failure. The fracture surface was intergranular, consistent with Stress Corrosion Cracking (SCC) with radial marks denoting the direction of crack propagation. There was light oxidation of the fracture surface, consistent with the relatively short period of service. The characteristics of the fracture face could not preclude the possibility that Hydrogen Embrittlement (HE) had also contributed to the failure mode.

Type 1 Blade attachment screw, fracture face

The primary failure mechanism for the type 1 screw was considered to be stress corrosion cracking but a contribution by hydrogen embrittlement could not be discounted.

The UAS was being operated near the coast and hence the saline content in the air may have provided an environment conducive for SCC. Radial markings indicated that a crack

had initiated on the surface, in the root of a thread and propagated across the diameter and the entire fracture surface area was intergranular in nature. Hydrogen may have been present as a result from the zinc plating process due to ineffective de-embrittlement. The complete coating of the screws with zinc would have trapped the hydrogen in the part and therefore not allowed a path for it to escape. The screw was susceptible to both HE and SCC as it was significantly above the threshold of 345 HV and it also exceeded the hardness specification value.

The type 1 screw failure was probably driven by the operational environment and the presence of hydrogen within the very hard steel. This combination resulted in stress corrosion cracking possibly exacerbated by hydrogen embrittlement.

In response to the two failures, the UA is now supplied with type 2 motor hub adaptors but with M4 screws. Single use locking nuts and shakeproof washers are used instead of the previously used thread locking compound. The assembly process is more detailed and controlled and a brass spacer bush has been fitted into the composite propeller blade root. Random sampling to test for hydrogen embrittlement has now been incorporated in the manufacturing process.

- Increased the screw diameter to M4
- Incorporated a stress test to ensure that bolts do not suffer from hydrogen embrittlement
- Used a serrated washer
- Used a single use lock nut
- Removed the thread locking compound
- Added a brass spacer to the blade root

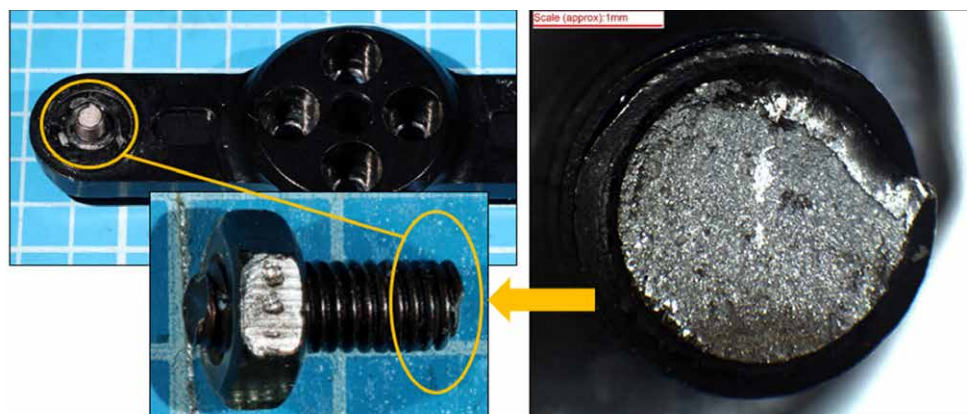
**Figure 5**

The predominant failure mode of the type 2 screw was through fatigue, which initiated from the thread root and had propagated across 90% of the cross section before final separation occurred. No initiating defect could be identified however, approximately 20% of the stable crack growth cross-section exhibited evidence of intergranular fracture, consistent with hydrogen embrittlement. The remainder being trans-granular indicative of fatigue crack growth. The level of embrittlement was determined to be insufficient to have caused the failure however, it may have reduced the threshold for crack initiation and would have accelerated the crack growth.

Type 2 Blade attachment screw, fracture face

The failure of the type 2 screw was predominately fatigue crack growth but with areas of the fracture surface exhibiting hydrogen embrittlement. No initiating flaw could be identified but it is possible that stress concentration at the thread root in combination with HE was sufficient to initiate a crack which then grew during the 3.6 million motor revolutions before failure. It is possible that the application process for the surface finish was the source of hydrogen in the screw. The high hardness of the material would have reduced the fracture toughness and in combination with the HE further reduced the time to failure.

The type 2 screw failure by fatigue crack growth was probably initiated and then accelerated by hydrogen embrittlement.

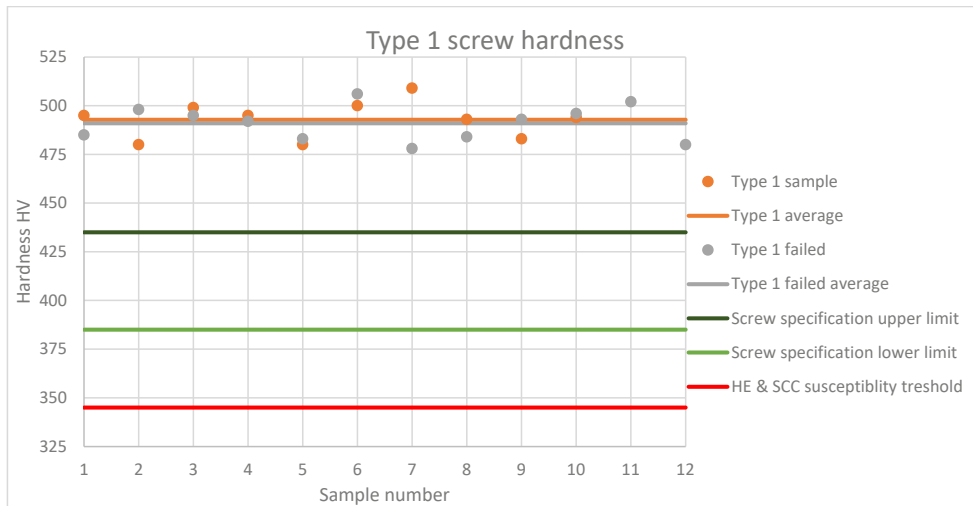
**Graph 1**

All the sample screws and the failed type 1 screw were very similar in hardness and exceeded the specification value. The difference between the average hardness of the sample screws and the failed screw was 2 HV.

Hardness testing of type 1 screw samples

The use of screws in both accidents with the hardness exceeding the specification value, was determined to be a causal factor in their failures.

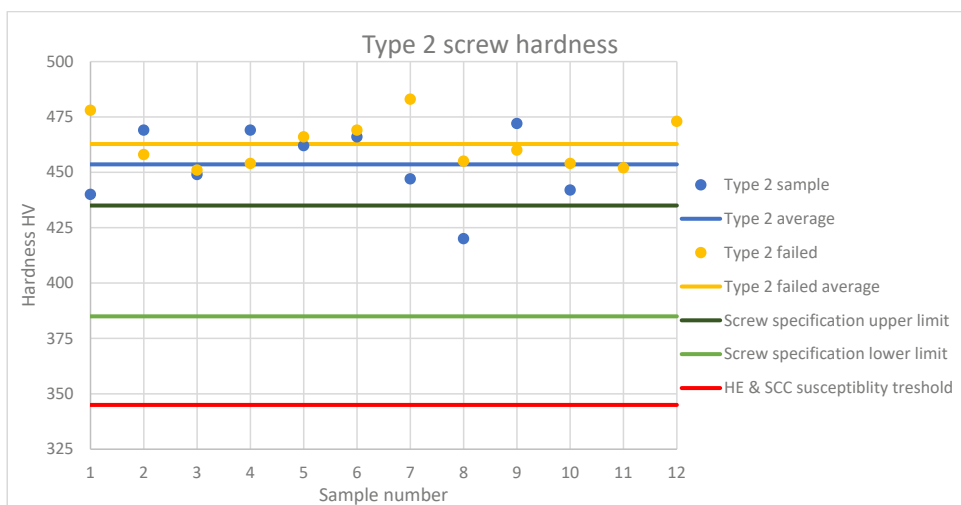
**Graph 2**

Apart from one of the sample type 2 screws, all screws exceeded the hardness specification. The average hardness of the failed screw was almost 10 HV greater than that of the average hardness of the sample screws.

Hardness testing of type 2 screw samples
