**SERIOUS INCIDENT**

<b>Aircraft Type and Registration:</b>	Jabiru J400, G-CCPV	
<b>No &amp; Type of Engines:</b>	1 Jabiru 3300A piston engine	
<b>Year of Manufacture:</b>	2006 (Serial no: PFA 325-14058)	
<b>Date &amp; Time (UTC):</b>	17 August 2021 at 1326 hrs	
<b>Location:</b>	Tevioyhead, Northwest of Spadeadam danger area, Scottish Borders	
<b>Type of Flight:</b>	Private	
<b>Persons on Board:</b>	Crew - 1	Passengers - None
<b>Injuries:</b>	Crew - None	Passengers - N/A
<b>Nature of Damage:</b>	None	
<b>Commander's Licence:</b>	Light Aircraft Pilot's Licence	
<b>Commander's Age:</b>	71 years	
<b>Commander's Flying Experience:</b>	491 hours (of which 266 were on type) Last 90 days - 20 hours Last 28 days - 6 hours	
<b>Information Source:</b>	Aircraft Accident Report Form submitted by the pilot, flight data and ATC recordings

**Synopsis**

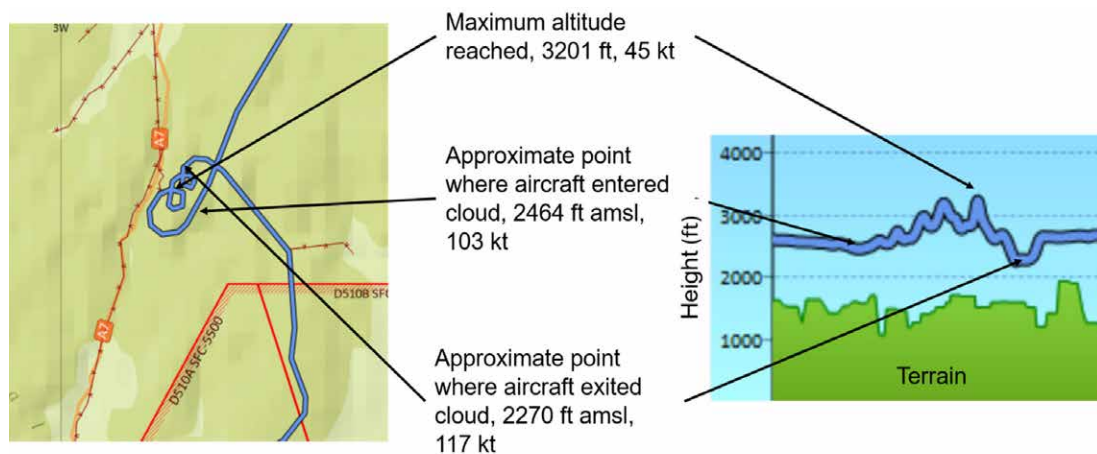
**Figure 1**

lost control. The aircraft completed three 360° right turns before it emerged from the cloud. The aircraft was in the cloud for between three and four minutes.

Aircraft track, altitude (ft amsl) and ground speeds (kt) during inadvertent entry to IMC
