SERIOUS INCIDENT

Aircraft Type and Registration:	Europa, G-FLOR	
No & Type of Engines:	1 Rotax 912-UL piston engine	
Year of Manufacture:	1999 (Serial no: PFA 247-12793)	
Date & Time (UTC):	23 June 2021 at 1415 hrs	
Location:	Brinkworth, Wiltshire	
Type of Flight:	Private	
Persons on Board:	Crew - 1	Passengers - 1
Injuries:	Crew - None	Passengers - None
Nature of Damage:	Left door, gas strut and hinges missing, minor damage to left tailplane	
Commander's Licence:	Airline Transport Pilot's Licence	
Commander's Age:	60 years	
Commander's Flying Experience:	19,864 hours (of which 4 were on type) Last 90 days - 85 hours Last 28 days - 20 hours	
Information Source:	Aircraft Accident Report Form submitted by the pilot and subsequent AAIB enquiries

Synopsis

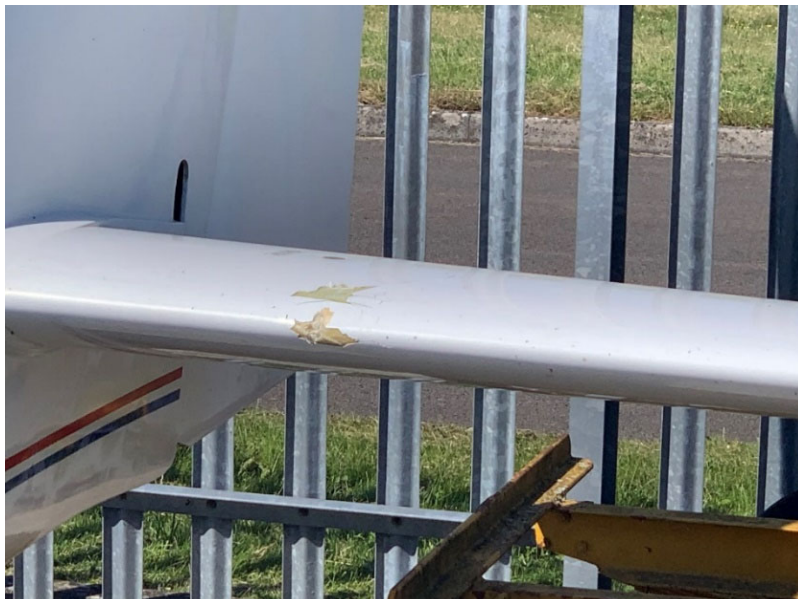
Figure 1

The left tailplane was subsequently found to have been damaged (Figure 1), in a manner consistent with it having been struck by the door. The door was not recovered.

Damage to G-FLOR's left tailplane

The rear tailplane sustained minor damage to its leading edge and upper surface.

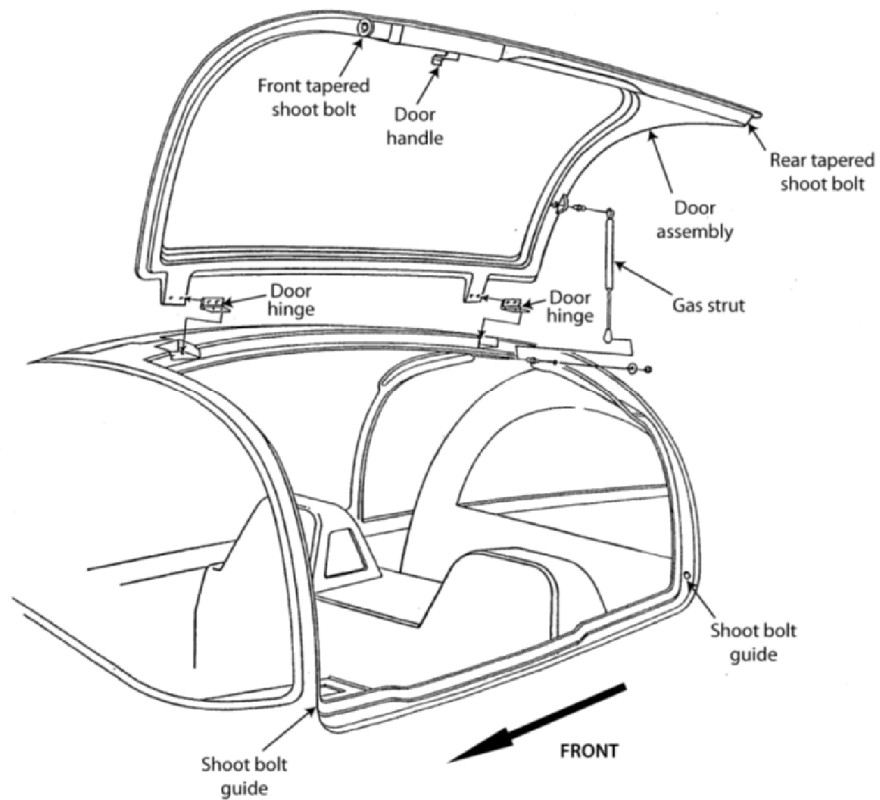
Figure 2

The doors are of a gull wing arrangement with each door hinged in two places along its top edge (Figure 2). Each hinge is attached to the fuselage using Araldite 420 adhesive mixed with flox¹, and two bolts that are secured using AN970-3 washers and nuts fitted from the inside of the fuselage (Figure 3). The large diameter 'penny' type washers assist in spreading the load and also prevent the nuts from embedding into the composite structure as they are tightened.

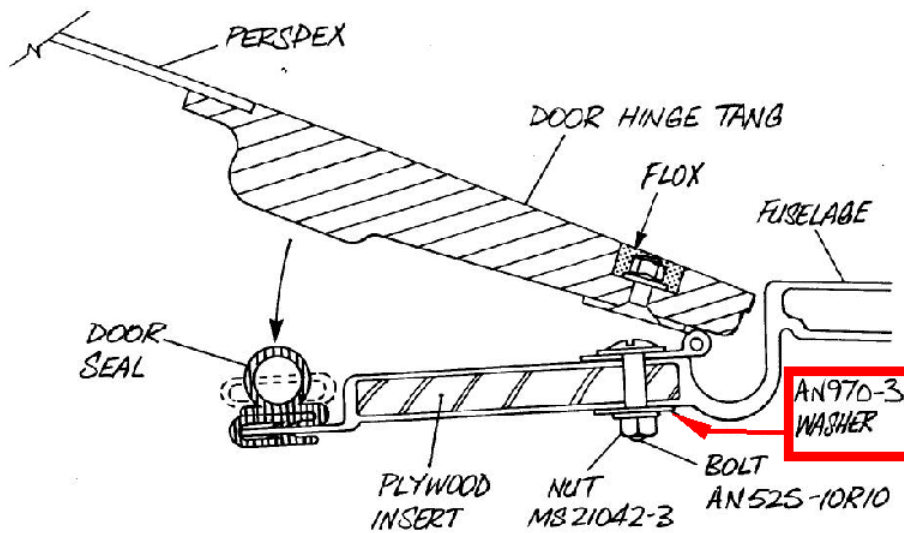
Figure 3

Inspection of the remaining left door forward hinge and both the right door hinges, showed that the AN970-3 washers were not fitted.

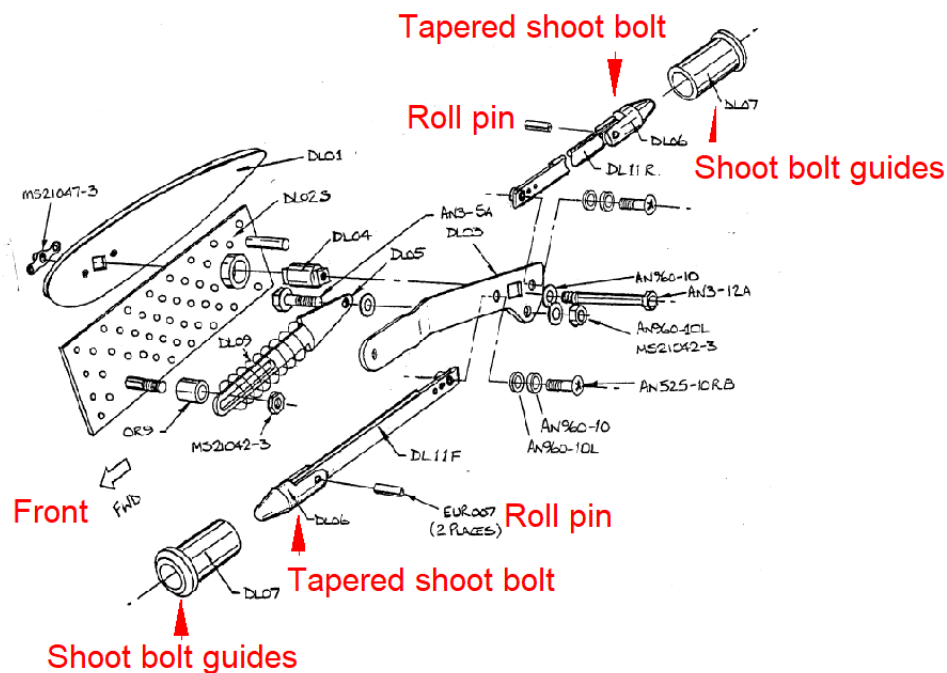
Figure 4

The door is held closed by two tapered shoot bolts which extend out longitudinally from the lower corners of the front and rear sides of the door, between 10 to 12 mm into guides in the door frame (Figure 4). The push rod for each tapered shoot bolt is attached to the door locking lever with a bolt, washers, and an anchor nut fitted to the push rod. The tapered shoot bolt tips are secured to the push rods using roll pins.

If the door is not fully closed at the rear, it is possible to move the door locking lever to the closed position with only the front tapered shoot bolt engaged in its guide. This gives the false impression that the door is closed and fully latched but with the rear tapered shoot bolt resting against the outside of the fuselage skin adjacent to the door frame. If this occurs, a small gap may be evident near the lower rear area of the door.

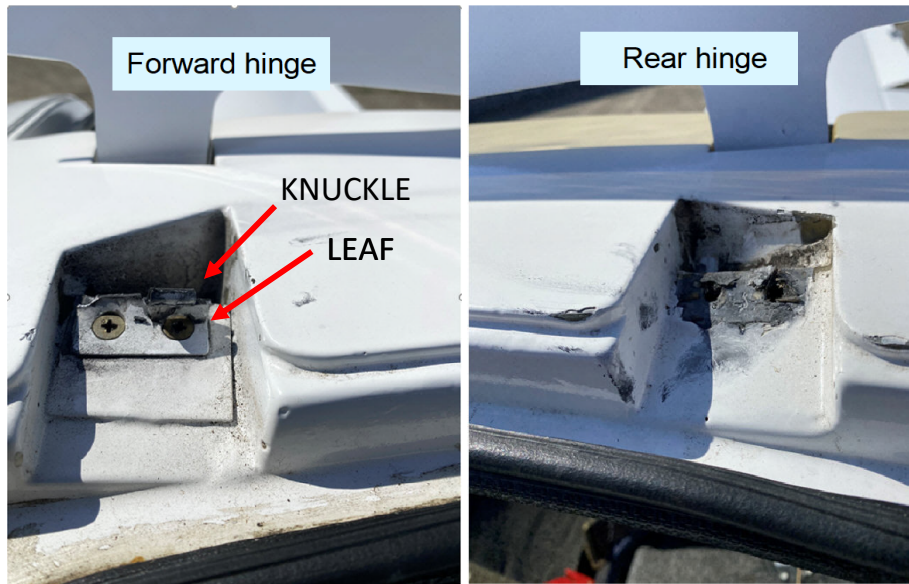
The left door's forward hinge leaf had remained attached to the fuselage with the hinge knuckles having failed due to overload. The rear hinge was missing (Figure 5), with damage consistent with it having been pulled from the fuselage. The damage was consistent with loads exerted by the door when it had opened in flight.

Figure 5
Left door forward and rear hinges

The evidence from this event is consistent with that of previous occurrences involving the inadvertent opening of cockpit doors fitted to Europa aircraft because the door was not correctly latched. This includes a lack of significant damage to the door guides and surrounding fuselage of G-FLOR, which would have been expected if a correctly latched door was to have detached from the aircraft. The damage to the forward hinge and airframe structure at the rear hinge location was consistent with overload failure as a result of the aerodynamic loads placed on the door as it had opened, rather than a fatigue-related failure of either hinge. The possibility that the rear hinge was also not fitted with washers, combined with higher loads that may have been placed on it as the door opened, may explain why this hinge detached from the fuselage.

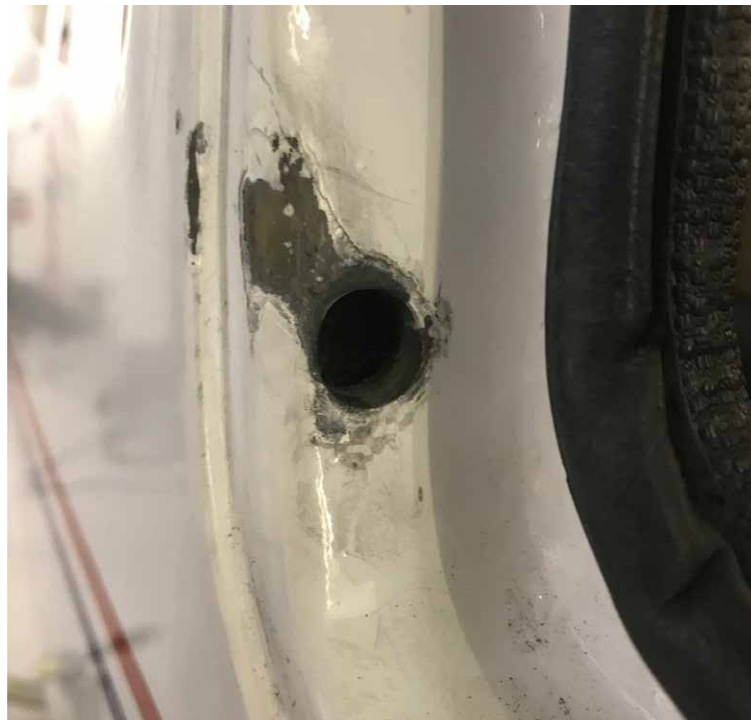
There was no evidence of significant damage to either the left door's front or rear shoot bolt guides, the surrounding door frame or fuselage. However, there was superficial damage to the paintwork adjacent to both the left door's front and rear guides (Figure 6 and Figure 7). The damage was similar and was consistent with having been caused by the tapered shoot bolt coming into contact with the fuselage skin and the door frame. Possible causes for this included:

- The shoot bolt had rested against the fuselage skin because it had not engaged into its guide when the door was closed, and the locking lever moved to its closed position.
- The shoot bolt had rested against the fuselage skin because the door had been inadvertently closed with the locking lever in the closed position.

- The shoot bolt had rubbed against the inside of the door frame because the door had been opened and/or closed with the locking lever not in the fully open position.
- The shoot bolt had rested against the inside of the door frame when the locking lever was in the closed position.

Figure 6
Front shoot bolt guide

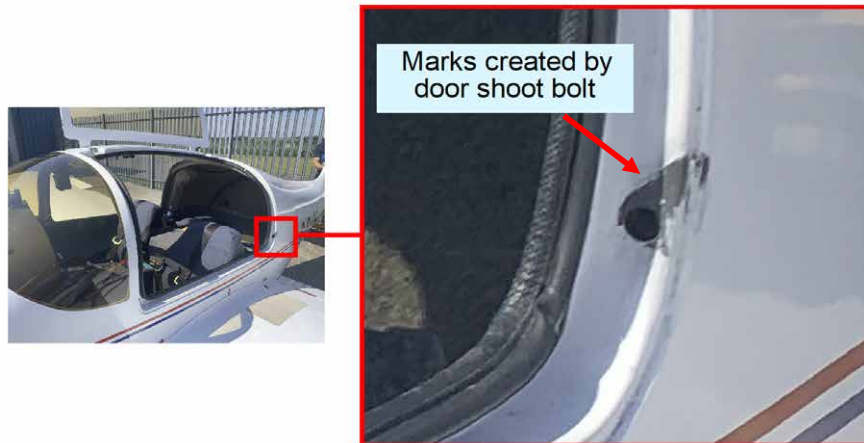
Figure 7

Rear shoot bolt guide

The pilot of G-FLOR had checked the left door twice before takeoff. Discussions with the LAA indicated that it was unlikely that the door could be incorrectly latched and still appear secure when pushed against. However, there were marks adjacent to the door guide that could have been caused by the shoot bolt pressing against it because the push rod had been bent at some point, and so the possibility remains that this could have presented a false indication to the pilot. The door has not been recovered and so a problem with the door mechanism could not be ruled out.

On 1 November 2021, the LAA approved and issued a standard modification (mod number SM 15833) for fitment to Europa aircraft to prevent the door latch from closing when the door is not pulled home at the rear, and the rear pin is properly engaged. The requirement for this modification has been promulgated by LAA Airworthiness Information Leaflet MOD/247/012, which has been allocated mandatory status for all Europa aircraft operating under an LAA Permit to Fly and is required to be fitted within five flying hours after that date, or next permit revalidation, whichever comes first.
