SERIOUS INCIDENT

Aircraft Type and Registration:	Airbus A319-111, G-EZBD
No & Type of Engines:	2 CFM CFM56-5B5/P turbofan engines
Year of Manufacture:	2006 (Serial no: 2873)
Date & Time (UTC):	13 July 2021 at 1048 hrs
Location:	London Luton Airport
Type of Flight:	Commercial Air Transport (Non-Revenue)
Persons on Board:	Crew - 2 Passengers - None
Injuries:	Crew - None Passengers - N/A
Nature of Damage:	None
Commander's Licence:	Airline Transport Pilot's Licence
Commander's Age:	32 years
Commander's Flying Experience:	4,412 hours (of which 4,272 were on type) Last 90 days - 16 hours Last 28 days - 1 hour
Information Source:	Aircraft Accident Report Form submitted by the pilot

Synopsis

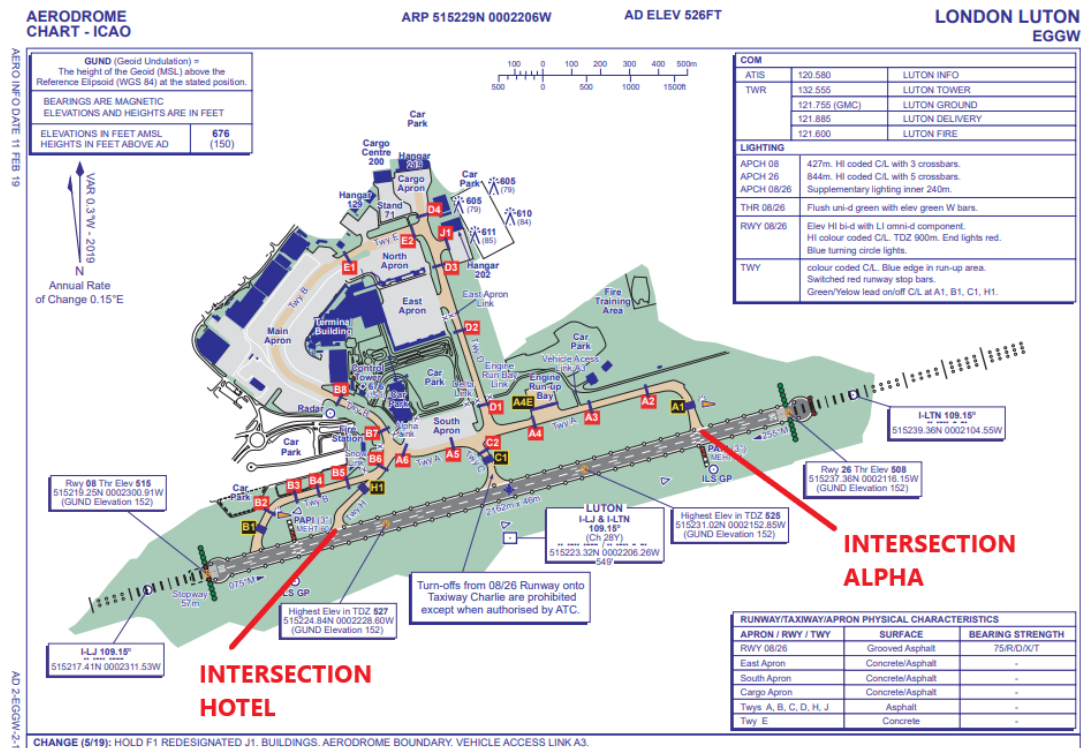
Figure 1
 Luton Airport Diagram

The pushback, engine start and taxi out were uneventful and there were no indications of any instrument malfunctions. The aircraft positioned for a departure from intersection H on Runway 07 at Luton (Figure 1).
