Defence
Infrastructure
Organisation

Safety Alert

Subject: Failure of assault course climbing ropes

Number: SA 2021/08

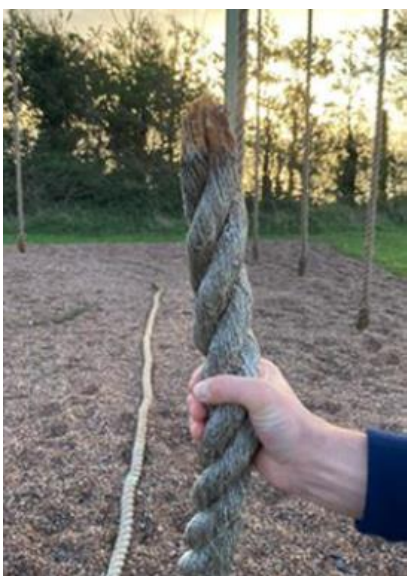
4. Students were using obstacle course climbing ropes when one of the 30-foot ropes parted from its securing 'tulip', fortunately the student had only taken one heave on the rope.

7. Evidence of the failed rope would appear that this was of natural-fibre construction, as opposed to the JSP 315 recommended polypropylene type for 'climbing ropes'. The rope that failed, along with others on the same obstacle, was renewed on 22 May 2020.

Failed natural hemp climbing rope

11. TLBs should take all climbing ropes out of use until they can confirm the inspection of obstacle course ropes have been undertaken IAW 2012DIN07-136.

12. That the correct type of climbing ropes are in use. (Design drawing DE Drawing E 8949/DE/A18 – Obstacle A 18 – Climbing Ropes indicates that the rope material for 'climbing ropes' should be polypropylene.)

13. Any climbing ropes isolated under Part A of this Safety Alert are not to be returned to service until they have been subject to appropriate condition inspection and confirmation of correct rope type and ALL remedials identified are completed.
14. On completion of any necessary inspection and any remedial work the units can be returned to service.
15. The MMO is to notify the DIO Service Manager, HoE and establishment 4Cs Duty Holder when any unit is returned to service.
16. Once the condition and serviceability of the assts are known the MMO is requested to provide an establishment specific Asset Management Plan, for approval of DIO Service Manager, confirming their strategy for the planned preventative maintenance IAW 2012DIN07-136 (or replacement where appropriate) of these assets by 4th February 2022.

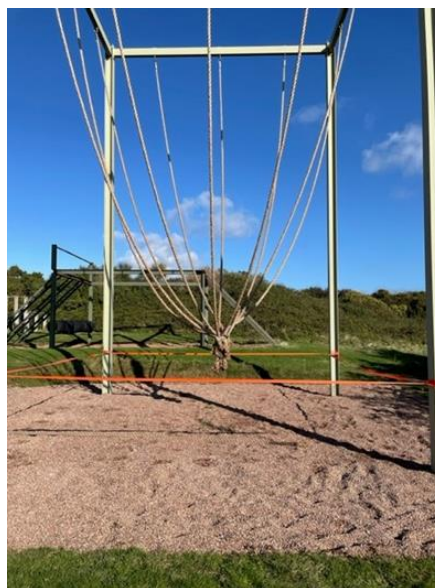
30ft climbing frame
