SERIOUS INCIDENT

Aircraft Type and Registration: ATR 72-211, G-CLNK

Date & Time (UTC): 16 April 2021 at 0630 hrs

Location: Guernsey Airport

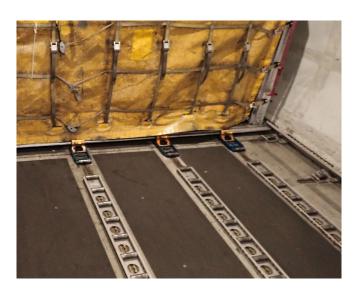
Figure 2
ULD rails and locking mechanisms

ULDs are filled, weighed and their position in the aircraft determined by the loading planners prior to being delivered to the aircraft. They are then individually loaded onto the aircraft at the forward cargo door and pushed into position by hand. The ULD slide along rails that are attached to the cargo bay floor (Figure 2).

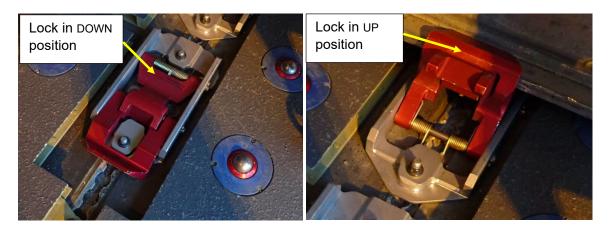
Figure 3
ULD lock positions

The locks can be used as a rear restraint, a forward restraint or when positioned between two ULDs as both a forward and rear restraint. When loading the aircraft, the locks at the rear of the bay in which the ULD is to be positioned should be in the UP position and the ULD is moved rearwards until it engages with these locks. Once in position, the forward locks are raised and engage with the front of the ULD preventing it from moving forward.

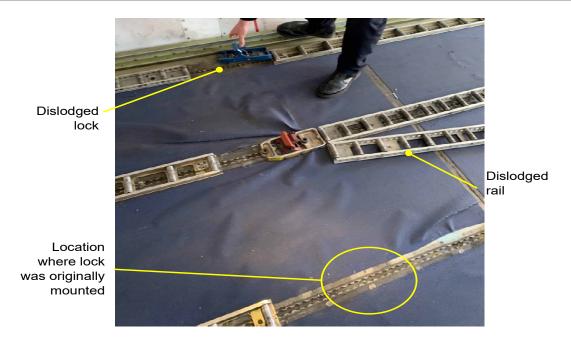
Figure 4

Examination of the aircraft by the operator found that the locks and rails between bays C2 and C3 were damaged and dislodged (Figure 4), and the locks to the rear of bay C3 were DOWN. The locks between bays C2 and C3 had been pulled out of the tracks in the cargo bay floor within which they were attached.

An investigation by the ground handling organisation identified that when the ULD in bay C3 was moved into location, the locks between bays C3 and C4 were not raised and remained in the DOWN position; however, the forward locks were raised. During the takeoff roll the slight thud heard by the crew was probably the ULD in bay C3 sliding rearwards to bay C4 and stopping against the forward locks which restrained the ULD in C5. During the landing the ULD would have slid forward as the aircraft decelerated, breaking the locks between bays C2 and C3 which were in the UP position. Its movement would then have been arrested when it hit the raised locks to the rear of the ULD in C1.

Damage to rails and locks between bays C2 and C3 (reproduced with permission)

The ground handling organisation has revised their loading procedures to introduce an independent check to verify that all locks are positioned in the correct position when the aircraft is loaded.
