ACCIDENT

Aircraft Type and Registration:	Beech Baron 95-B55, G-UROP	
No & Type of Engines:	2 Continental Motors Corp IO-470-L piston engines	
Year of Manufacture:	1982 (Serial no: TC-2452)	
Date & Time (UTC):	27 March 2021 at 1215 hrs	
Location:	Wellesbourne Mountford Airfield, Warwickshire	
Type of Flight:	Private	
Persons on Board:	Crew - 2	Passengers - 1
Injuries:	Crew - None	Passengers - None
Nature of Damage:	Damage to left outer wing, nose and landing gear components. Both propellers damaged and engines shock-loaded	
Commander's Licence:	Commercial Pilot's Licence	
Commander's Age:	65 years	
Commander's Flying Experience:	12,129 hours (of which 19 were on type) Last 90 days - 5 hours Last 28 days - 5 hours	
Information Source:	Aircraft Accident Report Form submitted by the pilot and further enquiries by the AAIB

Synopsis

The aircraft's landing gear retracted during a touch-and-go whilst the aircraft was on the runway. The cause of the landing gear retraction could not be conclusively identified.

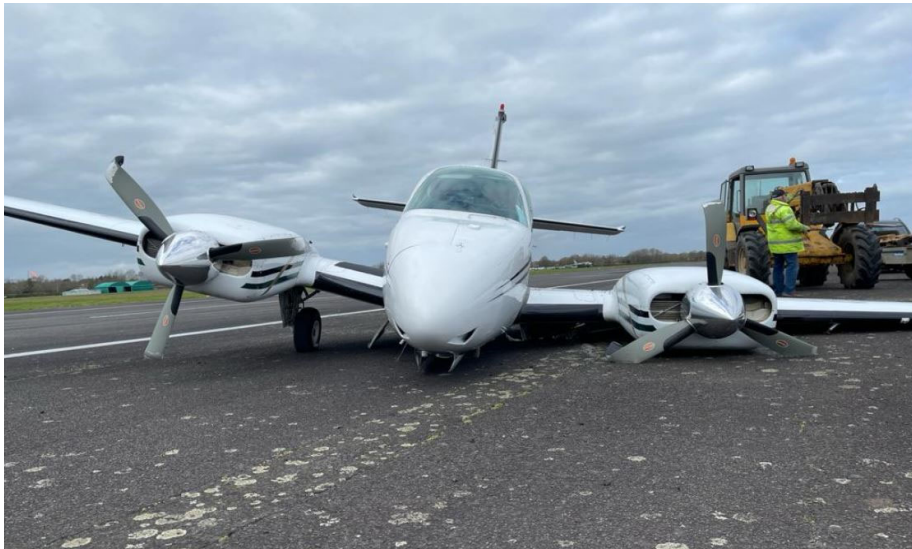
Figure 1

the pre-landing checks. The landing gear position indicator lights showed 'three-greens', indicating that the landing gear was down and locked. Full flap was selected on final approach and the aircraft touched down normally, however as the pilot flying increased engine power the aircraft was observed to settle onto its nose and left wingtip, and both propellers struck the runway surface. The right main landing gear leg remained locked in the down position. The aircraft slid to a halt slightly left of the runway centreline (Figure 1). The occupants were not injured and were able to vacate the aircraft without incident, using the cockpit door.

G-UROP following the landing accident

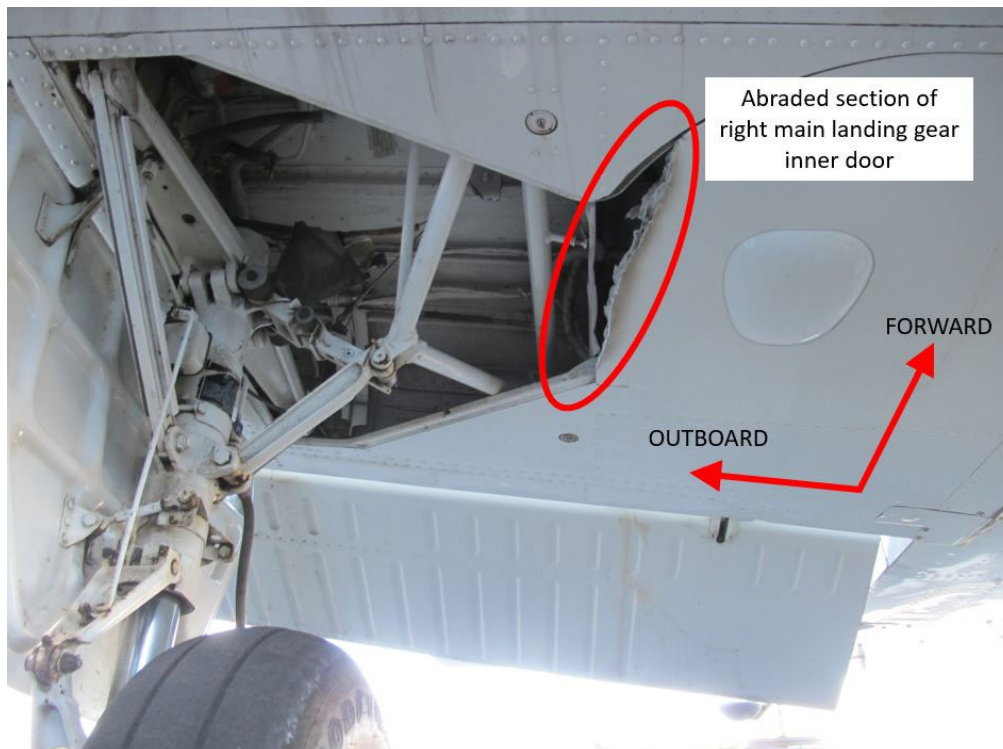
Figure 2

The aircraft was recovered by lifting it beneath the wings and extending the nose and left main landing gear legs, which locked down allowing the aircraft to be towed from the runway. Examination of the aircraft revealed that the outboard end of the right main landing gear inner door was abraded due to contact with the runway during the accident (Figure 2). This door is mechanically sequenced to open when the landing gear is extended or retracted, and is closed when the landing gear is either fully up or down. The damage indicated that the right main landing gear had partially retracted and then extended during the ground roll.

Abraded outer edge of right main landing gear inner door

The abrasion damage to the right main landing gear inner door indicates that the landing gear had partially retracted before then extending again during the ground roll, whilst the aircraft was below flying speed. The nose and left main landing gear legs collapsed under the weight of the aircraft, but the right main landing gear remained extended, possibly due to it experiencing an outward side-load during the accident.
