SERIOUS INCIDENT

Aircraft Type and Registration:	Piper PA-31, G-UKCS
No & Type of Engines:	2 Lycoming TIO-540-A2C piston engines
Year of Manufacture:	1974 (Serial no: 31-7400984)
Date & Time (UTC):	23 July 2021 at 0933 hrs
Location:	Doncaster Sheffield Airport
Type of Flight:	Aerial survey
Persons on Board:	Crew - 1 Passengers - 2
Injuries:	Crew - None Passengers - None
Nature of Damage:	Lower cabin door damaged
Commander's Licence:	Airline Transport Pilot's Licence
Commander's Age:	26 years
Commander's Flying Experience:	1,513 hours (of which 66 were on type) Last 90 days - 37 hours Last 28 days - 15 hours
Information Source:	Aircraft Accident Report Form submitted by the pilot and further enquiries by the AAIB

Synopsis

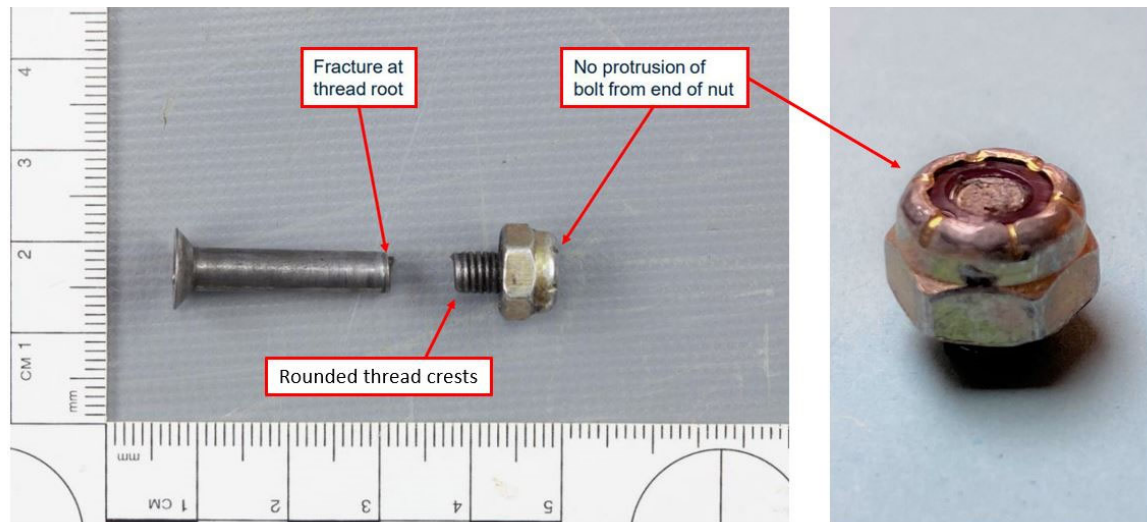
Figure 3

The cabin door latch mechanism was disassembled, revealing that the forward door latch pin screw had broken (Figure 3), and the door latch return spring was bent, with one end fractured.

Fractured door latch pin screw (image courtesy of QinetiQ)

The latch pin screw had fractured at the thread root, close to the shank of the screw, and the thread crests in this area were rounded and worn around the circumference. The self-locking nut was observed to be insufficiently engaged on the screw threads, with no projection of the screw thread beyond the end of the nut. The screw was measured and confirmed, with reference to the aircraft's Illustrated Parts Catalogue, to be the correct screw for the latch assembly³.

The forward latch pin screw fractured during flight due to propagation of a fatigue crack, through the threaded portion of the screw, which reached sufficient length that the remaining section of the screw could no longer withstand the loads applied to it. The screw was loose within the latch pin assembly because its self-locking nut had not been tightened at an unidentified previous maintenance event. The looseness of the screw contributed to the propagation of the fatigue crack as the screw had been subject to bending loads in service and rotation of the screw had caused fatigue to propagate from multiple initiation sites around the screw thread root.

The operator plans to conduct a fleet check on its PA-31 aircraft to ensure that the latch pin screws are not loose and are correctly mechanically fastened. It also plans to issue the following amplification statements:

- In its PA-31 Check 1 (50-hour) inspection to include specific visual inspections for correct engagement of the cabin door latch pins and hook plates when the door is locked closed, and also that the latch pin screws are correctly mechanically fastened. Correct rigging of the internal and external cabin door handles is also to be highlighted in the Check 1 instructions.
- In its PA-31 Operations Manual pre-flight checklist to include a specific visual inspection to ensure that the cabin door internal handle is flush to the door inner skin when the door is locked closed.

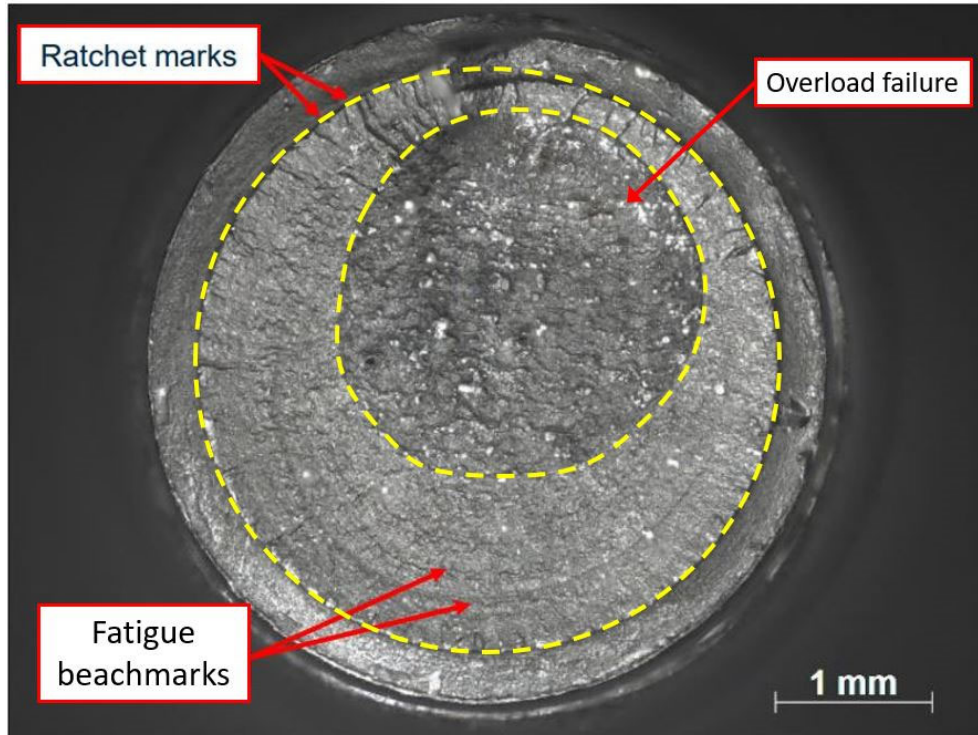
Figure 4

The screw's fracture surface exhibited fatigue beachmarks around the circumference of the fracture surrounding a smaller area of relatively rough, dull fracture characteristic of overload (Figure 4). A number of ratchet marks⁴ were also visible within the fatigue region of the fracture surface, which encompassed approximately 60% of the screw's cross-section.

The propagation of fatigue cracking around the periphery of the screw thread root, surrounding the overload region, is characteristic of the screw being loose in the door latch assembly and rotating between load cycles. The worn and rounded thread crests at the fracture location on the screw also indicate a similar wear mechanism.

End view of screw fracture surface showing regions of fatigue and overload crack propagation (image courtesy of QinetiQ)

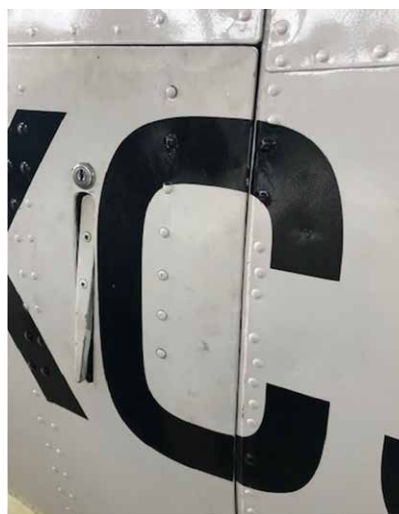
Figure 5

The operator conducted testing of the cabin door following the incident and noted that when closing the doors from the inside, the rear latch pin was observed to not always fully engage in its latch hook when the door handle was in the closed position. This condition could only be seen from inside the cabin when conducting a visual inspection using a torch and would not be immediately visible or apparent to the crew members.

The forward latch pin screw was replaced and the testing was repeated. Whilst the repaired forward latch locked reliably, the unlocked condition of the rear latch could be reproduced. In this condition the door ajar cockpit indication extinguished and the lower door appeared to be flush but both the internal and external door handles were not in their fully closed positions, with the external handle protruding outwards (Figure 5).

Protruding state of the lower cabin door handle observed during testing (image courtesy of 2Excel)

- In its PA-31 Aircraft Maintenance Programme daily inspection instructions to ensure that the internal and external door handles are flush when the door is in the locked closed.
