ACCIDENT

Aircraft Type and Registration:	Druine D.31 Turbulent (modified), G-AREZ	
No & Type of Engines:	1 Volkswagen 1834 piston engine	
Year of Manufacture:	1960 (Serial no: PFA 561)	
Date & Time (UTC):	8 July 2021 at 1730 hrs	
Location:	Easterton Airfield, Birnie, Elgin	
Type of Flight:	Private	
Persons on Board:	Crew - 1	Passengers - None
Injuries:	Crew - 1 (Serious)	Passengers - N/A
Nature of Damage:	Engine separated from aircraft and aircraft broken in two. Damaged beyond economic repair	
Commander's Licence:	Private Pilot's Licence	
Commander's Age:	55 years	
Commander's Flying Experience:	1,614 hours (of which 64 were on type) Last 90 days - 45 hours Last 28 days - 19 hours	
Information Source:	Aircraft Accident Report Form submitted by the pilot

Synopsis

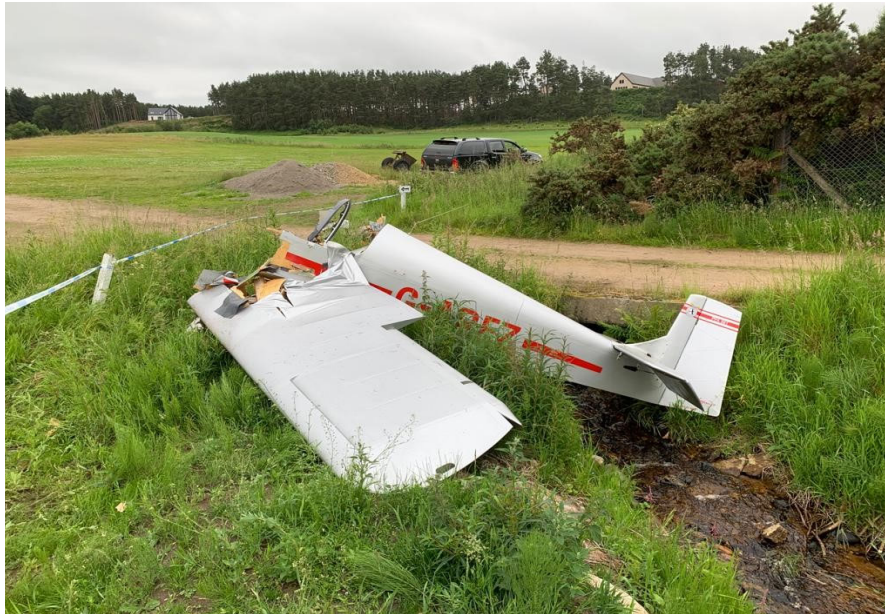
Figure 3
Aircraft at accident site

During the accident sequence the forward fuselage separated from the rest of the airframe just forward of the cockpit. There was extensive damage (Figure 3).
