ACCIDENT

Aircraft Type and Registration:	Rollason Druine D.31 Turbulent, G-ARGZ
No & Type of Engines:	1 Volkswagen 1600 piston engine
Year of Manufacture:	1961 (Serial no: PFA 562)
Date & Time (UTC):	16 October 2021 at 1245 hrs
Location:	Damyns Hall Aerodrome, Upminster, Essex
Type of Flight:	Private
Persons on Board:	Crew - 1 Passengers - None
Injuries:	Crew - 1 (Serious) Passengers - N/A
Nature of Damage:	Aircraft destroyed
Commander's Licence:	Private Pilot's Licence ¹
Commander's Age:	44 years
Commander's Flying Experience:	7,496 hours (of which 10 were on type) ² Last 90 days - 154 hours Last 28 days - 53 hours
Information Source:	Aircraft Accident Report Form submitted by the pilot and further evidence obtained by the AAIB

Synopsis

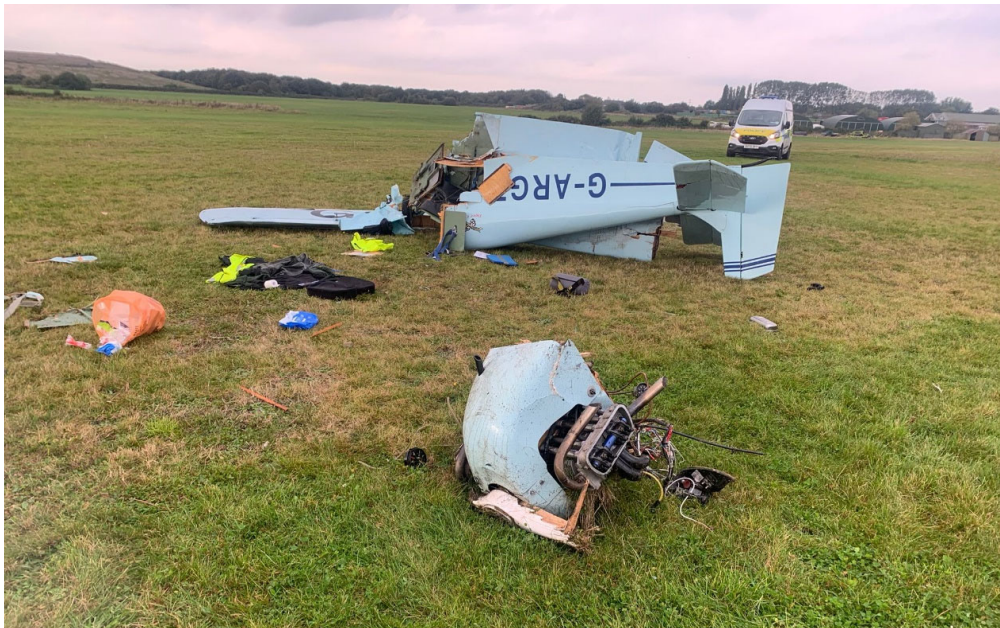
Figure 1

The second flight commenced with formation practice away from the airfield as before. On return to the airfield the team planned to conduct two passes through the limbo gate as they had done on the first flight. The first two aircraft passed through the limbo gate without incident. However, as the third aircraft approached the gate it was seen to pitch down and hit the ground. As the aircraft hit the ground the wings folded upwards and the aircraft came to rest inverted approximately 80 m past the limbo poles (Figure 1 and 2). The pilot was

G-ARGZ after the accident

Whilst flying under the limbo gate the aircraft pitched nose-down and collided with the ground. The aircraft struck the ground with sufficient force to break the wing spar, causing both wings to fold up.

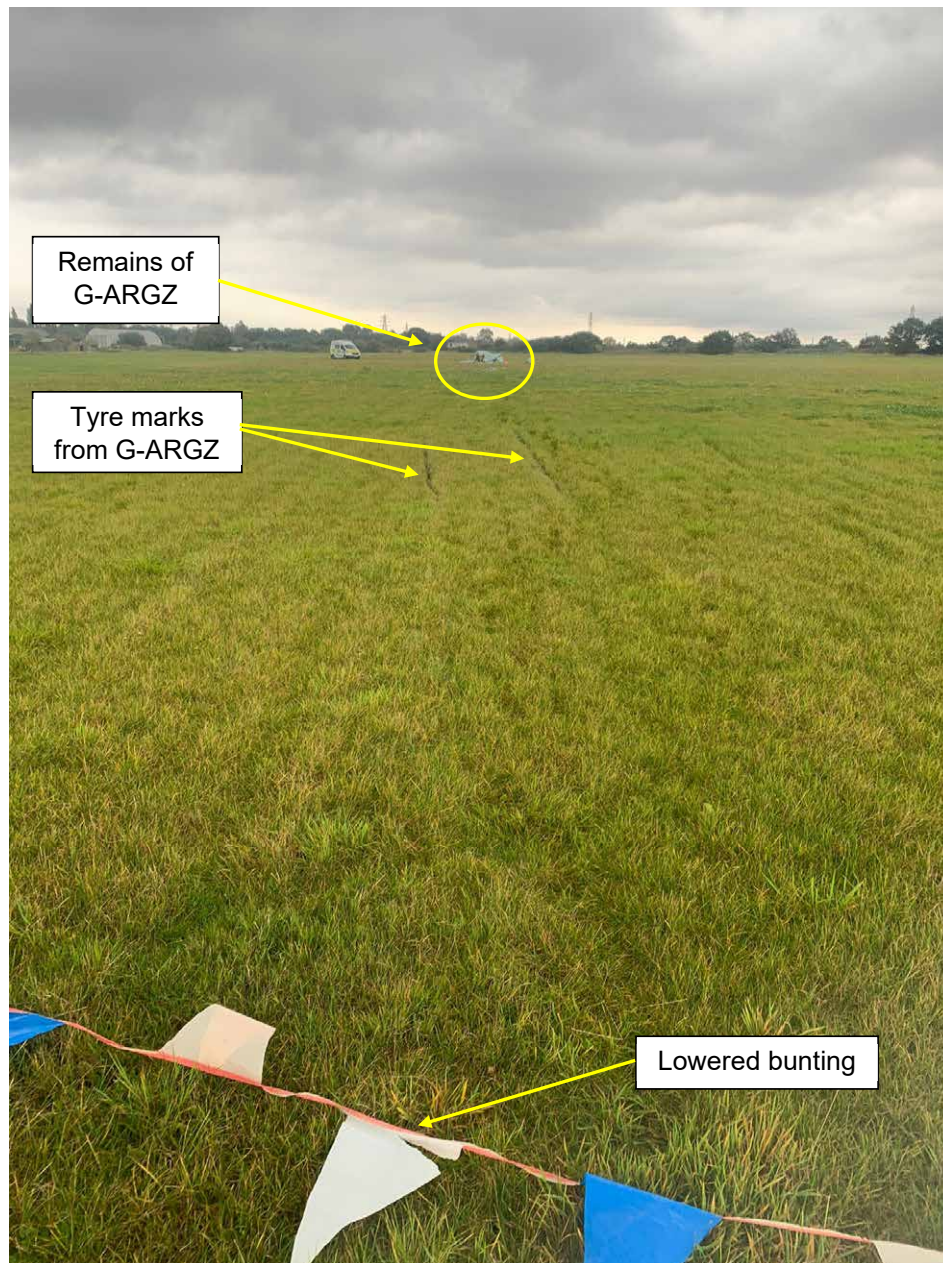
Figure 2

Accident site with the bunting in the fore ground and tyre marks for the accident aircraft

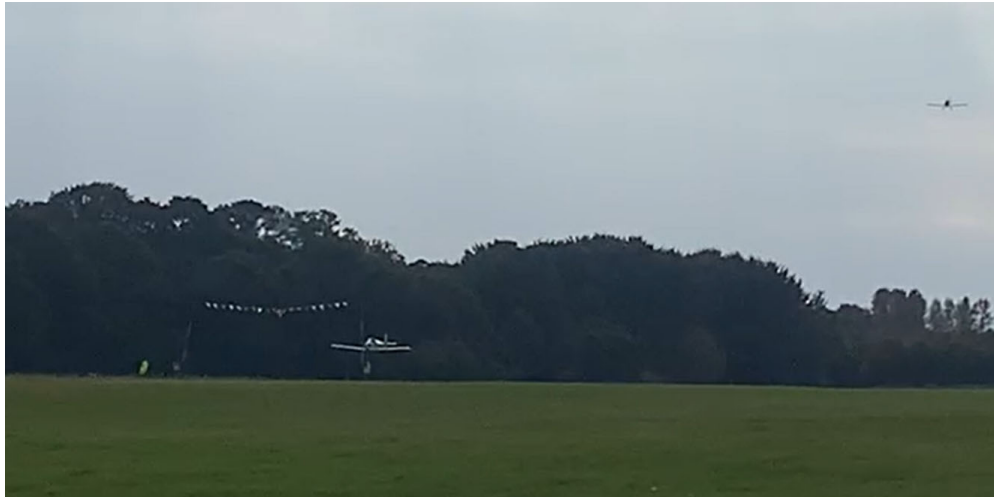
The aircraft was fitted with a cockpit mounted camera but the recording stopped just prior to the accident. The accident was filmed from the ground from two camera positions. The footage shows the aircraft approached the poles with the wings level and in level flight (Figure 3). The video showed that just before it reached the pole the aircraft pitched nose-down (Figure 4). There was no roll or yaw with the pitch change. The aircraft struck the ground on its main wheels in a wings level attitude. As it struck the ground both wings folded upwards (Figure 5). There was less than one second between the pitch change and the aircraft striking the ground.

Figure 3
Accident aircraft approaching the limbo gate

The video showed the aircraft was in stable flight as it approached the limbo gate and there was no roll or yaw as the pitch changed. This suggests the aircraft was not affected by turbulence or wake from another aircraft. The other pilots flying at the same time also did not report any turbulence.

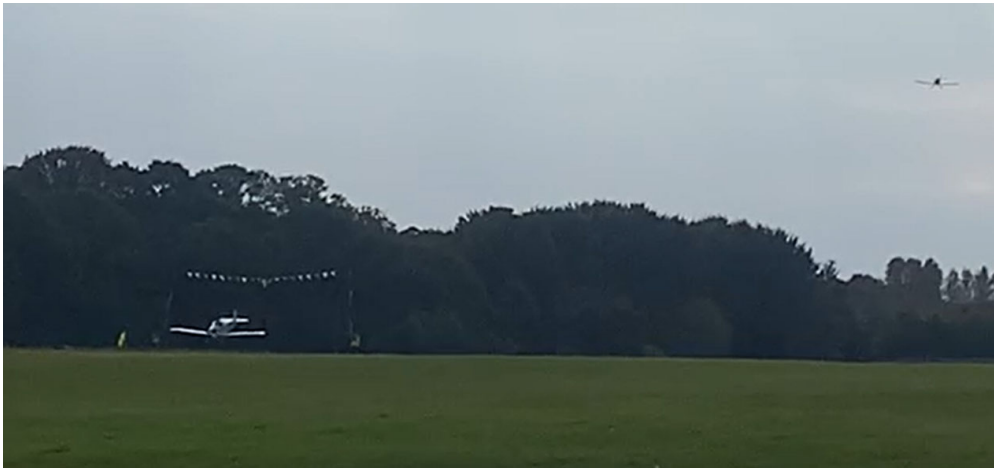
Figure 4
Accident aircraft pitched nose-down

Whilst the pilot was not certain what happened during the accident, he thought that as he approached the limbo gate, he had felt the aircraft was too high and had instinctively pitched forward. The video recording showed that the aircraft struck the ground less than one second after the pitch change. It is unlikely the pilot had sufficient time to realise the effect of the pitch change prior to the impact. He considered that his considerable experience on helicopters may have caused him to make a control input more suitable for a helicopter rather than the Turbulent.

The flying club conducted an internal review following the accident and decided that in future new pilots will be required to practice flying along the runway at 5 ft and 90 kt to become familiar with flying the aircraft at low level and high speed prior to flying under the limbo gate. It intends to place an additional marker on the ground immediately beneath the central triangle to give pilots an additional reference point to help position the aircraft. It also intends to film all future limbo transits to inform pilots about their positioning. The flying club considered these measures would help to prevent a similar accident occurring again.

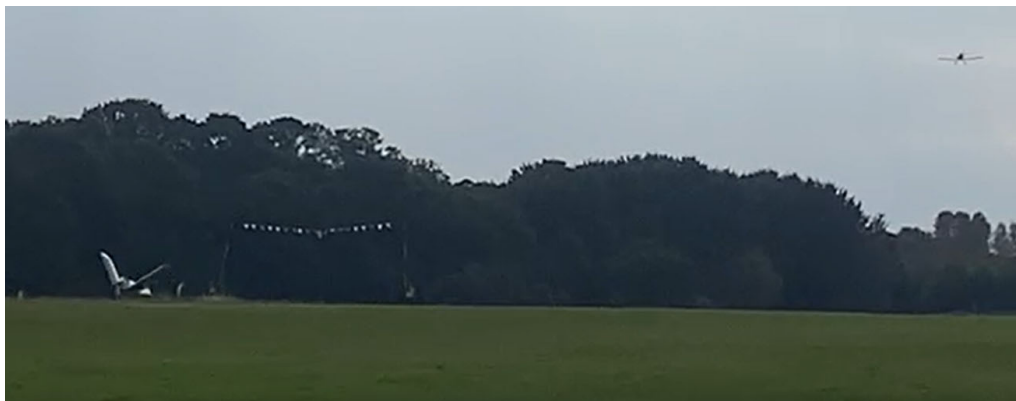
Figure 5
Accident aircraft as it struck the ground and the wings folded upwards
