## ACCIDENT

<b>Aircraft Type and Registration:</b>	Supermarine Aircraft Spitfire Mk 26, G-CIEN	
<b>No &amp; Type of Engines:</b>	1 Isuzu V6 piston engine	
<b>Year of Manufacture:</b>	2014 (Serial no: PFA 324-14492)	
<b>Date &amp; Time (UTC):</b>	12 August 2021 at 2010 hrs	
<b>Location:</b>	Newtownards Airport, County Down	
<b>Type of Flight:</b>	Private	
<b>Persons on Board:</b>	Crew - 1	Passengers - None
<b>Injuries:</b>	Crew - None	Passengers - N/A
<b>Nature of Damage:</b>	Damage to landing gear, left wingtip, propeller, and engine cowlings	
<b>Commander's Licence:</b>	Private Pilot's Licence	
<b>Commander's Age:</b>	47 years	
<b>Commander's Flying Experience:</b>	712 hours (of which 1 was on type) Last 90 days - 42 hours Last 28 days - 8 hours	
<b>Information Source:</b>	Aircraft Accident Report Form submitted by the pilot and further enquiries by the AAIB

## Synopsis

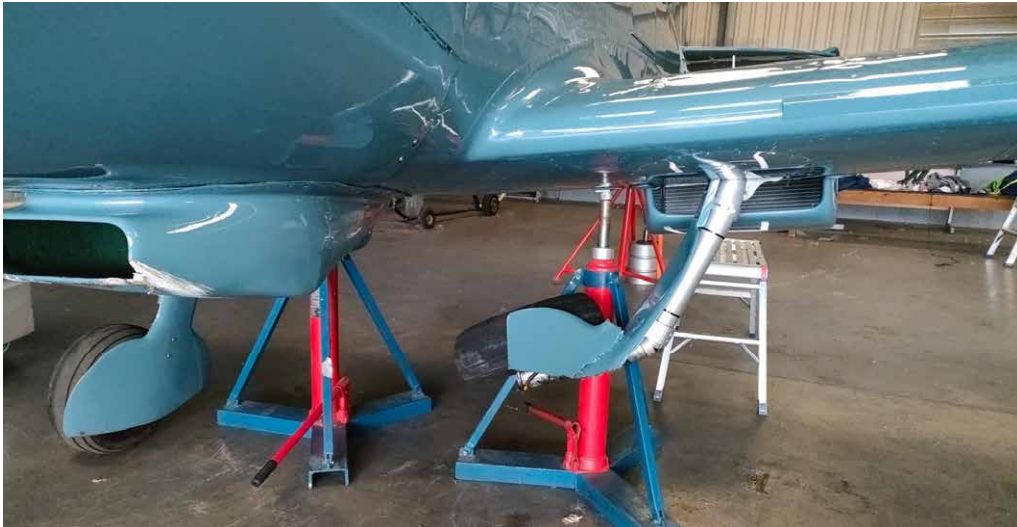
**Figure 1**

The pilot had recently purchased the aircraft and conducted a Permit to Fly revalidation check flight after various modifications had been embodied. The flight passed without incident and the pilot landed on Runway 21 at Newtownards Airport. The aircraft was slowing down on the runway centreline when it suddenly veered to the right. The pilot first applied left rudder and then full left brake but could not prevent the left wingtip, propeller and lower engine cowl scraping the runway. The aircraft came to rest off the runway with damage to both landing gear legs (Figure 1).

Landing gear damage  
(Photograph used with permission)

During the landing roll, the weld between the thick washer and the splined shaft on the left main gear leg failed, allowing the lower leg, and consequently the wheel assembly, to rotate. This resulted in the aircraft veering to the right, despite the pilot applying full left rudder and left braking. The left leg was bent as the right wing lifted and the left wingtip, propeller and engine cowl scraped the runway.

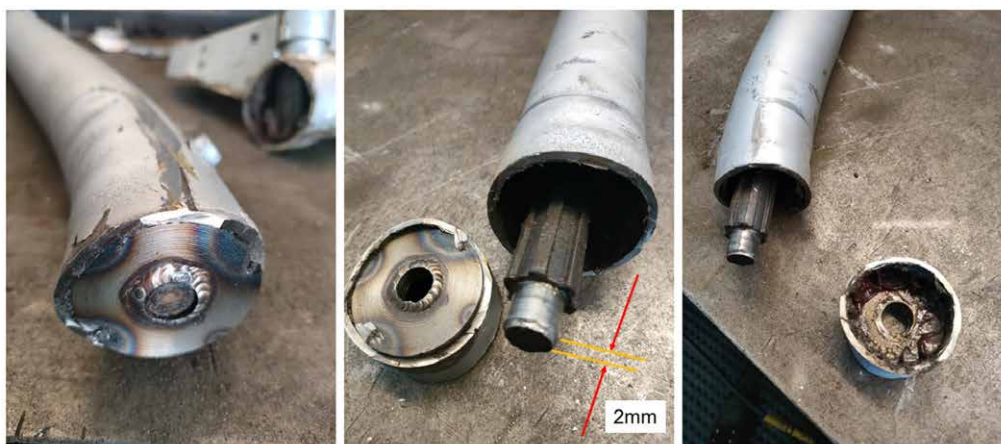
**Figure 4**

The left main gear leg was removed from the aircraft, and the upper tube was cut between the pintle pin and the thick washer (Figure 3). This enabled the fillet weld between the splined shaft and the thick washer to be inspected. It was evident that the weld had broken, and the splined shaft had rotated. The fillet weld was measured to be approximately 2 mm (Figure 4) with minimal weld penetration on the splined shaft.

The left main gear leg with the thick washer removed

Comparison of the failed weld from G-CIEN and another pair of Mk 26 gear legs revealed poor weld penetration. This may have been the result of manufacturing variability and would have reduced the strength of the welded joint. The heavy landing may have damaged the weld, such that it failed after a further two landings.

The Light Aircraft Association has issued a warning to all UK owners of Spitfire Mk 26 aircraft that there is potential for hidden damage to a weld following a heavy landing.

The Light Aircraft Association is reviewing of the design of the Spitfire Mk 26 undercarriage leg, including the access restriction to inspect the weld that failed.
