ACCIDENT

Aircraft Type and Registration:	DJI Matrice 300 RTK	
No & Type of Engines:	4 electric motors	
Year of Manufacture:	2021 (Serial no: 1ZNBJ1G00C00ED)	
Date & Time (UTC):	3 August 2021 at 2337 hrs	
Location:	Seymour Grove, Old Trafford, Manchester	
Type of Flight:	Commercial Operations (UAS)	
Persons on Board:	Crew - None	Passengers - None
Injuries:	Crew - N/A	Passengers - N/A
Nature of Damage:	Aircraft destroyed	
Commander's Licence:	Other	
Commander's Age:	44 years	
Commander's Flying Experience:	18 hours (of which 18 were on type) Last 90 days - 4 hours Last 28 days - 1 hour	
Information Source:	Aircraft Accident Report Form submitted by the pilot

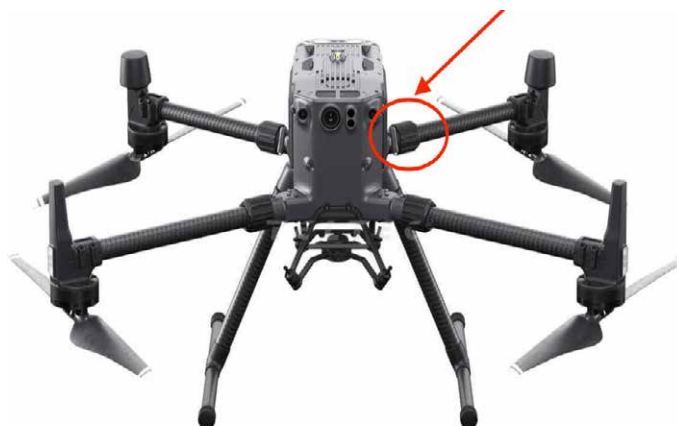
The DJI Matrice 300 RTK was being operated at night in support of RFFS operations to locate a missing person. After approximately nine minutes and 28 seconds of flight, when at a height of 63 metres, the pilot and observer heard an audible “bang or pop.” The UA initiated a three-rotor emergency landing sequence, flying in a rapidly descending arc until it struck the ground. The aircraft was destroyed. Examination of the UA and review of the log file by the UAS manufacturer identified that the left rear frame arm folded back during the flight and struck the motor. This resulted in failure of the rotor, triggering the emergency landing mode. The UAS manufacturer considered there was a high likelihood that the locking collar at the junction of the frame arm had not been fully tightened, causing the rotor arm to fold back in flight.
