Defence
Infrastructure
Organisation

Safety Alert Parts A, B & C

Subject: Generator Firewire Failure

Number SA 2021/02

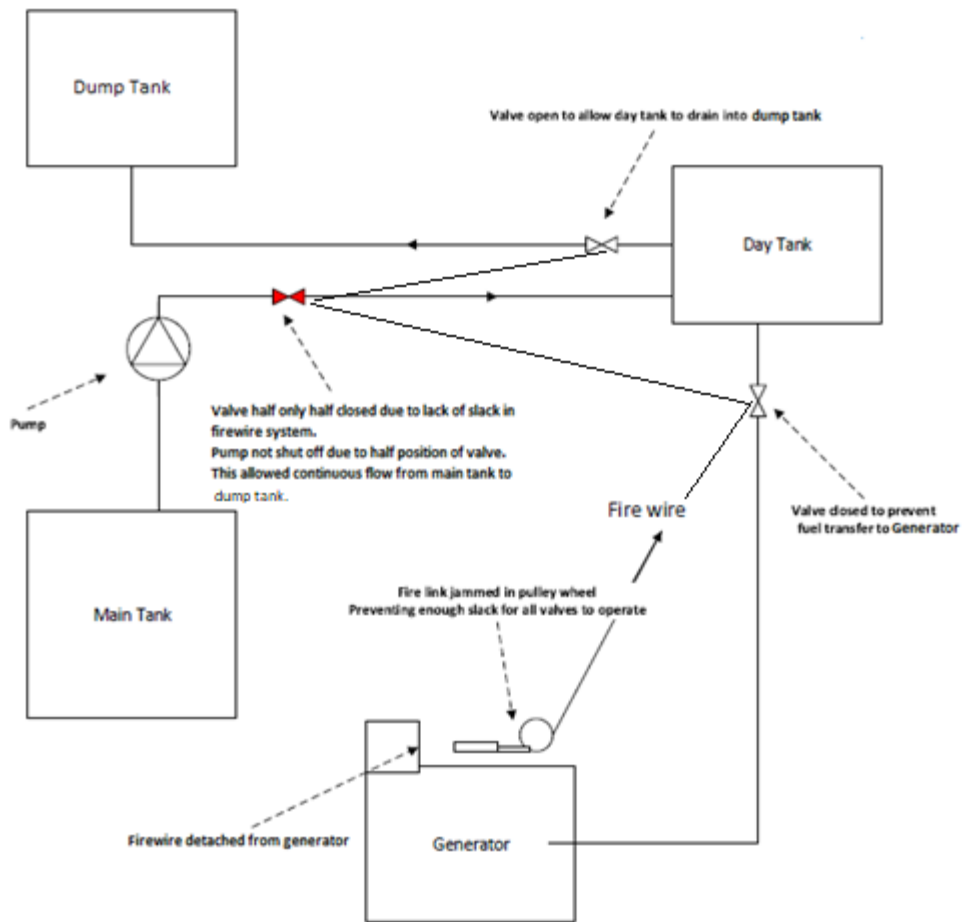
6. Failure of the firewire system led to a significant fuel spill and environmental pollution with associated remediation costs.
7. The subsequent investigation found a significant contributor to this failure was that the mechanism which connects the fusible link to the generator had become loose. This caused the firewire slacken and the fusible link to jam on the first pulley wheel, which prevented all 3 valves connected to the fire wire from operating correctly.

Mechanism which became loose and detached from generator, subsequently becoming jammed in the firewire pulley wheel.

10. A review of all generator firewire systems should be undertaken to evaluate the general condition and ensure correct operation of the system, including checking for looseness of connections as a result of vibration or movement. The system should be evaluated to ensure that in the event of a fire, there is sufficient wire between the fusible link and the first pulley such that system will operate as required, operating all valves as necessary. This may be completed initially by means of a full functional test of the system, replicating the effect of the system operating in the event of a fire. This should also include evaluation of the need for remote monitoring of alarms, for example where local alarms may not be adequate to alert relevant persons that a fault has occurred on the system.

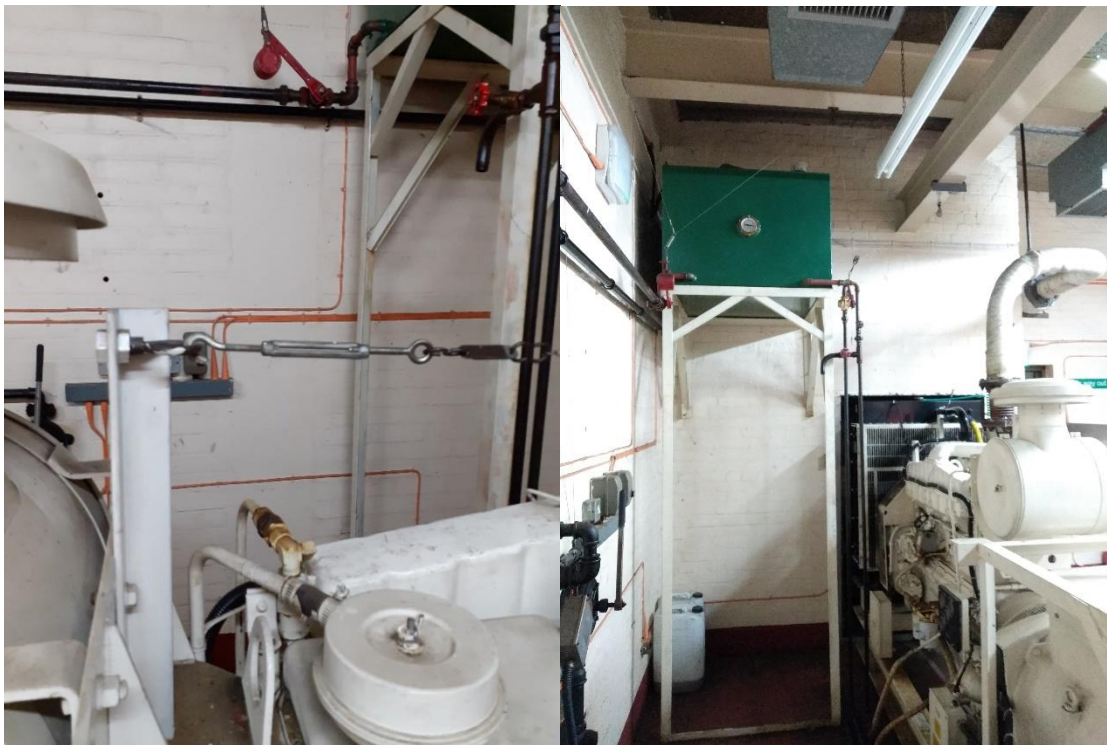
8. The generator stopped working due to the closure of the valve supplying fuel to the generator from the day tank. The valve from the main fuel supply tank was in a half open / half closed position which failed to shut off fuel supply from the transfer pump and allowed fuel to continue to flow to the day tank. The valve from the day tank to the dump tank remained in an open position due to the firewire, whereas usually this would be closed. When the day tank level dropped to minimum, the transfer pump started, and fuel flowed direct via the day tank to the dump tank. This pump operated continuously, eventually causing the dump tank to be overfilled. A drawing of the firewire system and some photographs can be seen below.

Overview of generator firewire system
