Report on the investigation of
the man overboard from the dredger

Cherry Sand

resulting in one fatality

in the non-tidal basin at Port Babcock Rosyth,

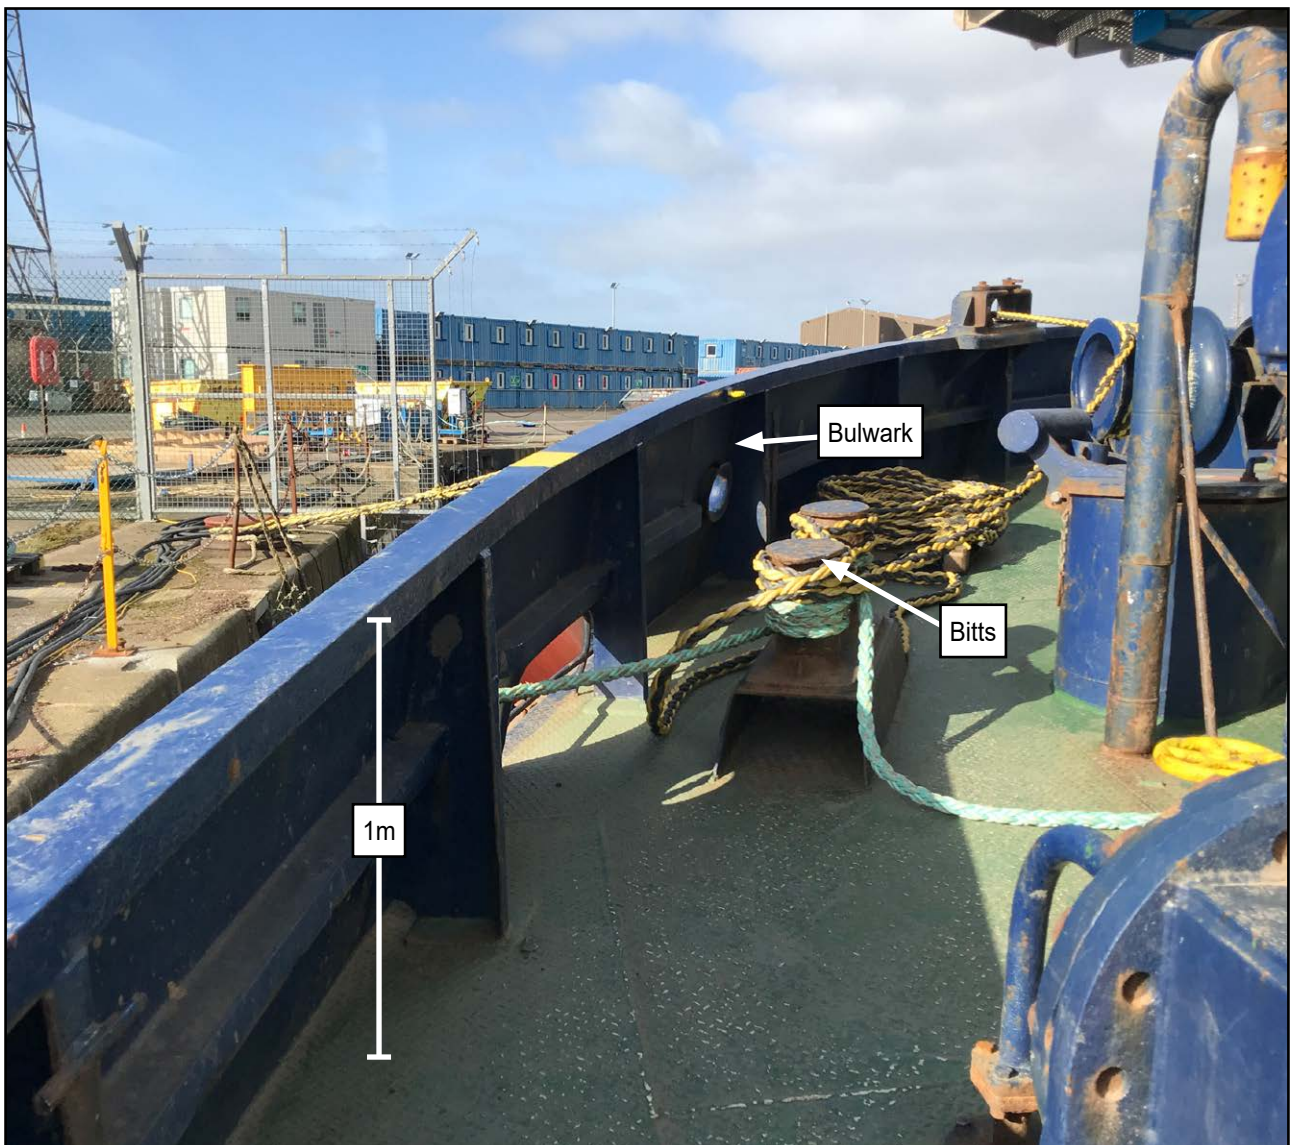
Figure 4: *Cherry Sand* fore deck bulwark and mooring bitts

Shortly afterwards, at 1551.25, the master, who was stationed at the port shoulder with an AB, stood on the mooring bitts⁴ (**Figure 4**) and looked towards the quay. After 7 seconds he stood back down. The chief officer had misjudged the approach, and at 1552 he brought the vessel to a stop in the water. The operations manager then took the con and started to give helm orders to the chief officer. Five seconds later the master briefly looked over the side, once again standing on the mooring bitts before stepping back down to the deck almost immediately. Using the VHF radio, the AB then reported to the bridge that the bow was 3 metres off the berth. The master was standing slightly forward of him but behind the mooring bitts on the port side. At 1552.08 *Cherry Sand* began to move astern as the chief officer realigned the vessel to make another approach. By 1552.30, *Cherry Sand* was again approaching the berth, and the master once again stood on the mooring bitts.

At 1553.02, the master stepped down from the bitts. Twenty three seconds later he stepped up on to the bitts, and at 1553.34 he climbed over the bulwark to stand on the vessel's rubbing band (**Figure 5**). He then stood with his back to the bulwark, facing the direction of travel, with his hands holding on to the bulwark.

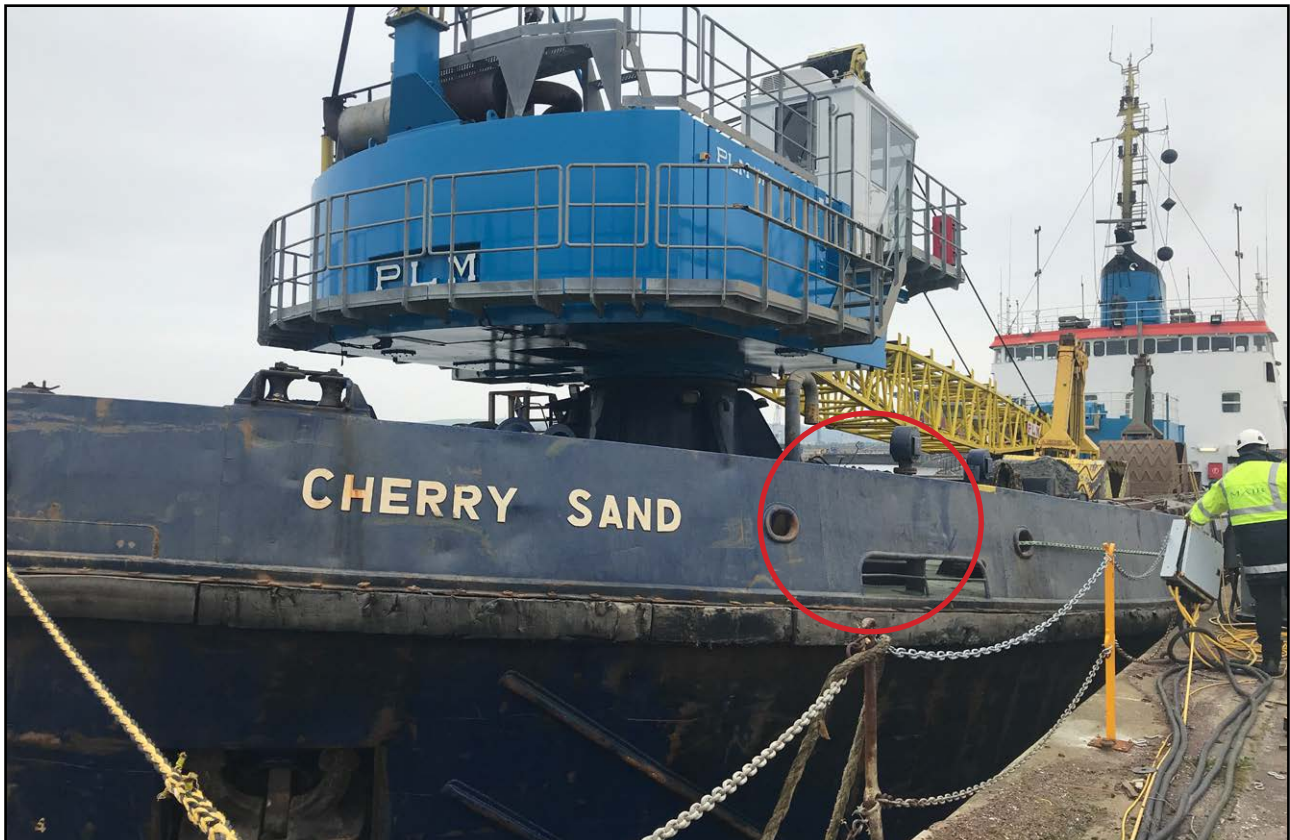
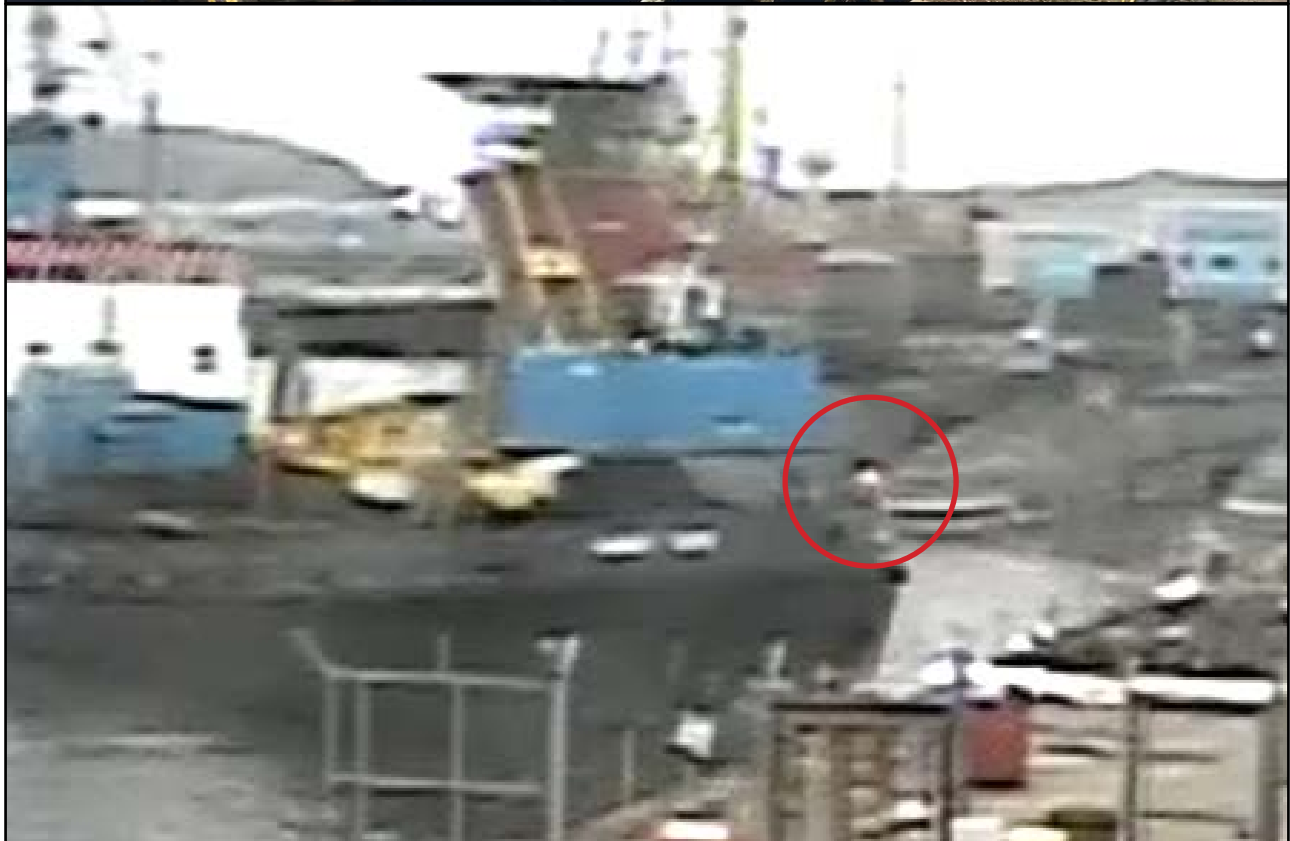
Figure 5: Master's location at the break of the forecastle

The operations manager attempted to call the master back in board using the VHF. The AB also advised him that it was too early to step outboard, but the master assured him that he would wait until the vessel was alongside before stepping ashore. By that time *Cherry Sand* was closer to the quay and closing the berth at a slow but steady pace. At 1554.08, some 33 seconds after he had climbed on to the rubbing band, the master held on to the bulwark with his right hand and extended his left leg towards the quay. One second later, as the master moved towards the quay, he fell. The master's foot missed the quay, and his torso hit the chains and quay edge (**Figure 6**) before he bounced between the dredger and the quayside and disappeared from sight.

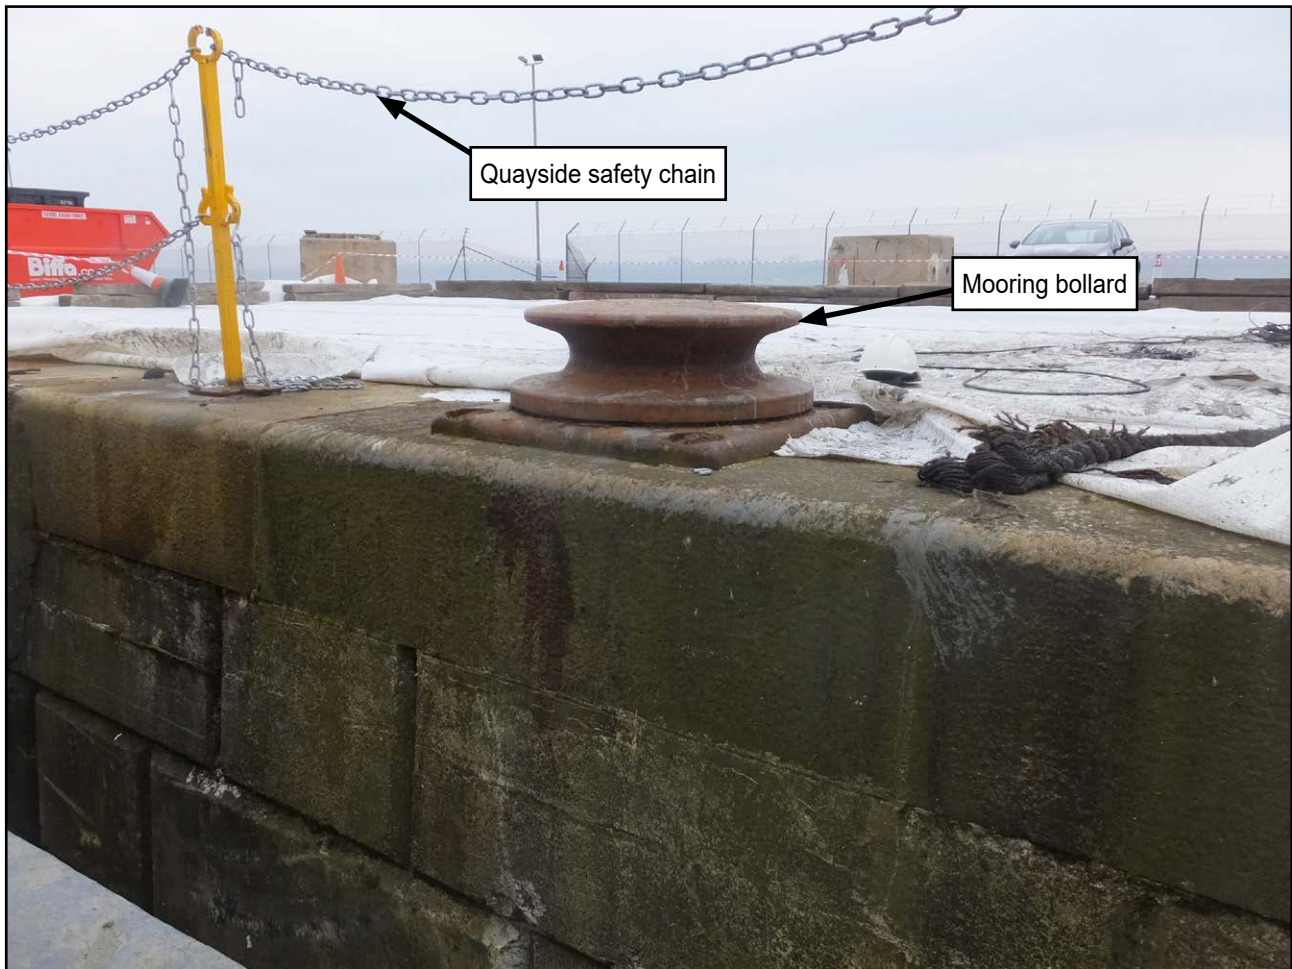
Figure 6: Quayside where the master was attempting to step ashore

It is possible that the master misjudged the distance to the quay. He required a prosthetic lens for his right eye, without which his depth/distance perception would have been negatively affected. The postmortem report makes no reference to the presence of the prosthetic lens in his right eye, but as the master's lens case was empty when found, and he might have lost the lens during the accident, there can be no certainty that he was not wearing it when he attempted to step ashore.

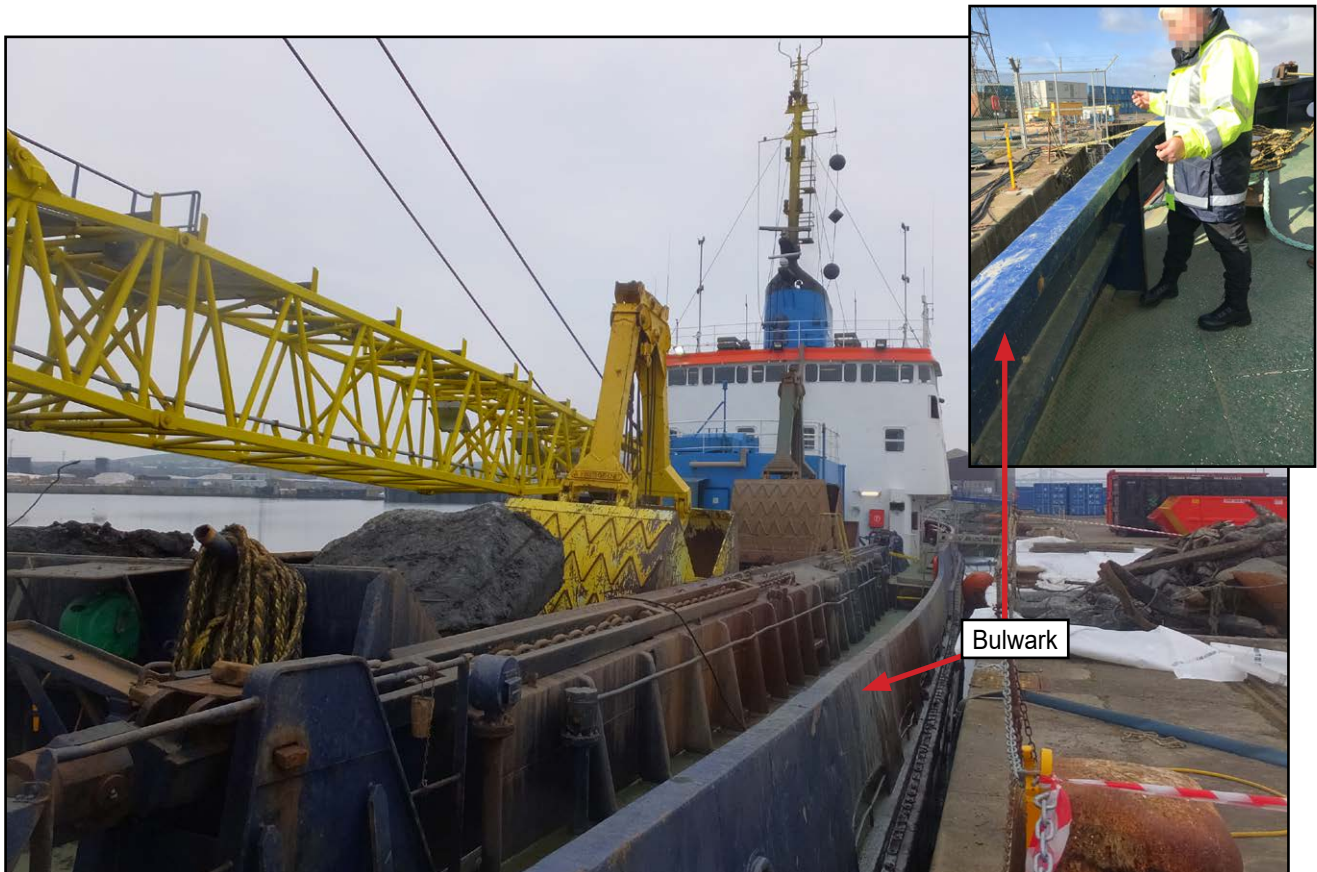
Figure 7: *Cherry Sand's* bulwark

Cherry Sand had a 1 metre high solid steel bulwark (**Figure 7**), which encircled the freeboard deck. There were openings for the running of mooring lines and to allow water to run off the deck. There were no bulwark gates or identified boarding station.

6. *Cherry Sand* did not have any gates in the bulwarks nor any mechanism for safely crossing the bulwark. Once outboard, there were no suitable footplates that crew could stand on safely prior to stepping ashore. These were significant material deficiencies that should have been identified during risk assessment. [2.6.1]

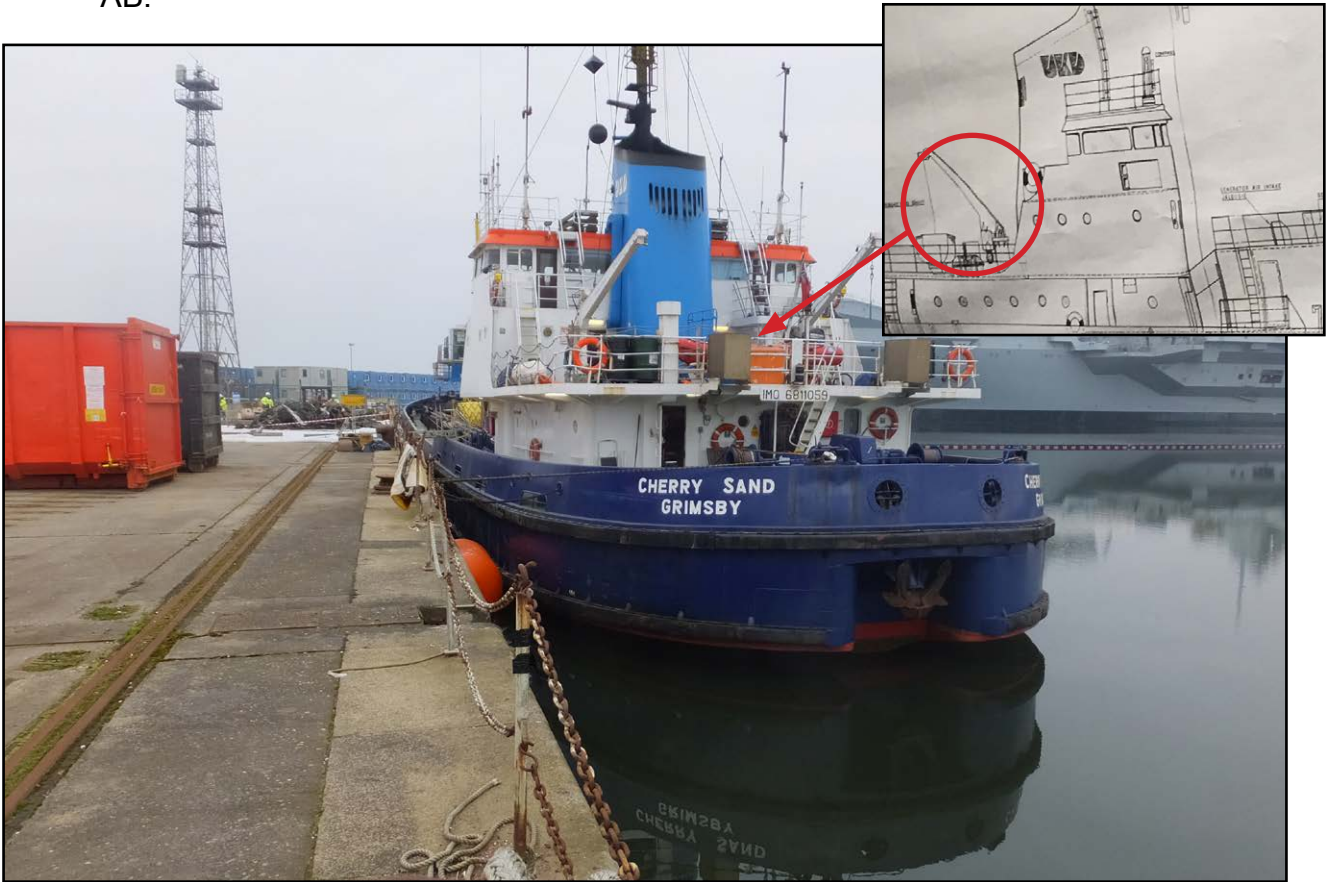
Figure 8: Stowage position of rescue boat

Cherry Sand's lifesaving equipment included a rescue boat that was stowed aft of the accommodation (**Figure 8**). The boat had its own davit and was capable of being launched quickly. The rescue boat was usually crewed by the chief officer and an AB.

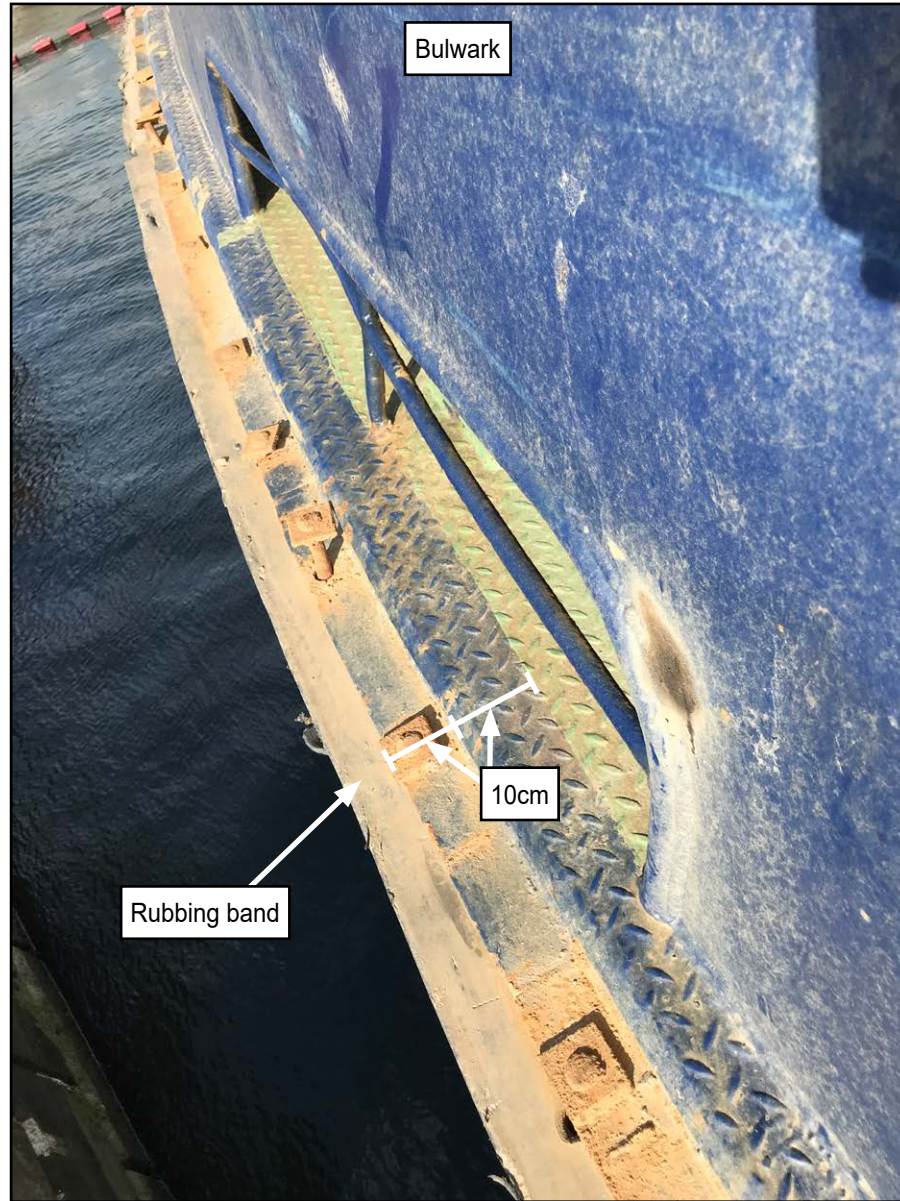
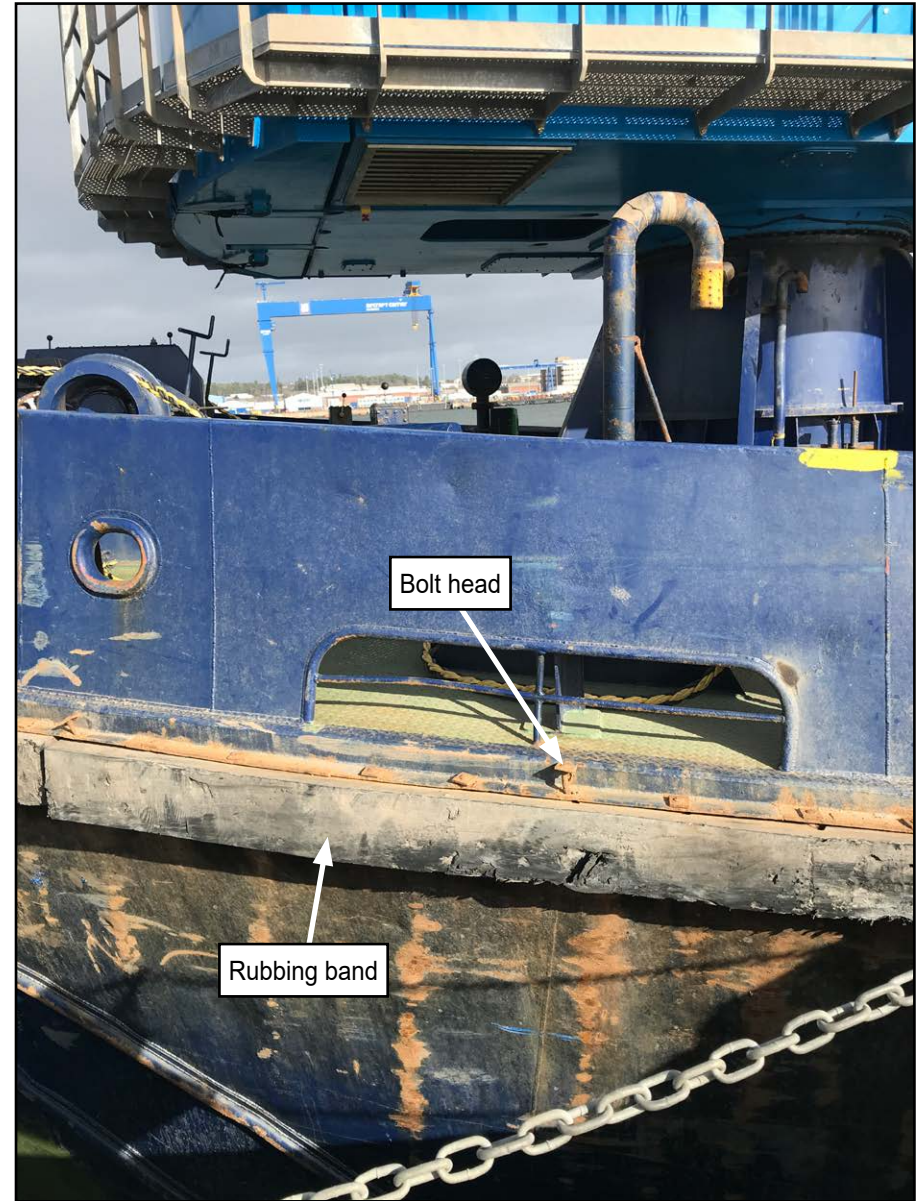
Figure 11: *Cherry Sand* fore deck bulwark and rubbing band

The rubbing band was not a safe place for crew to stand, nor was it a safe place from which to step ashore. The deck edge was narrow; the bolts holding the rubber banding to the securing flanges on the hull created an uneven surface and in some areas a trip hazard; the paint had no non-slip properties; and the entire rubbing band, including the rubber, was too narrow and uneven to create a safe platform on which to stand (**Figure 11**). Once on the rubbing band, there was no barrier to prevent a fall from height, and the task of stepping ashore precluded the crew from wearing either a fall restraint or fall arrest equipment.

were no suitable footplates that crew could stand on safely prior to stepping ashore. These were significant material deficiencies that should have been identified during risk assessment.

Climbing over safety barriers, or any obstacles, and stepping across gaps, are inherently hazardous activities that increase the risk of slips, trips and falls. Such activities should be avoided. In circumstances when they cannot be avoided, strict controls should be put in place. These include; appropriate PPE, good lighting, level and clean surfaces, and competent and sufficiently fit and agile crew. It is evident that a more thorough assessment of the master's physical abilities was required before he was allowed to work as a member of the deck crew and, specifically, to take on the role of stepping ashore.
