# AIRCRAFT ACCIDENT REPORT 1/2020

Report on the accident to  
**Piper PA-46-310P Malibu, N264DB**  
22 nm north-north-west of Guernsey  
on 21 January 2019

**Air Accidents Investigation Branch**

Published 13 March 2020

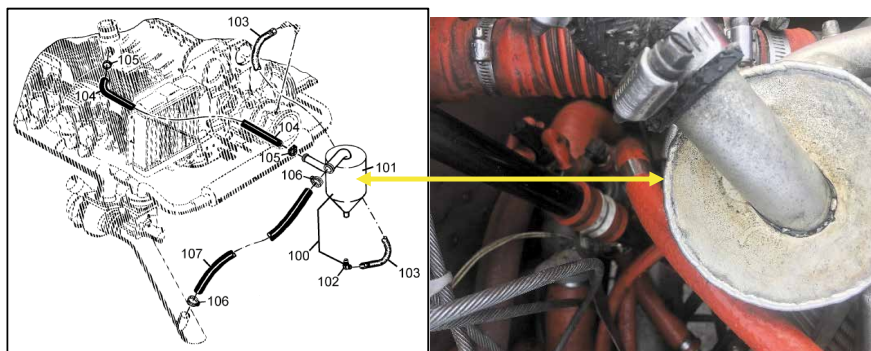
**Figure 10**

Following the engine ground run carried out at Nantes to investigate the bang on the outbound flight, the pilot noticed what he thought might be a small oil leak from the top of the oil accumulator, which he believed had been present for some time. The pilot took photographs, which he sent to the individual who managed the aircraft who then forwarded them to the FAA IA. From one of the photographs, the component was identified by the engine manufacturer as the air / oil separator assembly (Figure 10).

Photograph sent by pilot showing location of oil leak from the air / oil separator (item 101 in the left image)

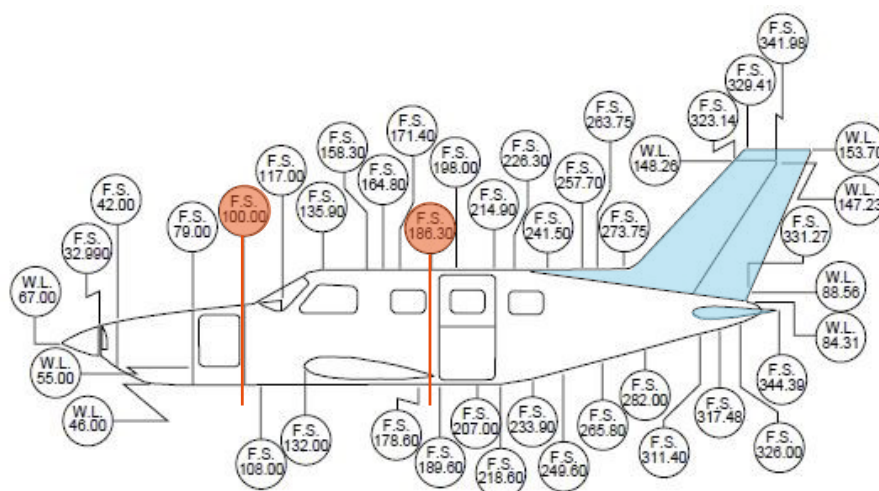
**Figure 13**

The central fuselage had broken away from the nose section at Fuselage Station (F.S.)100 and from the tail section at F.S. 186.30 (shown in orange in Figure 13). The roof section of the central fuselage aft of the front seats was missing. There was significant compression damage along the top of the aircraft from the windscreens to the tail cone. There was no evidence of compression damage on the lower surface of the tail section. The fin and horizontal stabiliser assemblies had detached from the tail section at their attachment points (shaded blue).

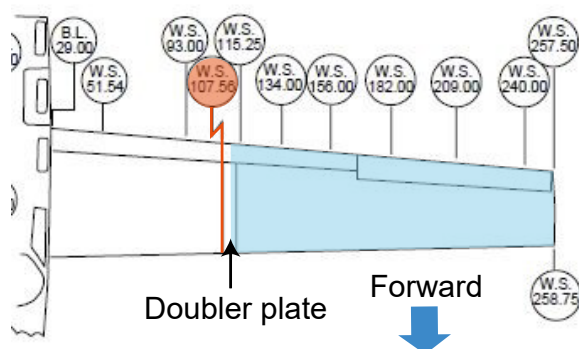
**Figure 14**

The left wing and flap had failed at Wing Station (W.S.) 107.56 (shown in orange in Figure 14) beneath the skin doubler plate where the inboard section of the wing joins the outer section (shaded blue) at the splice joint. The inboard section of the main wing spar appeared to be undamaged. The failure of the main spar splice joint and the adjacent structure was consistent with the wing failing due to a downward bending force. The top wing surface displayed evidence of a compressive force that had pushed the skins inwards with the edges having been torn away from the fasteners. The remainder of the wing structure and flaps were extensively damaged.

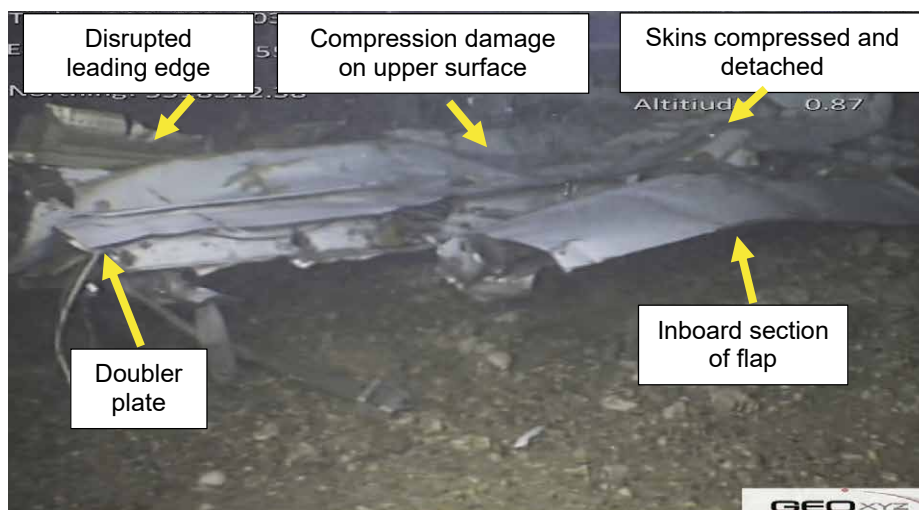
**Figure 15**  
Damage to left wing

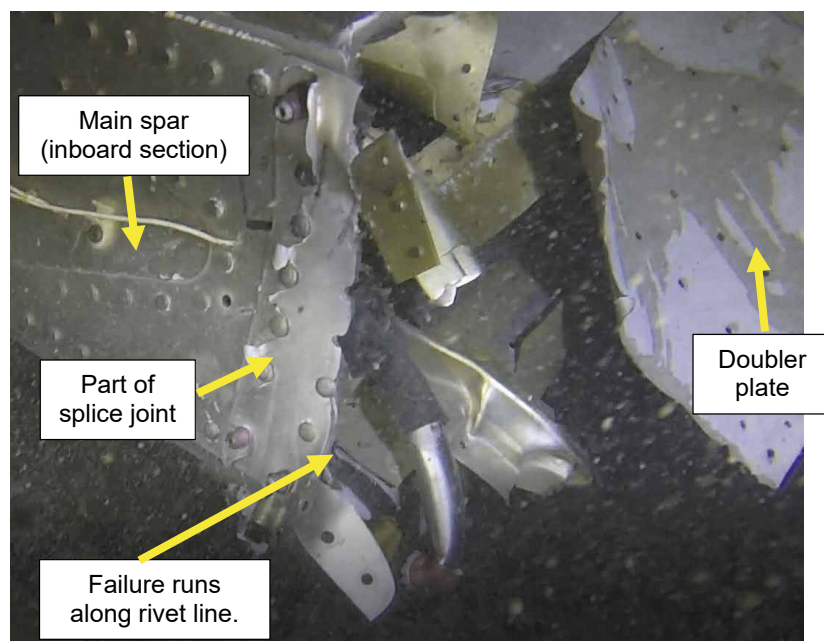
**Figure 16**

Failure of left-wing main spar at the splice joint  
(Image taken from a video provided by Blue Water Recoveries)

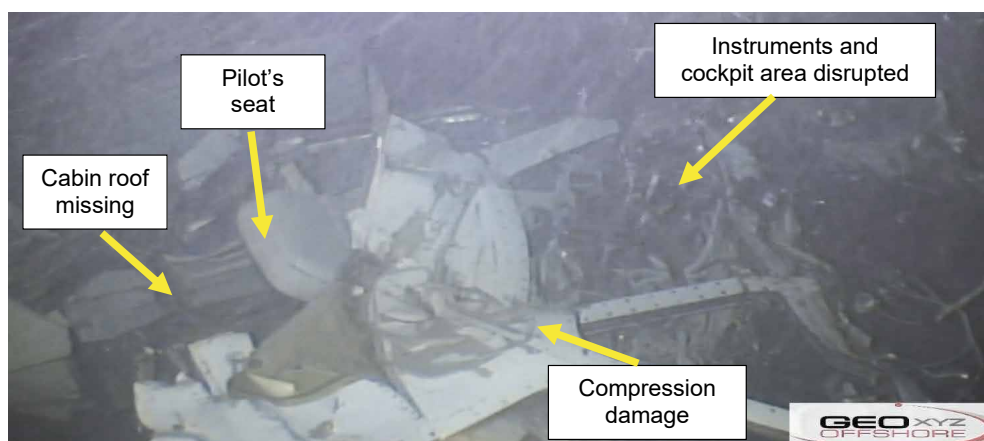
**Figure 17**

Damage to cockpit roof

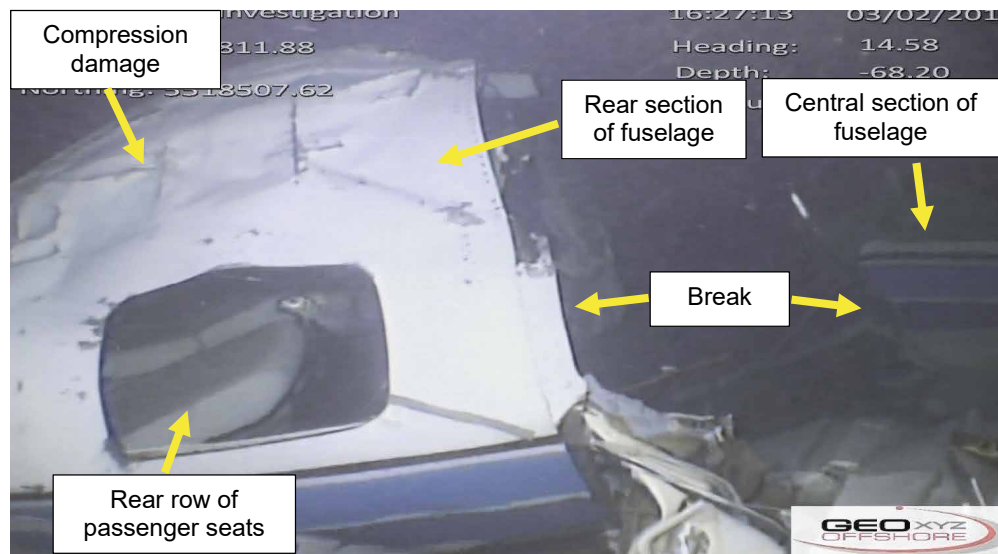
**Figure 18**

Break in central fuselage

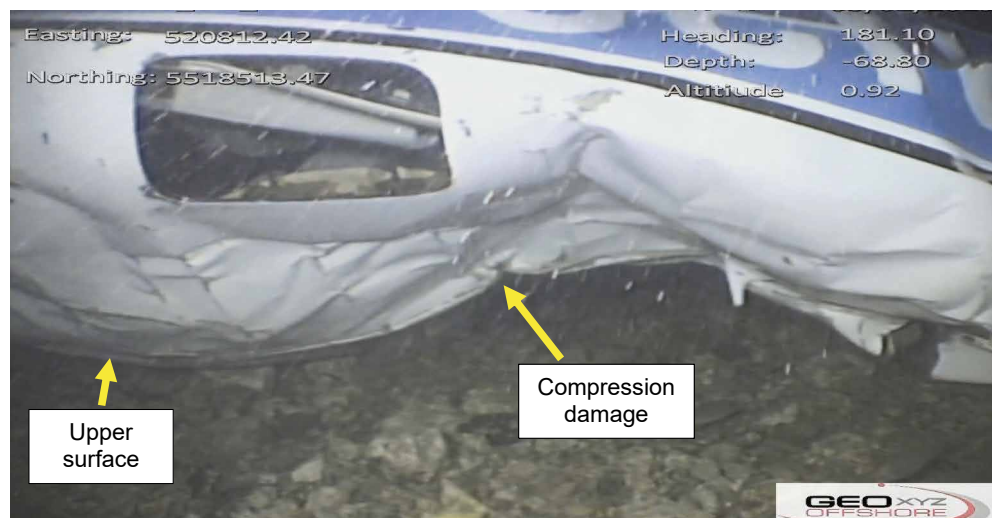
**Figure 19**

Damage to roof of rear section of the fuselage  
(This section of the fuselage has been rotated by the tidal flow)

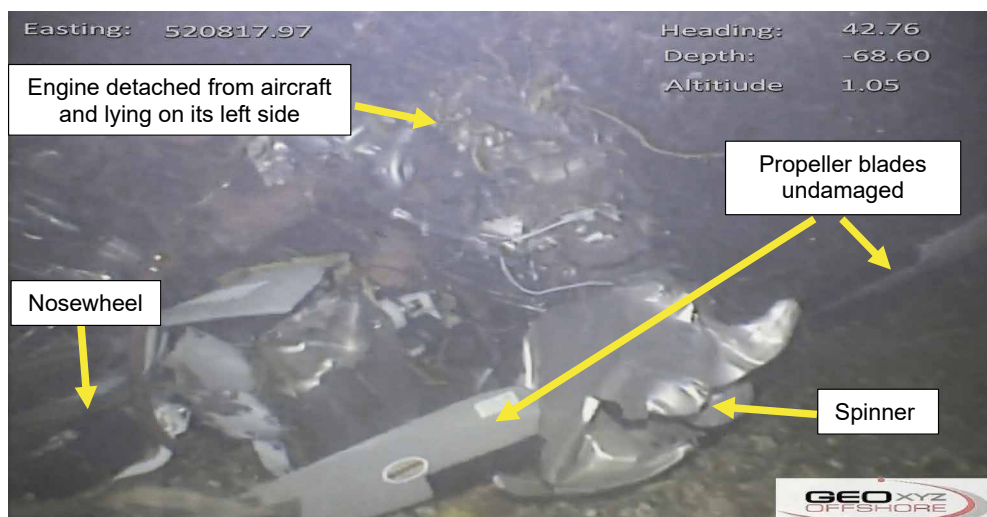
**Figure 20**

Apart from a slight rearward bend in one of the blades, the propeller blades were undamaged. The engine cowlings had detached and the engine and nosewheel had rotated 90° relative to the front of the cockpit. Several components had detached from the engine. The right tailpipe / heater shroud was still attached to the right turbocharger and video footage of part of the right tailpipe showed no evidence of scoring on the inside. There was no evidence of burnt oil residue on the inside of the exhaust. The induction, heating and ventilation pipes, and the engine baffles had been disrupted. The ignition harness was still connected to the engine.

Propeller and engine

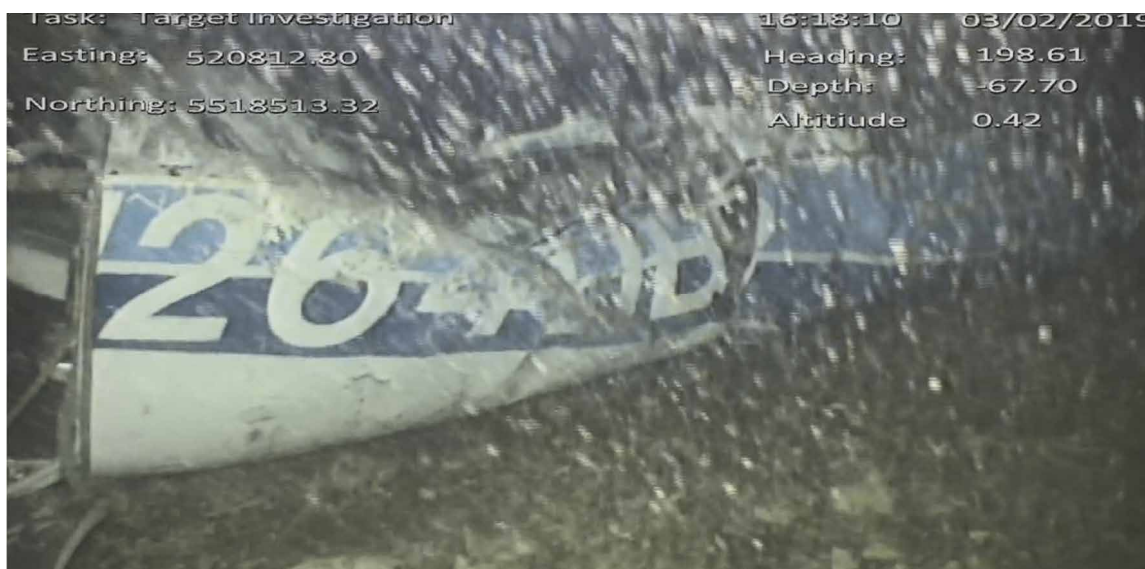
**Figure B-6**

Tail section of N264DB on seabed at a depth of 68 m

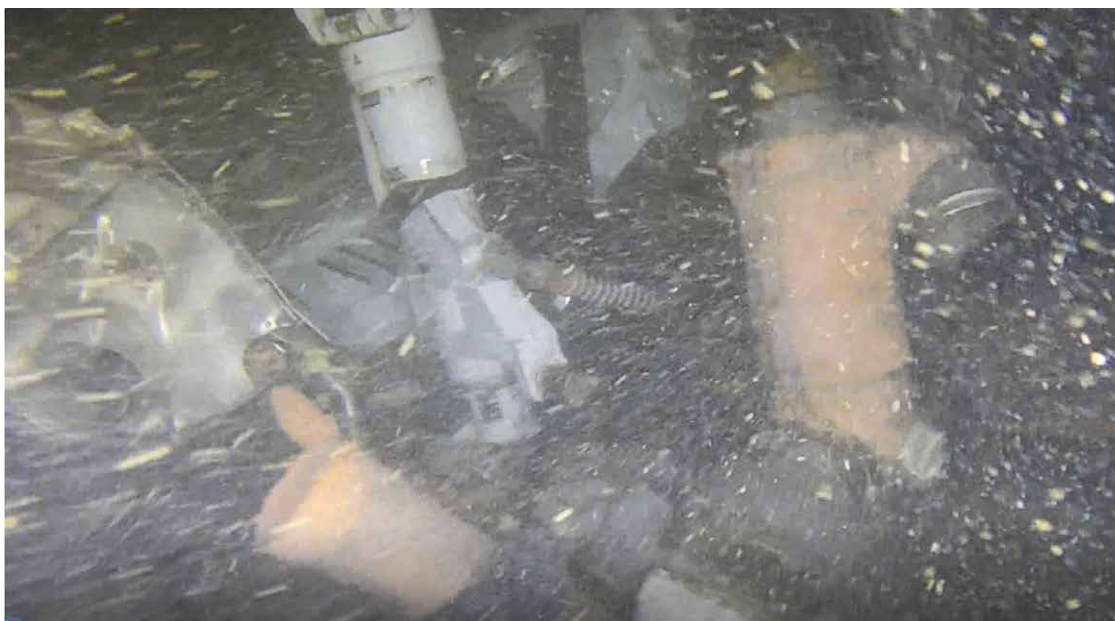
**Figure B-7**

Right tailpipe and heater muff / shroud  
(image taken from video provided by Blue Water Recoveries)

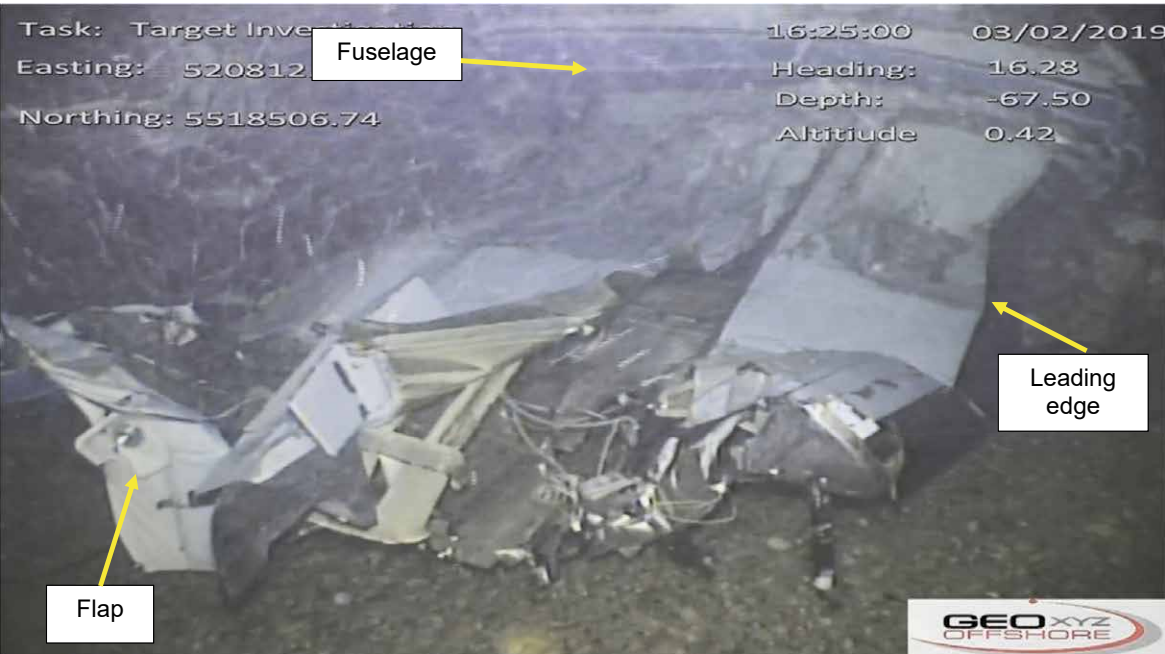
Figure B-8  
Remains of right wing

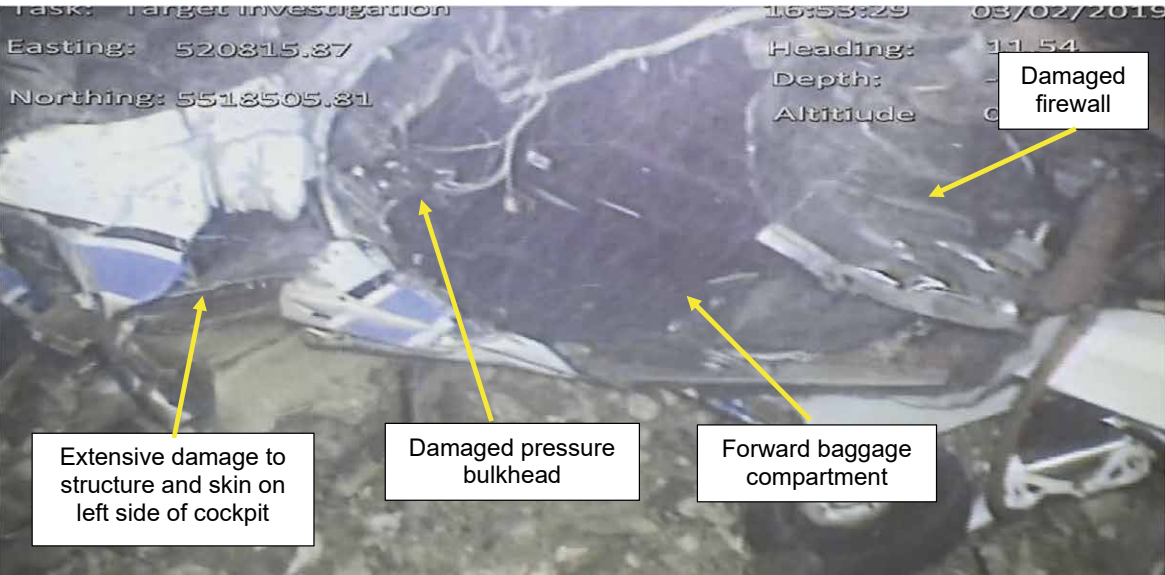
Figure B-9  
Forward of cockpit

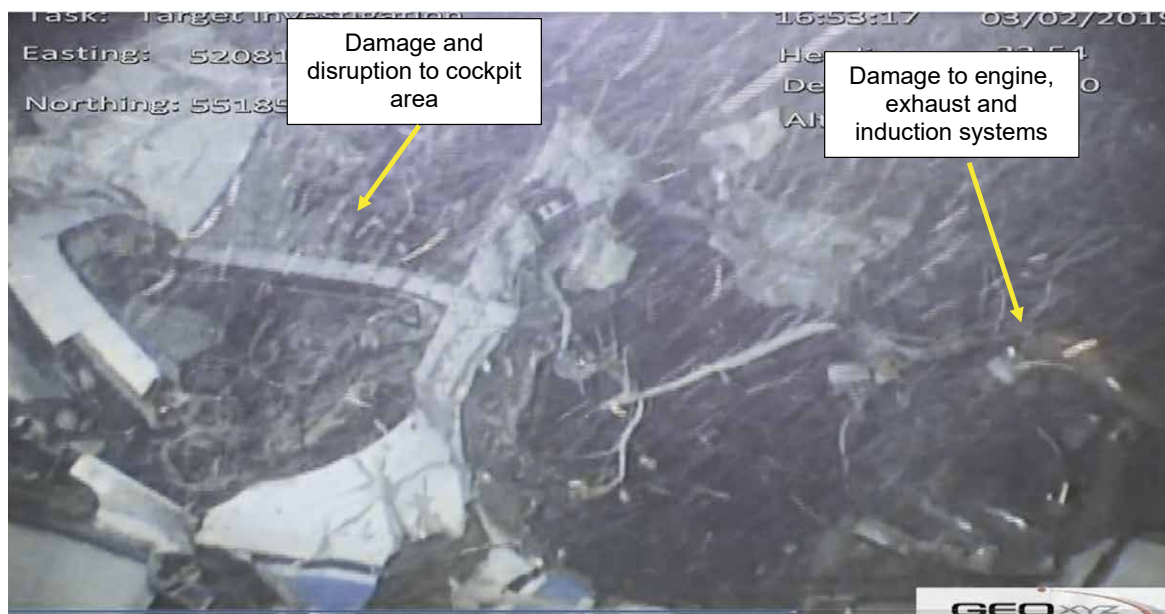
**Figure B-10**

Disruption to cockpit and engine

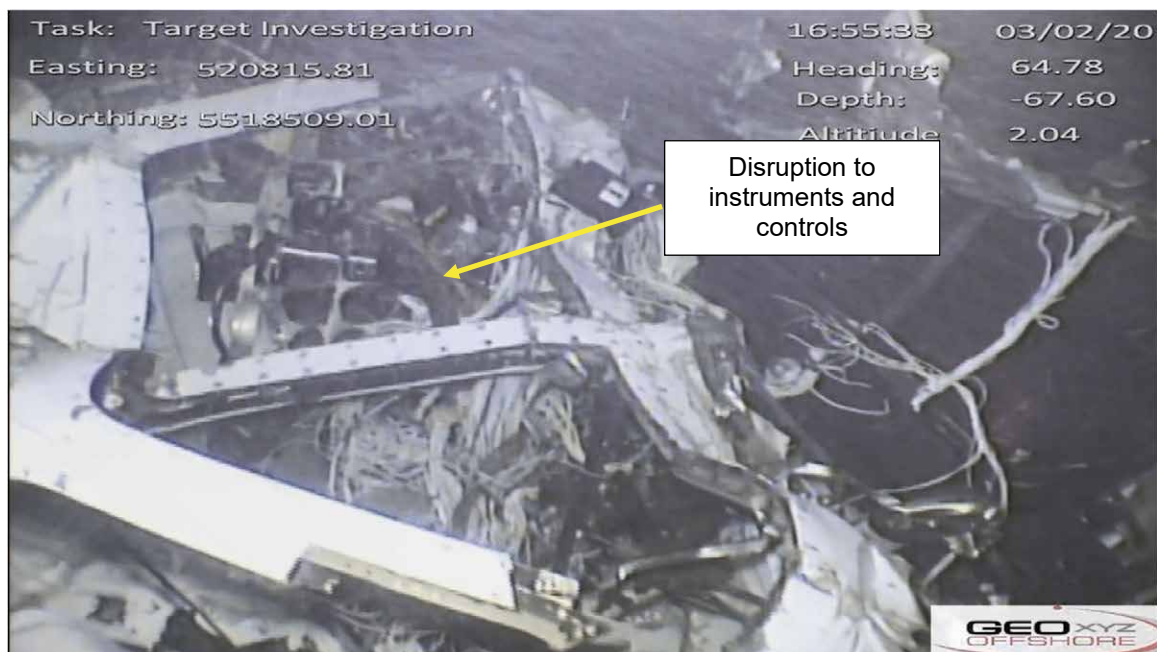
**Figure B-11**

Damage and disruption to instruments and controls

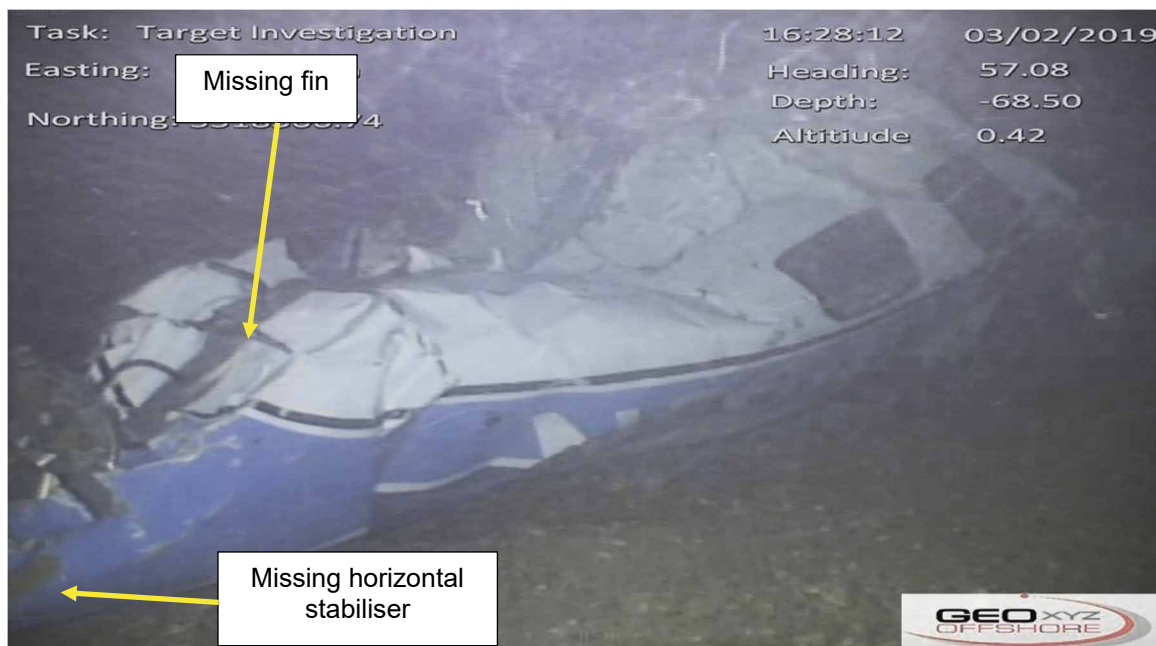
**Figure B-12**

Missing fin and horizontal stabiliser
