SAFETY FLYER TO THE FISHING INDUSTRY

Flooding, capsize and foundering of the trawler *Diamond D* (SN100) north-east of Tynemouth, England, on 16 August 2020

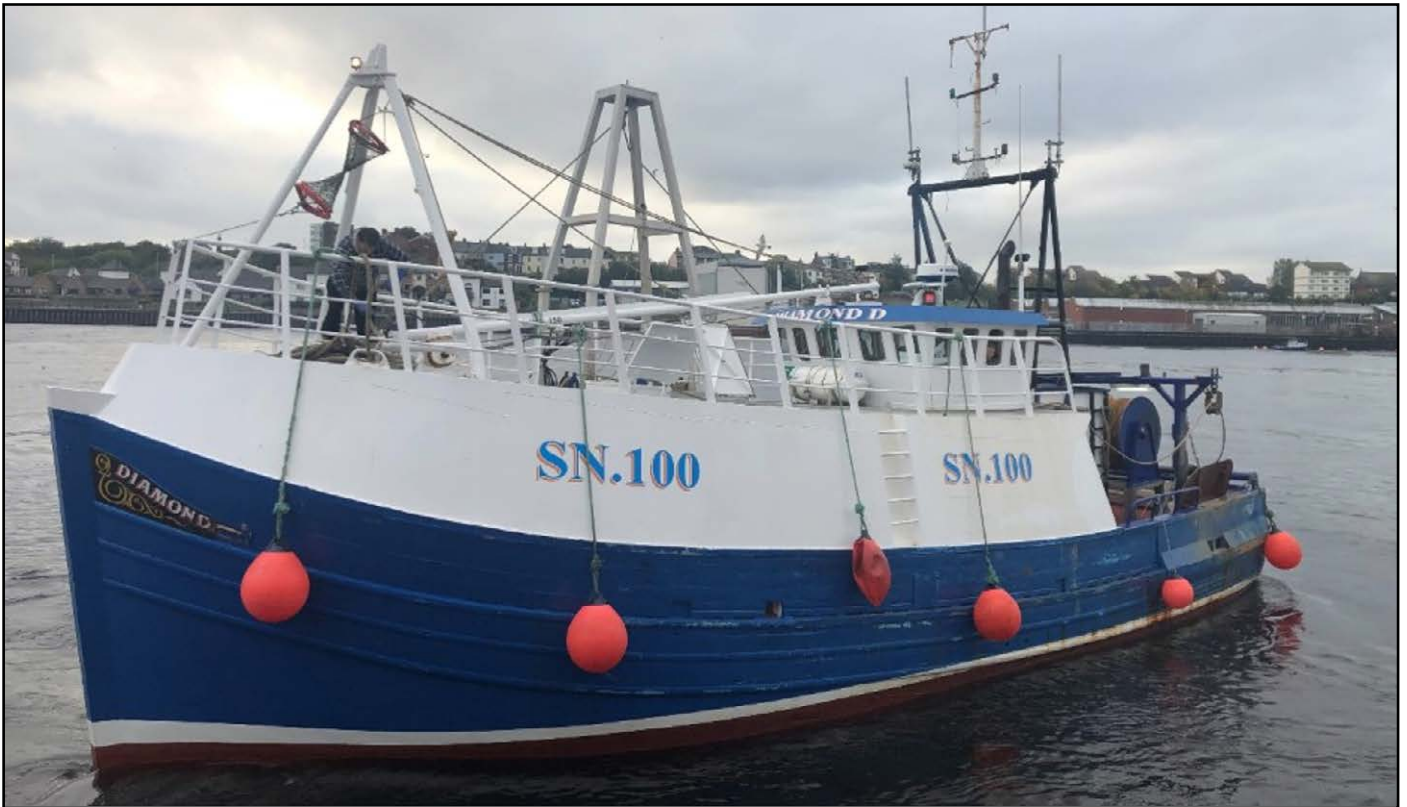
Diamond D

At about 1500 on 16 August 2020, the wooden-hulled 15.67m fishing vessel *Diamond D* capsized and sank after suffering hull damage and subsequent water ingress while trying to uncross its towing wires.
