## **Flooding, capsize and foundering of the trawler *Diamond D* (SN100) 20 nautical miles north-east of Tynemouth, England on 16 August 2020**

### **SUMMARY**

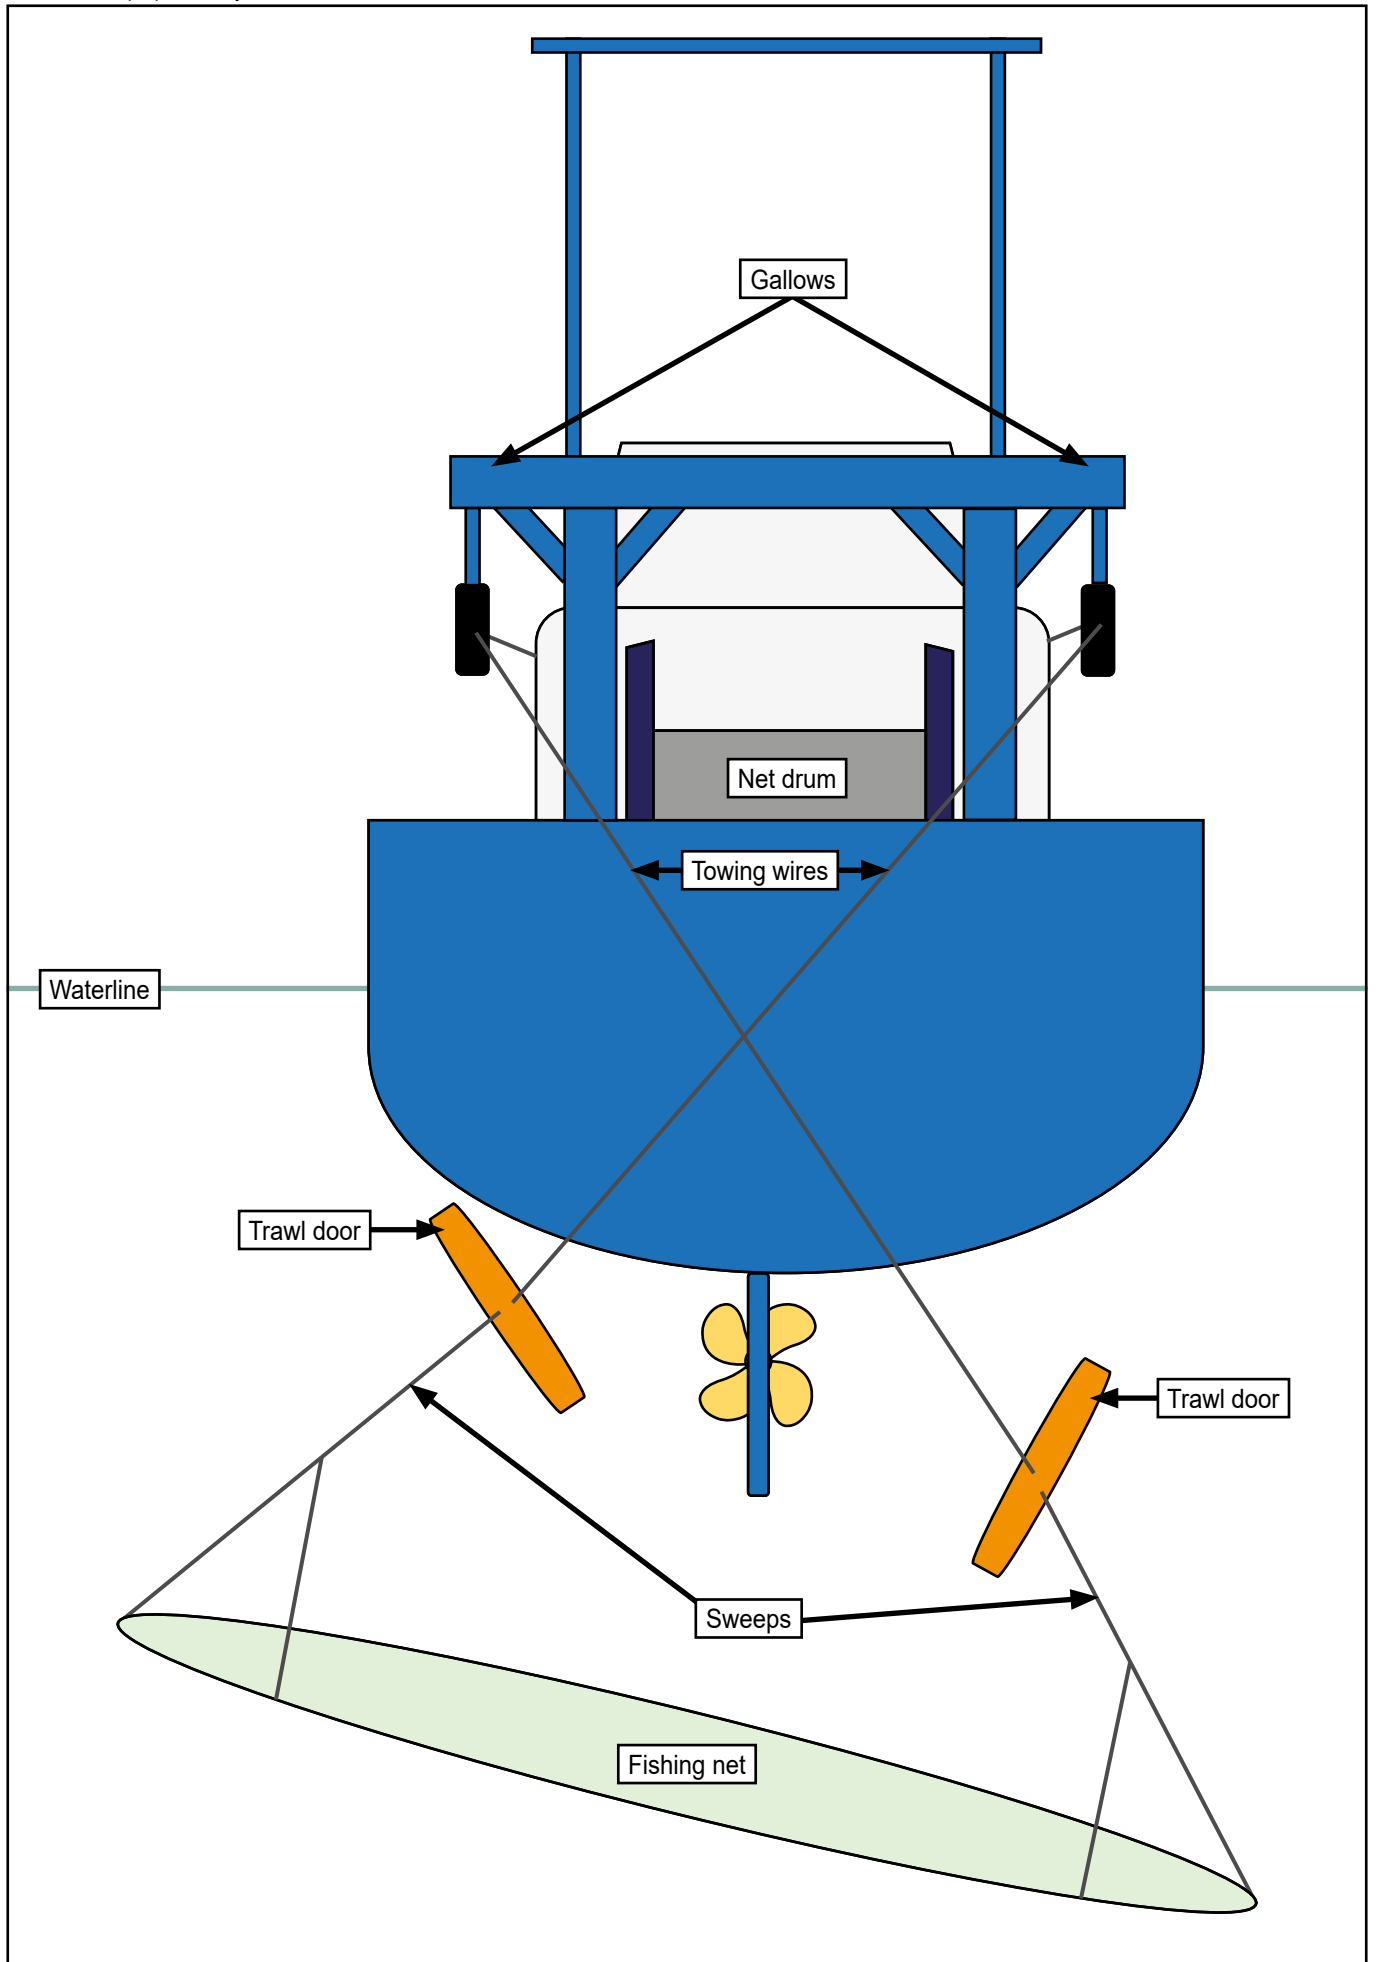
As the trawl gear was being hauled in, it became apparent that the towing wires had crossed (**Figure 2**). To uncross the wires, the owner repeatedly heaved in and released each wire in turn while the skipper periodically turned *Diamond D* around the suspended gear. During this process the trawl doors were heard hitting the vessel's hull several times. After 2 to 3 hours, the towing wires finally uncrossed.

**Figure 2:** Graphical representation of a likely scenario, showing the towing wires crossed

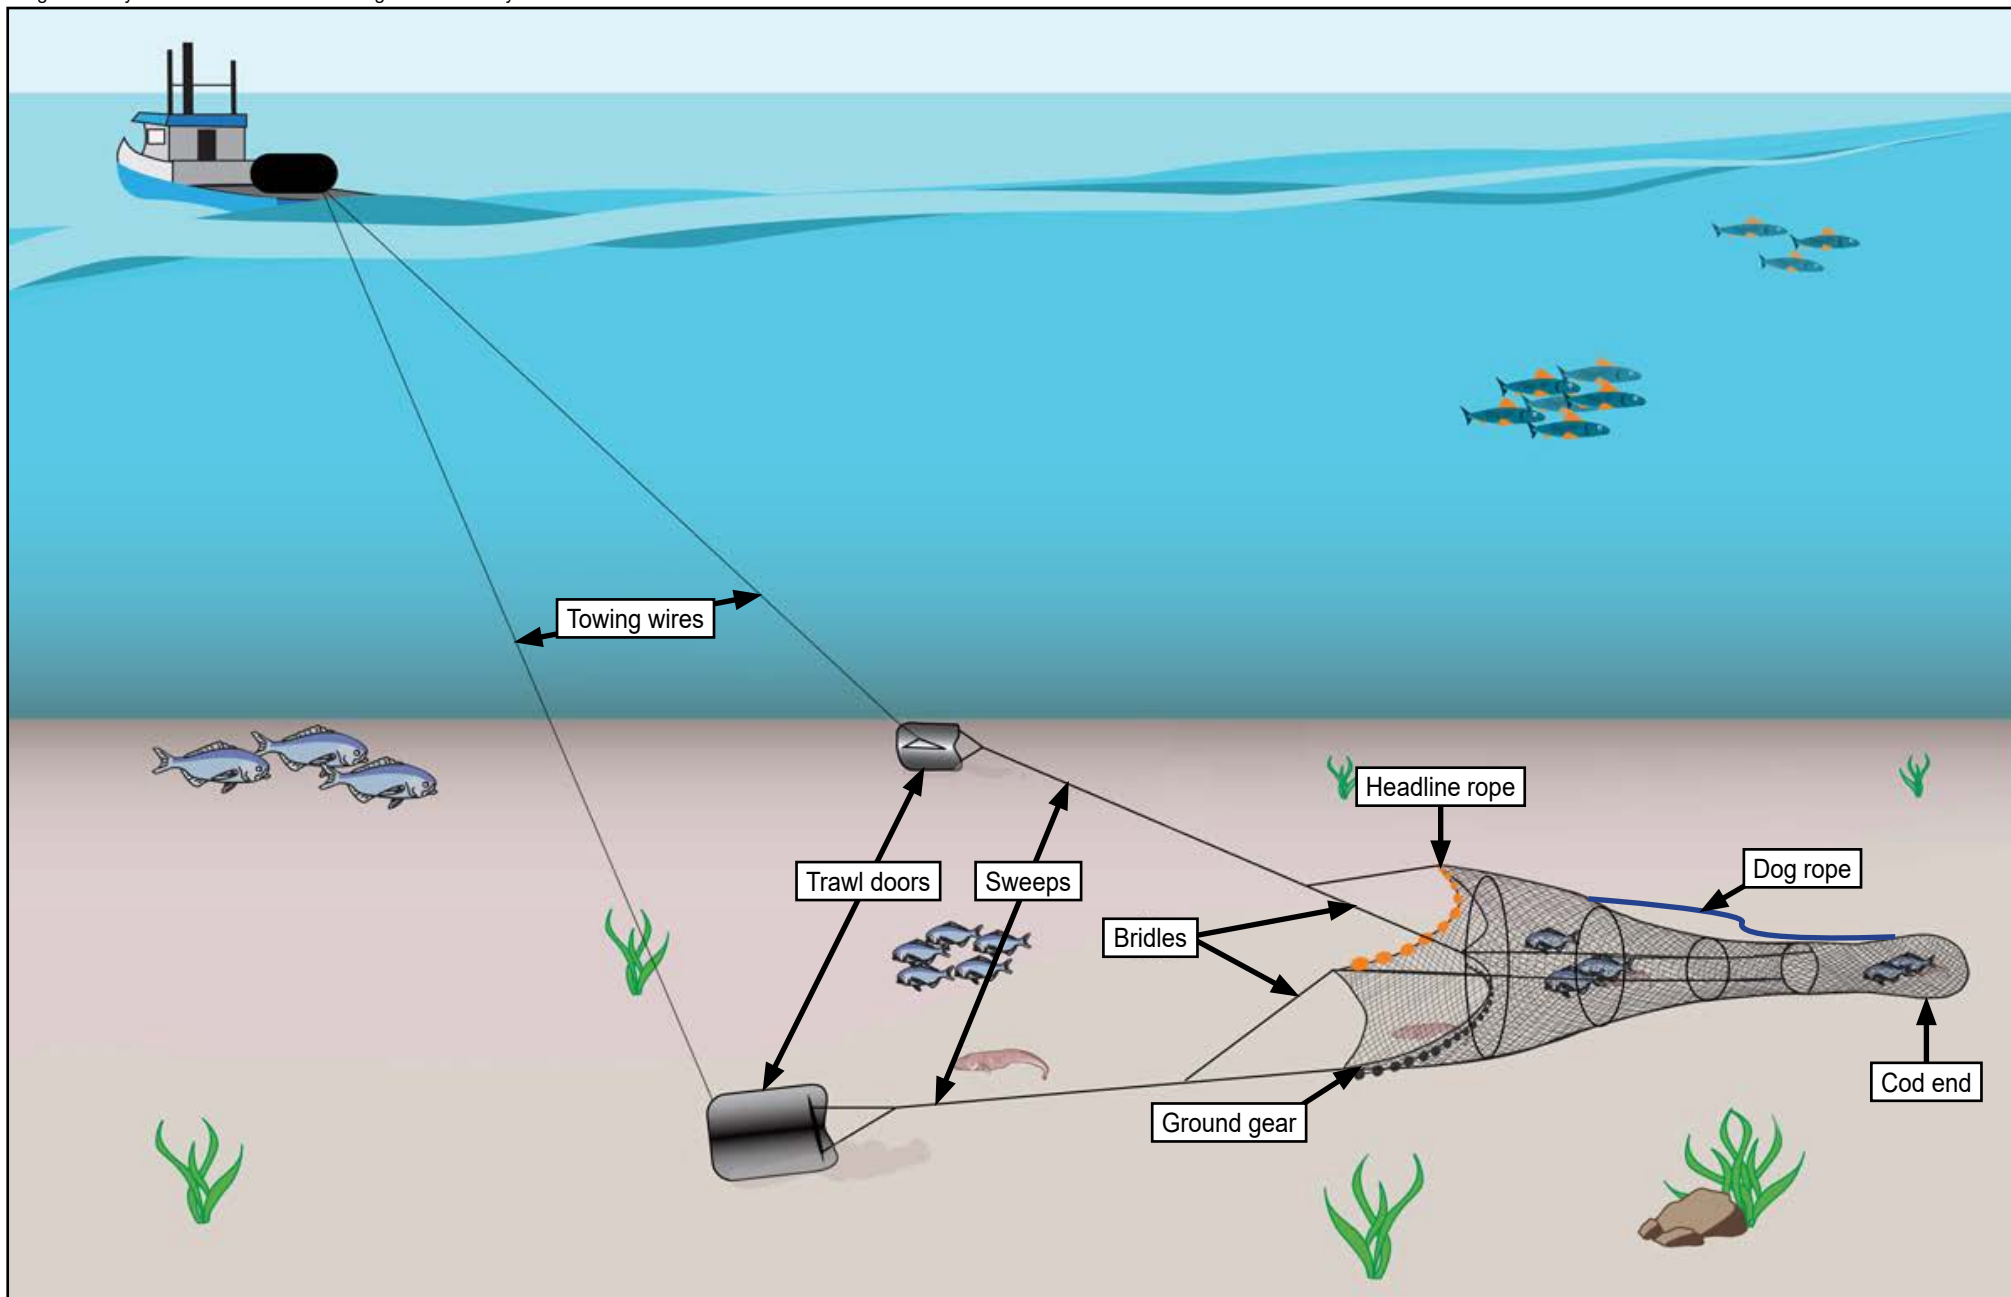
Once on board the vessel, the trawl doors were secured and the towing wires attached to the sweeps (**Figure 3**). The net was then hauled up until it could be fed onto the net drum at the vessel's stern. Because of the weight in the net, the net drum struggled to haul it in. After a further 2 hours, the dog rope<sup>1</sup> was able to be brought on board and was then led through a pulley on the starboard side of the gallows and attached to the starboard towing wire. During this 2 hour period *Diamond D* had slowly developed a starboard list of about 10°.

Figure 3: Trawling arrangement

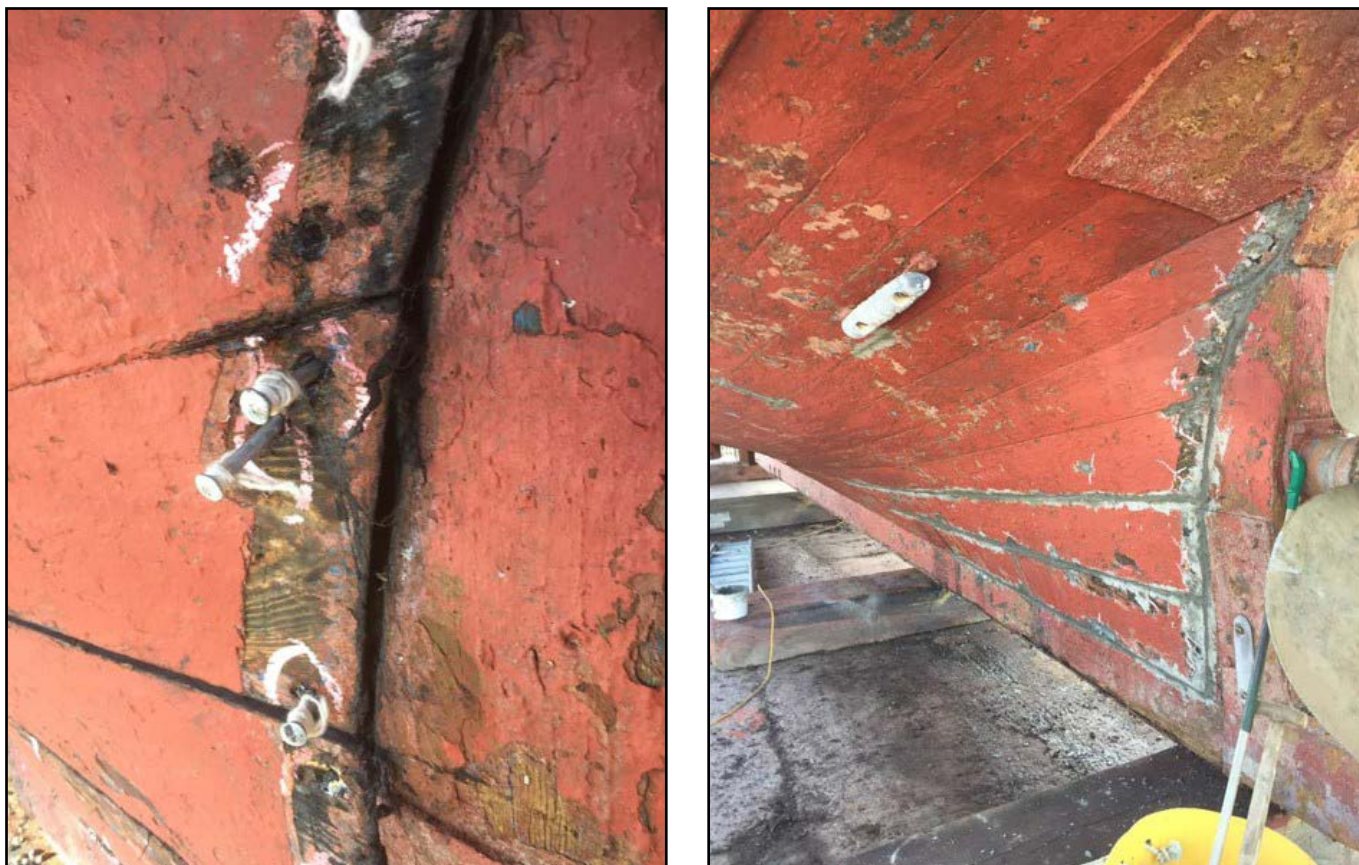
During a maintenance period in 2019, some refastening of the hull planking took place, mostly around both sides of the stern section of the vessel (**Figure 5**).

**Figure 5:** Hull refastening

The hull planking at the stern of *Diamond D* was almost 37 years old and surveys had identified minor soft patches. When the planking was hit by the heavy trawl doors, it is most likely that the damage allowed water to flood into the vessel. The flood water was able to spread through the vessel's internal spaces because there were no watertight bulkheads to contain it. As it was a frequent occurrence, the sound of the trawl doors hitting the hull did not cause concern to the skipper or owner.
