SERIOUS INCIDENT

Aircraft Type and Registration:	Edge 540, G-EDGY	
No & Type of Engines:	1 Lycoming AEIO-540-EXP piston engine	
Year of Manufacture:	1997 (Serial no: 18)	
Date & Time (UTC):	1 May 2021 at 1220 hrs	
Location:	Overhead Tempsford Airfield (disused), Bedfordshire	
Type of Flight:	Private	
Persons on Board:	Crew - 1	Passengers - None
Injuries:	Crew - None	Passengers - N/A
Nature of Damage:	Loss of right aileron and damage to right wing skin	
Commander's Licence:	Private Pilot's Licence	
Commander's Age:	45 years	
Commander's Flying Experience:	598 hours (of which 51 were on type) Last 90 days - 4 hours Last 28 days - 3 hours	
Information Source:	AAIB Field Investigation

Synopsis

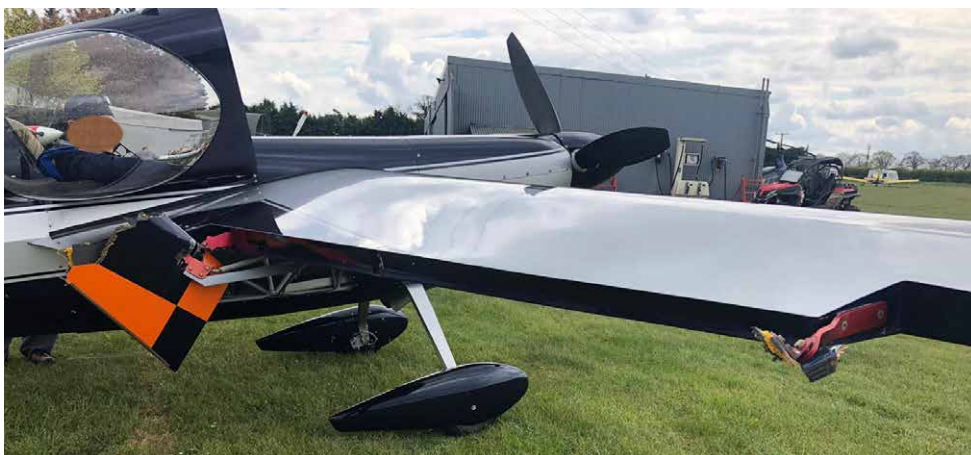
Figure 1

G-EDGY after landing, showing inboard hinge with section of aileron still attached and the distorted outboard hinge

aileron, had been bent upwards. The aileron had separated from the outboard hinge, but a small section of aileron remained attached to the inboard hinge along with the 'spade' (Figure 1). This part appeared to have been flailing in the slipstream and had caused some damage to the wing skin.

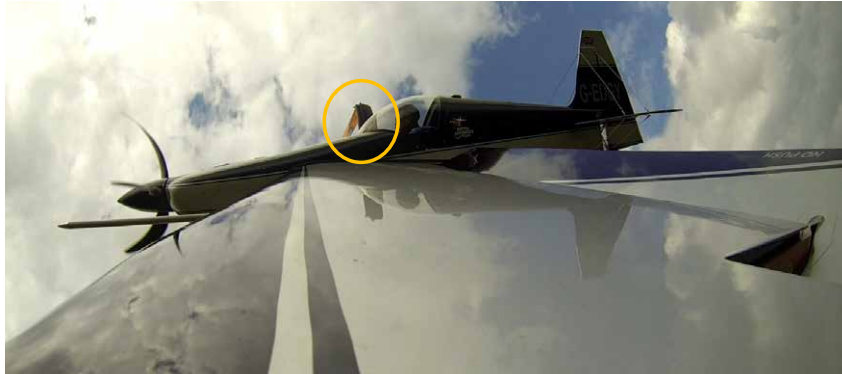
Figure 2

Aircraft entering the left roll showing the right aileron failing upwards (circled)

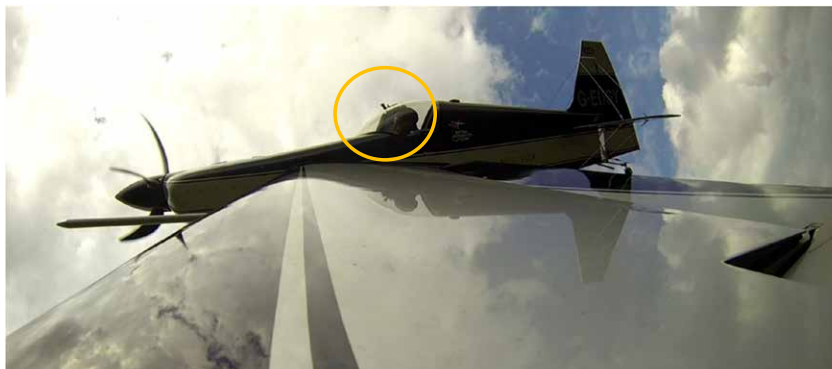
Figure 3

Right aileron failure continued (circled, behind canopy)

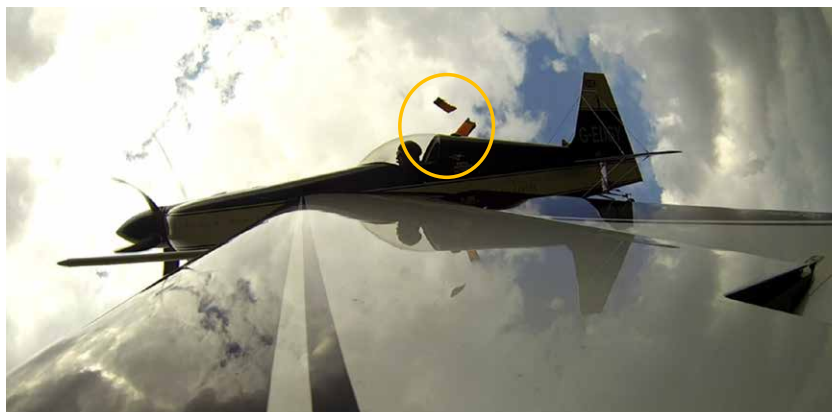
Figure 4

Parts of the right aileron departing the aircraft (circled)

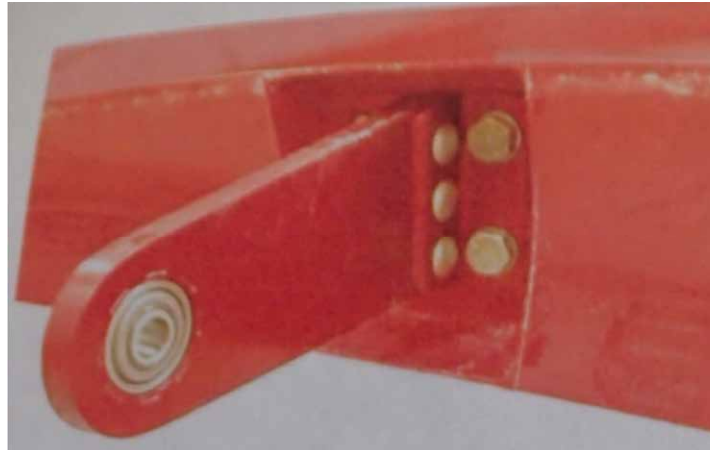
Figure 5

Image of centre hinge arrangement looking forward at wing rear spar

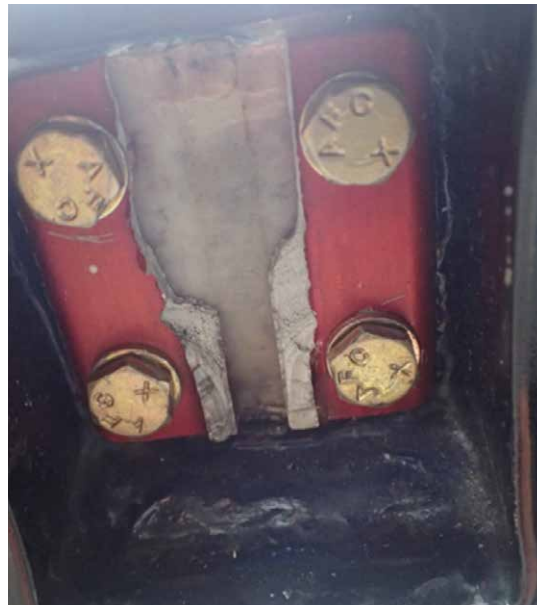
Figure 6

Parts of the failed centre hinge attachment for the right aileron before removal from wing

- The right aileron centre hinge attachment had failed through the corner radii of the two 'L' shaped brackets attaching the hinge assembly to the wing.

- Physical features of the right aileron centre hinge failure surfaces confirmed that both inboard and outboard sides had failed due to multi-origin fatigue.

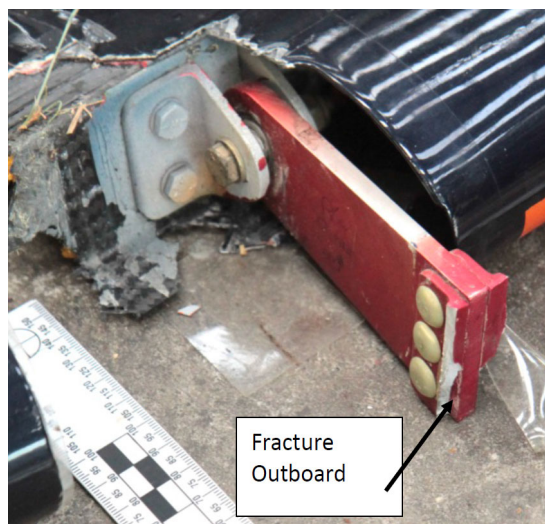
Figure 7

Remainder of the right aileron centre hinge attachment, still attached to the aileron

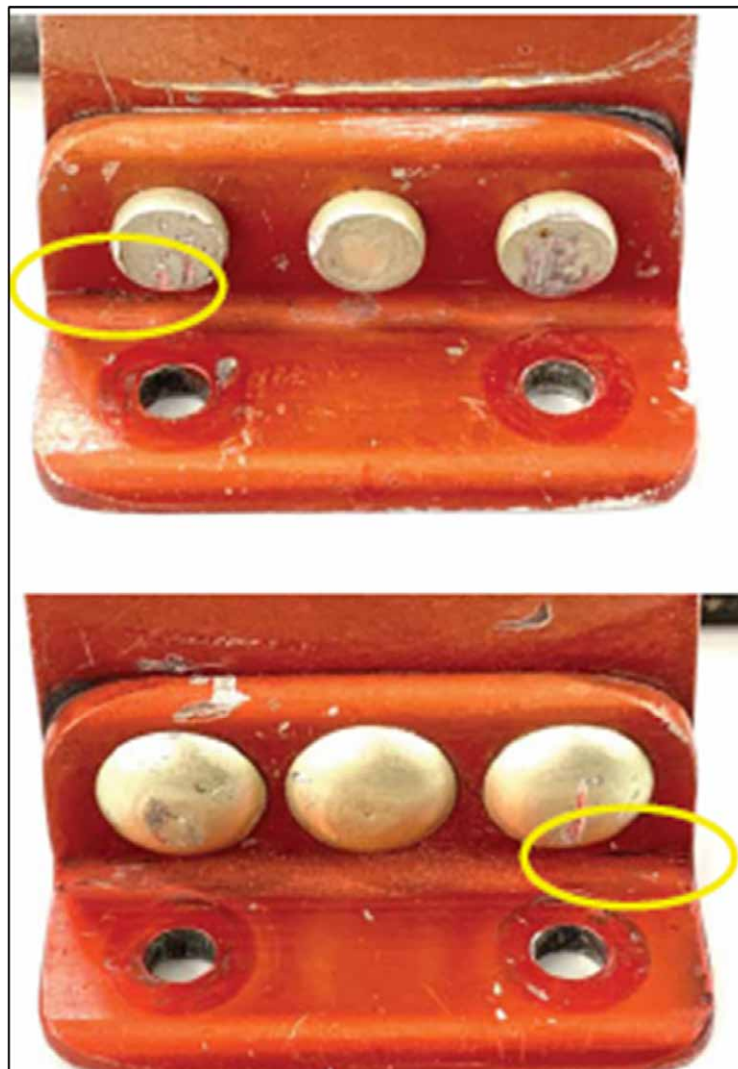
Figure 8

The intact hinge assembly from the left wing was also examined. Evidence of cracking in the corner radii, in a similar area to those found on the failed right hinge assembly, was observed (Figure 8). To allow detailed examination, these parts were pulled open to failure using a machine. Once exposed, the failure surfaces were examined using the same methods as the failed parts.

Evidence of cracking to left aileron centre hinge along corner radii

The similar hinge attachment assembly on the left wing had not failed, but fatigue cracks like those on the right aileron hinge were found, although they had not developed so extensively.

The aircraft manufacturer has issued Service Letter, SB E540015 to all known owners of affected aircraft. This letter is annotated 'MANDATORY' and recommends removal of the centre aileron hinge attachment assemblies at each 100 hour or annual inspection to allow inspection for cracks using a dye-penetrant method.

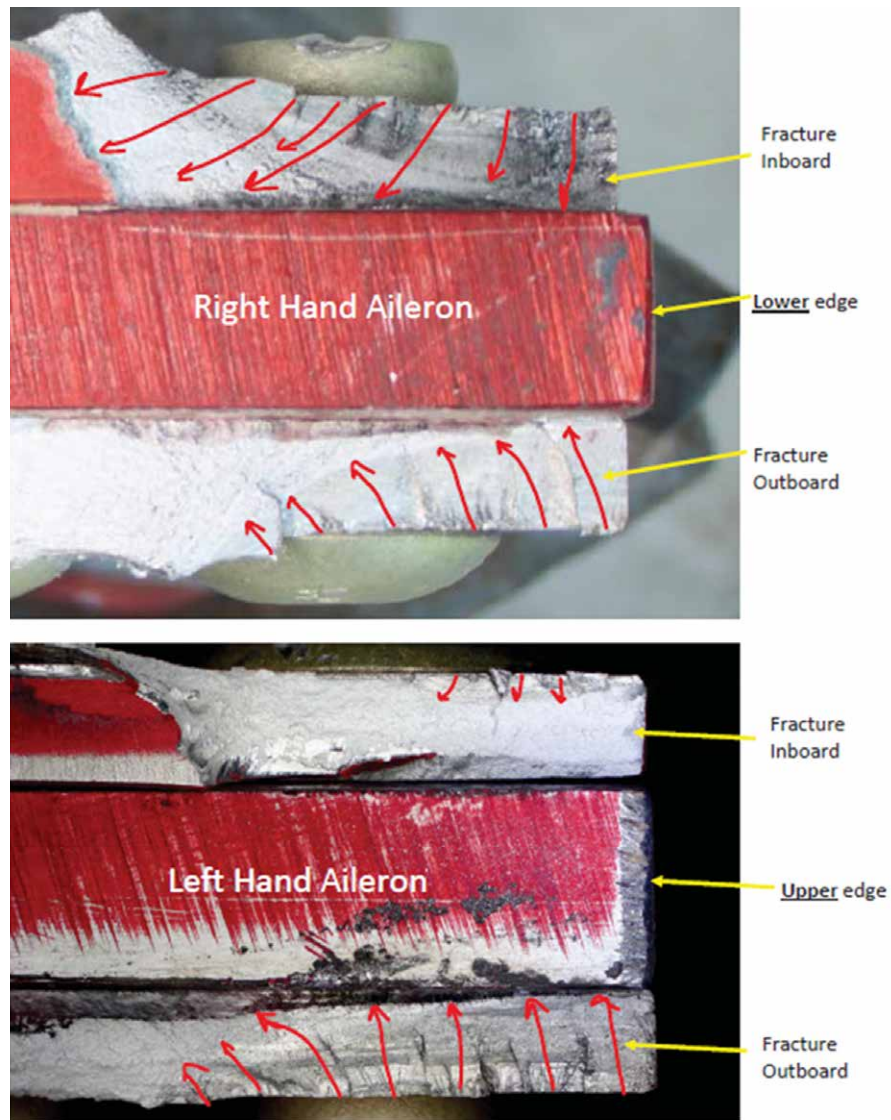
Figure 9

- On both the left and right aileron centre hinges, the cracks were multi-origin fatigue driven fractures. The right hinge had failed from the lower surface upwards and the left hinge from the upper edge downwards (Figure 9). This is consistent with control inputs to roll left.

Fractographic summary of damage observed to centre aileron hinges (red arrows indicate direction and extent of fatigue crack growth)

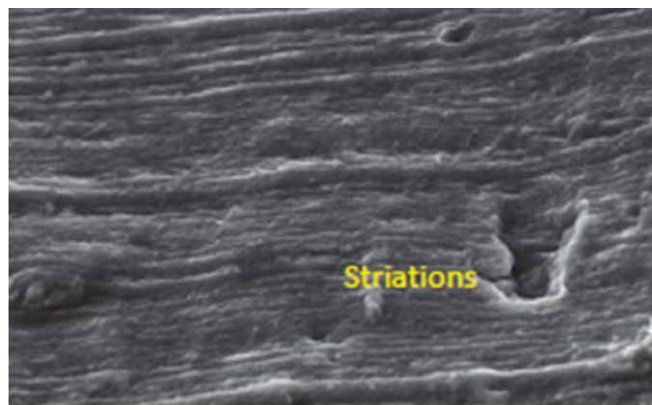
Figure 10

- Striation counting of the failure surfaces suggested that the estimated number of load cycles to failure was approximately 14,000 cycles (Figure 10).

From the striation marks, the metallurgy laboratory estimated that the hinge had been subjected to approximately 14,000 load cycles prior to failure. This is of the same order of magnitude as the owner's estimate of the number of full control deflections to roll quickly left which was 23,000.

High magnification, scanning electron microscope image of fatigue striations on a fracture surface of the failed right hinge (each striation is the result of a load cycle)
