ACCIDENT

Aircraft Type and Registration:	Piper PA-22-150, G-ARDS	
No & Type of Engines:	1 Lycoming O-320-A2B piston engine	
Year of Manufacture:	1959 (Serial no: 22-7154)	
Date & Time (UTC):	11 August 2021 at 1012 hrs	
Location:	Beverley Airfield, Yorkshire	
Type of Flight:	Private	
Persons on Board:	Crew - 1	Passengers - None
Injuries:	Crew - 1 (Minor)	Passengers - N/A
Nature of Damage:	Damaged beyond economical repair	
Commander's Licence:	Private Pilot's Licence	
Commander's Age:	66 years	
Commander's Flying Experience:	119 hours (of which 27 were on type) Last 90 days - 16 hours Last 28 days - 11 hours	
Information Source:	Aircraft Accident Report Form submitted by the pilot

Synopsis

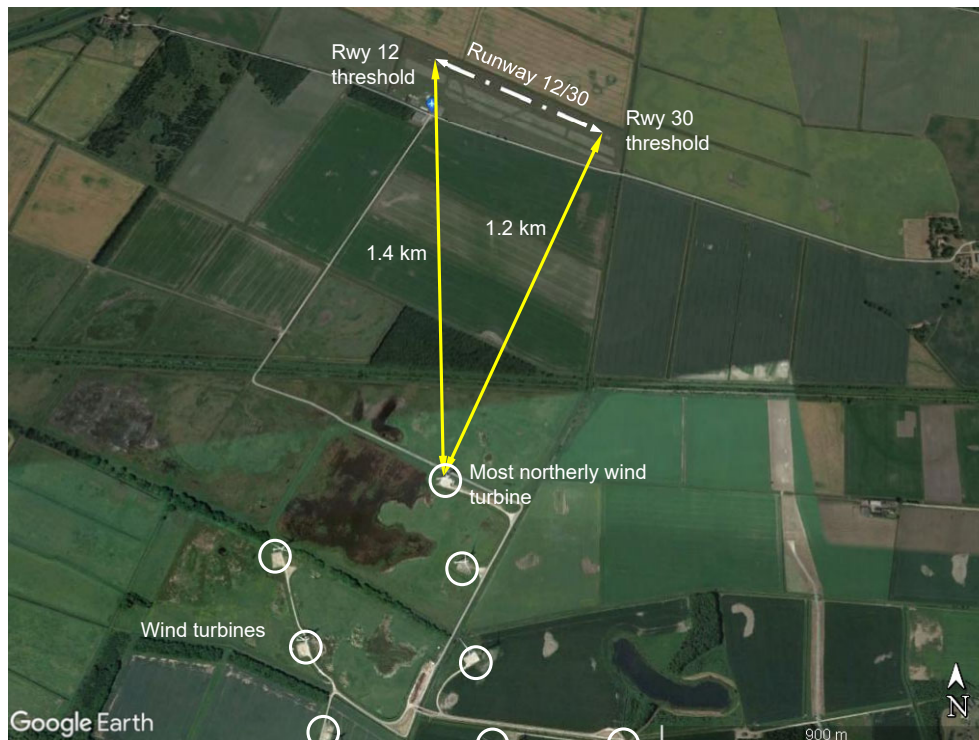
The installation comprises twelve 82 m diameter wind turbines, the most northerly is approximately 1.4 km south of Runway 12 threshold and 1.2 km south southwest of Runway 30 threshold (Figure 2).

Figure 2

Location of most northerly wind turbine at Hall Farm in relation to the runway at Beverley Airfield

The windfarm installation to the south of Beverley Airfield is 1.4 km from the Runway 12 threshold, which is just over 17 times the wind turbine diameter. The threshold of Runway 30 is within 15 times the wind turbine diameter.

The available literature would suggest that the possibility of encountering wake turbulence from the windfarm at this airfield is remote. However, it cannot be entirely ruled out. The accident aircraft flew an approach that crossed downwind of the wind turbines but the distance from the closest turbine to the location that the aircraft encountered the upset was further than 16 rotor diameters identified in CAP 764 as the furthest distance that turbulence would be encountered. It was also well outside that of the most recent estimates of eight rotor diameters downwind of windfarms.

The analysis that has been conducted has been based on limits for commercial fixed-wing and rotary-wing aircraft and may not take into account the effects on general aviation operations. It is therefore incumbent on the General Aviation community to provide feedback to the CAA, via an MOR, if they suspect they have been affected by wind turbine wake turbulence. This will allow a more representative understanding of the issue and ensure the guidance for operating close to a wind farm is based on theoretical and practical knowledge.
