ACCIDENT

Aircraft Type and Registration:	Spitfire Mk.T IX (Modified), G-CTIX	
No & Type of Engines:	1 Packard Motor Car Co Merlin 224 piston engine	
Year of Manufacture:	1944 (Serial no: PT462)	
Date & Time (UTC):	20 July 2021 at 1305 hrs	
Location:	Duxford Aerodrome, Cambridgeshire	
Type of Flight:	Safety Standards Acknowledgement and Consent (SSAC)	
Persons on Board:	Crew - 1	Passengers - 1
Injuries:	Crew - None	Passengers - None
Nature of Damage:	Paint marks on underside of right wing	
Commander's Licence:	Airline Transport Pilot's Licence	
Commander's Age:	57 years	
Commander's Flying Experience:	19,000 hours (of which 500 were on type) Last 90 days - 42 hours Last 28 days - 17 hours	
Information Source:	Aircraft Accident Report Form submitted by the pilot

Synopsis

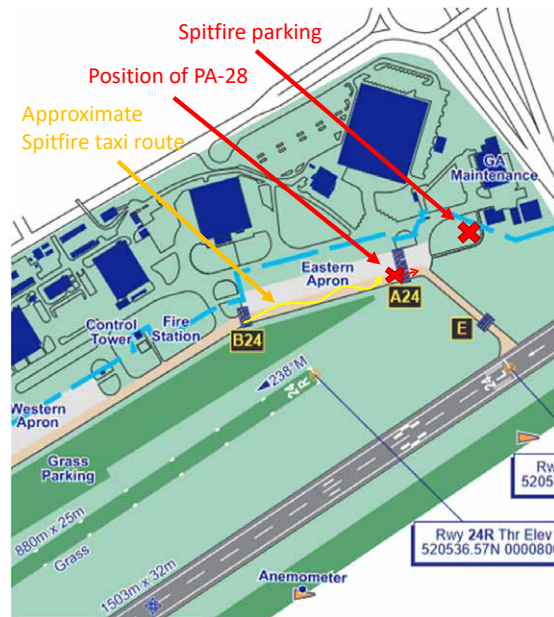
Figure 1

Following an experience flight in the local area, the Spitfire landed on the paved Runway 24L at Duxford Aerodrome. The pilot was given taxi instructions to its parking position to the north-east of the Eastern Apron (Figure 1). The aircraft taxied across the grass runway onto the paved taxiway, where it was given a further instruction by ATC to hold position due to conflicting traffic under tow. Once this traffic had passed, G-CTIX was given onwards taxi instructions. There was a Bearcat aircraft preparing for departure to the right of the taxiway which the pilot commented was not a common sight.

A portion of G-CTIX taxi route relative to PA-28

It is normal in a taildragger such as a Spitfire to weave from side to side when taxiing, enabling the pilot to see along the intended route. In preparation to leave the main taxiway and enter its parking area to the left, the pilot turned the aircraft right, away from the barrier; as he commenced the reverse turn, he saw a PA-28 forward of the right wing at the A24 holding point. The PA-28 was facing in a north-easterly direction and could not have seen the Spitfire approaching.

On seeing the PA-28 the Spitfire pilot applied full left rudder and brake. The Spitfire then swung to the left and its right wing contacted the left wing of the PA-28. The Spitfire pilot stopped the aircraft and shut down the engine. He also indicated to the PA-28 pilot to shut down, and went to check on the occupants. The airfield emergency services attended the scene, as did staff associated with the experience flight who arranged for the passenger to disembark. Both aircraft sustained minor cosmetic damage and there were no reported injuries.
