ACCIDENT

| Aircraft Type and Registration: | Europa XS, G-IMAB | |

Synopsis

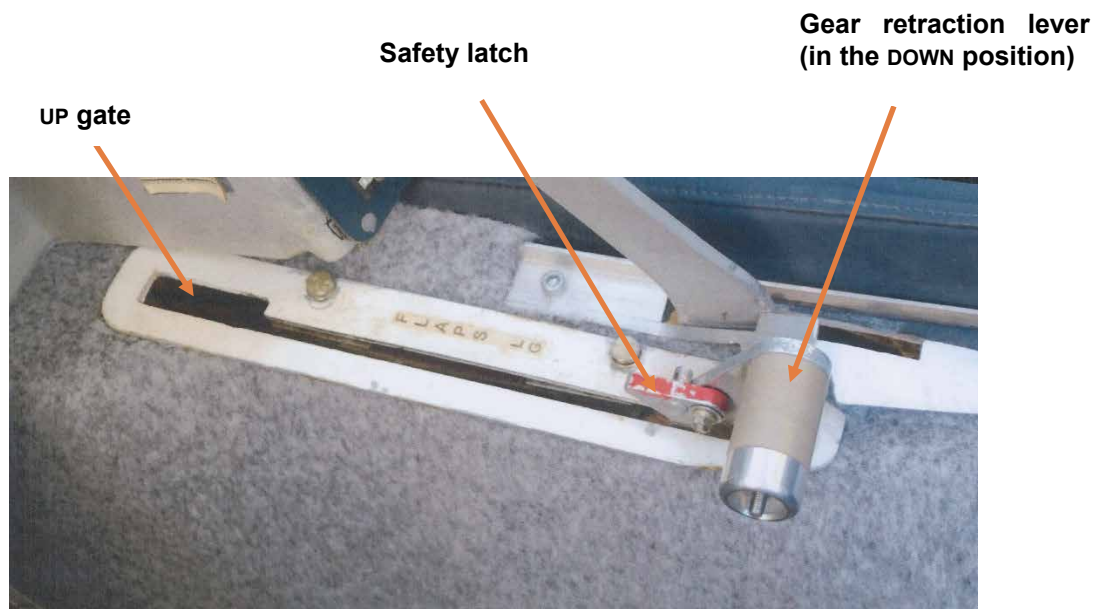
Figure 1

The Europa XS has a retractable mainwheel with a fixed tailwheel and retractable outriggers on the wings. The landing gear and flaps are selected by a single lever on the centre console between the seats (Figure 1). The lever has two gates at either end of its travel, coinciding with the UP and DOWN positions; it is biased to the right so that it naturally enters the gates. To avoid inadvertent retraction, a safety latch rotates under its own weight, dropping into the retraction lever slot. Some owners have installed a spring to assist the operation of the safety latch, but this was not the case with G-IMAB.

To retract the landing gear, positive action is required to lift the latch out of the slot before the lever can be moved sideways out of the gate and pushed forwards. By design, if the lever is inadvertently moved out of the DOWN gate, the landing gear over-centre mechanism should stop the lever moving forwards without input.

Landing gear operating lever

The pilot stated that he verified that the safety latch was in place during his pre-flight checks and he thought that the bumpy runway may have resulted in it jumping out of position. If the gear lever then moved sideways out of the gate, he considered the forces would have been sufficient for the landing gear to retract.

An initial check by an LAA inspector found wear in the landing gear mechanism, but no obvious cause for the uncommanded landing gear retraction. At the time of writing, the aircraft was awaiting a more detailed inspection prior to repair.

The original AAIB report also stated that '*An initial check by an LAA inspector found wear in the landing gear mechanism, but no obvious cause for the uncommanded landing gear retraction. At the time of writing, the aircraft was awaiting a more detailed inspection prior to repair.*' This inspection has been completed and the LAA inspector reports that no anomalies were found with the landing gear system. The aircraft has been repaired and an optional spring to assist the operation of the landing gear safety latch has been installed.
