# ***AAIB Bulletin***

***1/2019***

Agusta AW 169	G-VSKP	27-Oct-18	3
---------------	--------	-----------	---

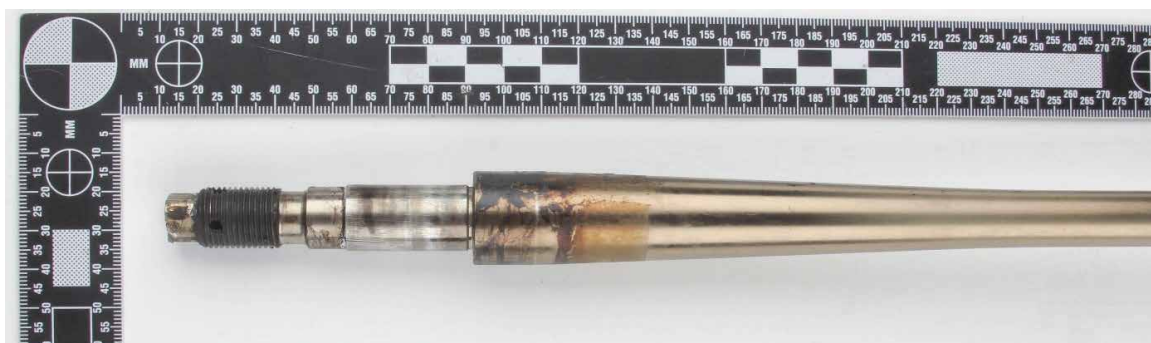
**Figure 5**

The control shaft, the locking nut and pin carrier, and the duplex bearing/sliding unit assembly were removed from the wreckage and inspected in detail. The locking nut on the bearing end of the control shaft was found to have a torque load significantly higher than the required assembly value. The inner races of the bearing could only be rotated a few degrees in either direction by hand. There was a build-up of black grease inside the slider unit around the inboard face of the duplex bearing. The section of the control shaft adjacent to this bearing face showed evidence of burnt-on grease and was discoloured along its length (Figure 5).

Duplex bearing location on tail rotor actuator control shaft after removal

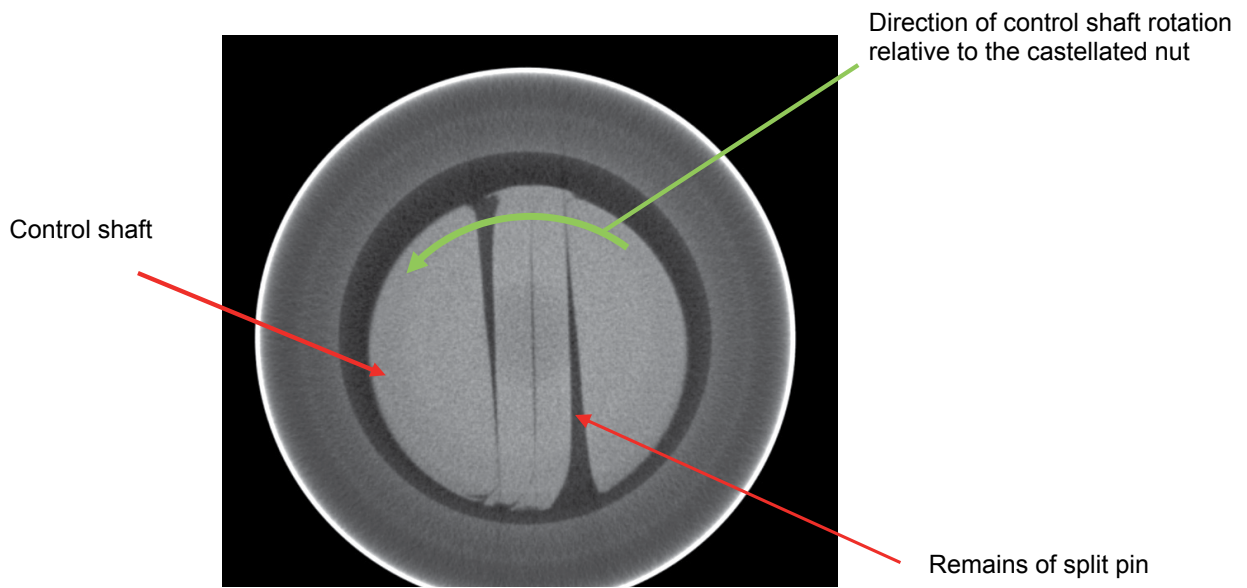
**Figure 6**

CT Scan through tail rotor actuator control shaft (viewed from actuator end)

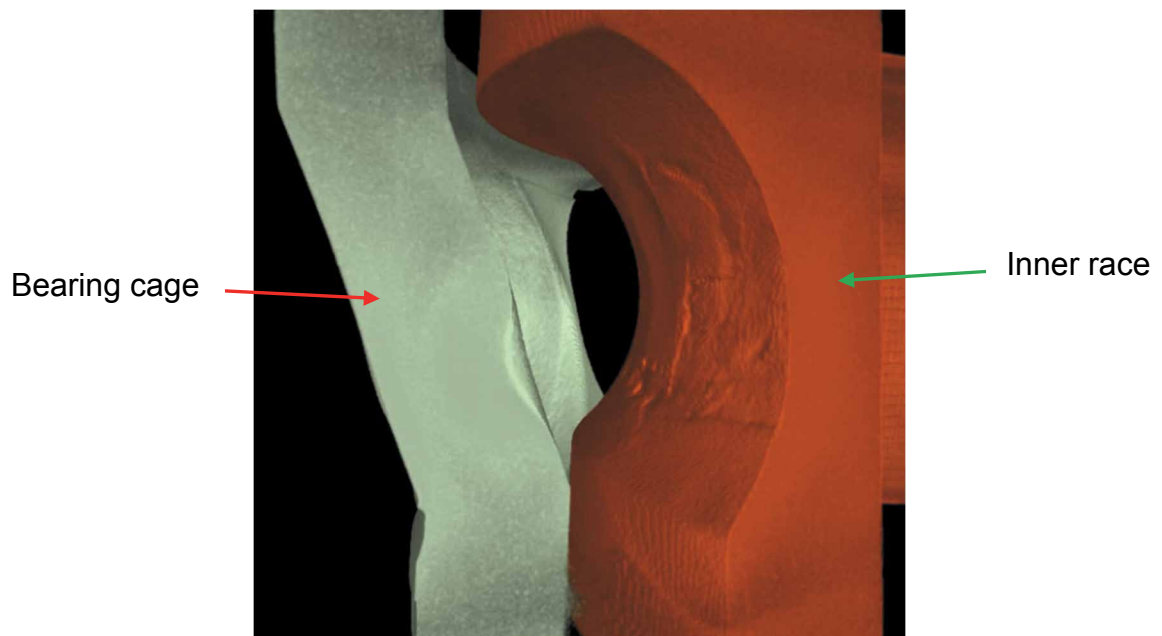
**Figure 7**

The scan of the bearing showed fractures to the bearing cages and significant damage to the surface of the inner bearing races, the damage being worse on the inboard bearing race (Figure 7) where there was also evidence of sub-surface damage.

CT imagery of duplex bearing inboard inner ring surface damage

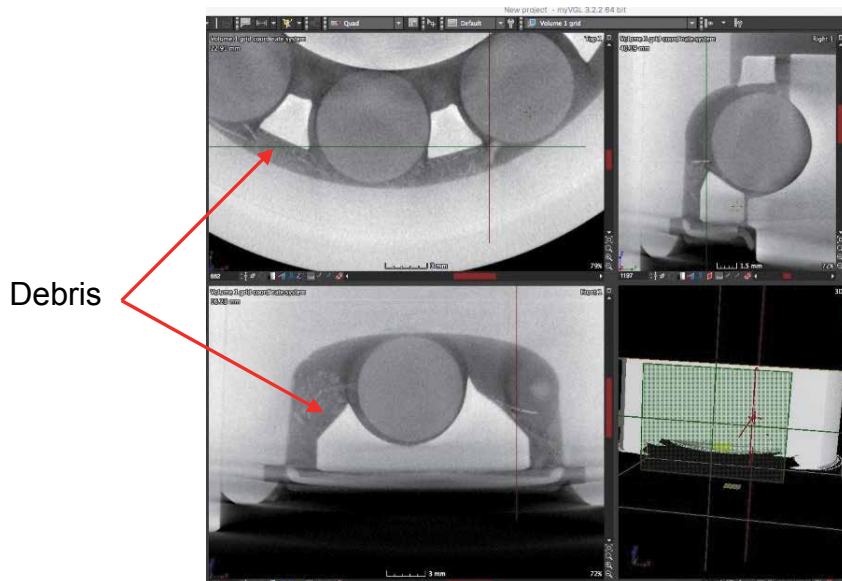
**Figure 8**

The scan also showed evidence of debris accumulating in the bearing raceways (Figure 8).

Scan images of duplex bearing showing raceway debris accumulation

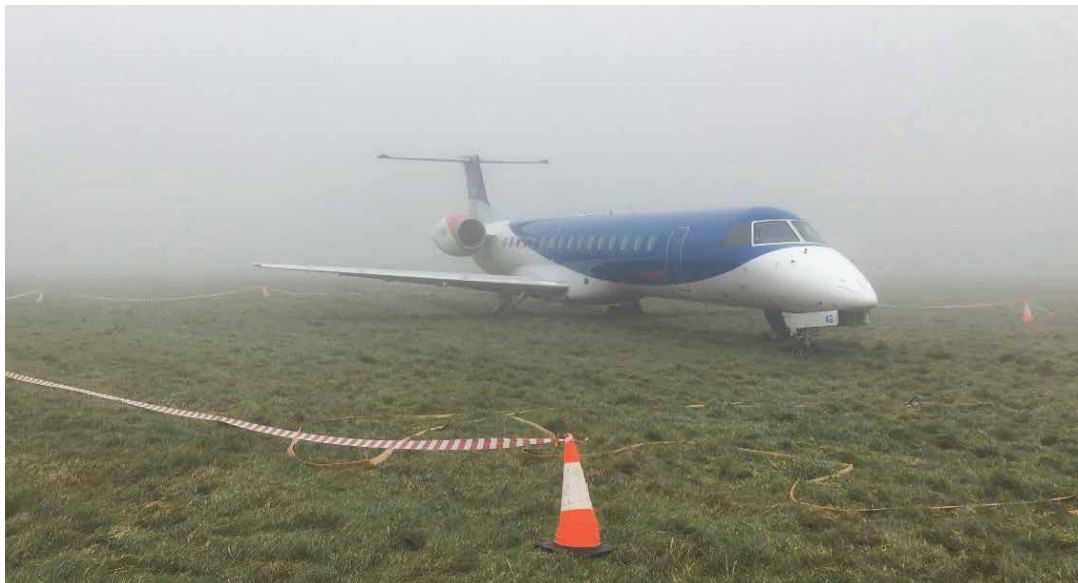
Figure 4 shows the aircraft where it had come to rest and the poor visibility shortly after the time of the accident. Marks and rubber fragments on the runway defined the touchdown point, approximately 468 m from the threshold, and showed the aircraft initially tracking on the runway centreline before drifting first slightly to the right of the centreline and then veering left over 280 m. Overheated fragments of vulcanised rubber were found at various points along the runway, with a cluster of larger fragments approximately 400 m from the touchdown point over an area of approximately 40 m by 3 m. After this point there were faint but reasonably clear lines left on the runway surface made by the wheel rims up to the point where the aircraft left the runway and continued onto the grass.

**Figure 4**  
G-CKAG off the runway

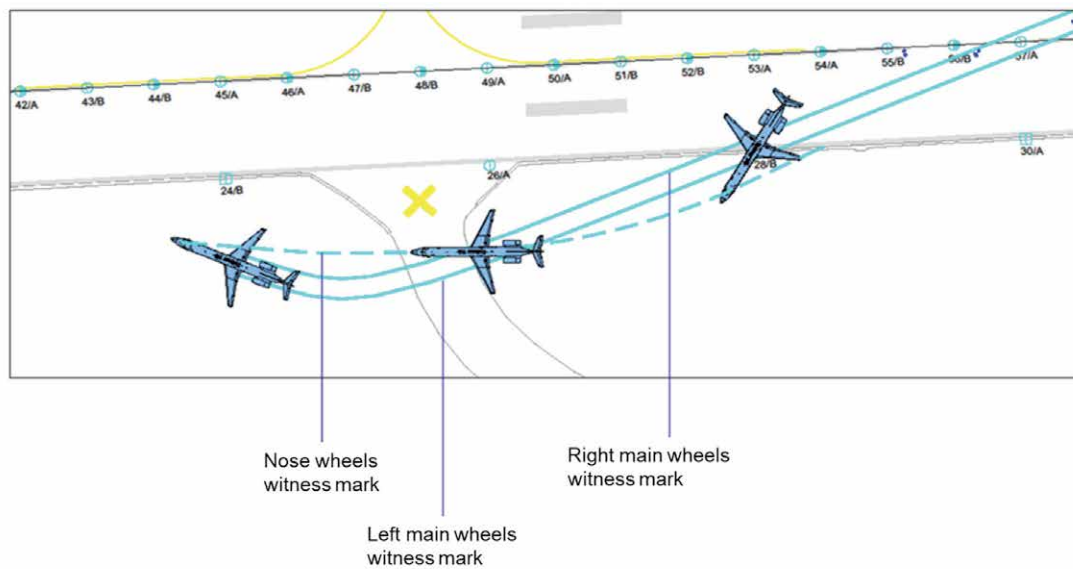
Once on the grass the aircraft left deep furrows in the top soil up to where it traversed a disused taxiway with further deep furrows beyond leading to its final position. The distance from where the aircraft left the main runway until coming to stop was approximately 120 m. Marks showed that it had 'fishtailed' from right to left whilst on the grass. The path of the aircraft from the runway is shown in Figure 5.

**Figure 5**  
The aircraft's path leaving the runway

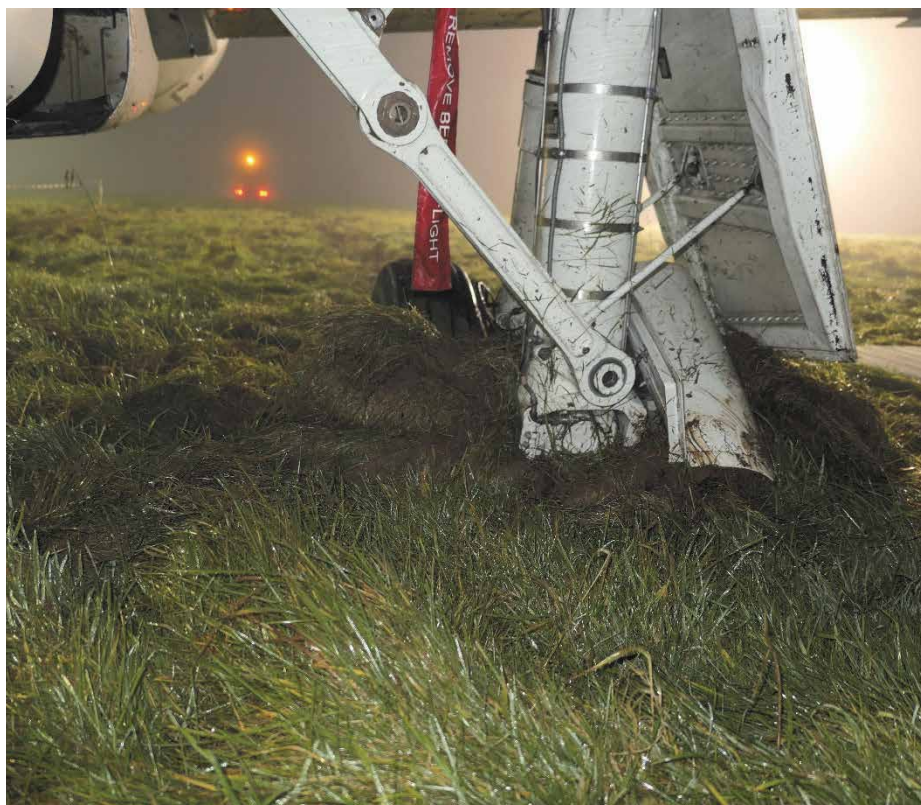
The aircraft stopped on a heading of 296°(M) and all four main wheels were buried up to their axles. The components attached to the front of the left and right main landing gear were clogged with soil and turf. Apart from the detached and loose lower fairing mounting strut on the left landing gear, there appeared to be no other damage. The nose landing gear, fuselage, wings and engines were undamaged although the left wing leading edge had soil residue along its length. Figure 6 shows the extent that aircraft main wheels and landing gear had dug in.

**Figure 6**  
The extent of the entrapment of the main wheels and landing gear  
(left side shown, the right side was similar)

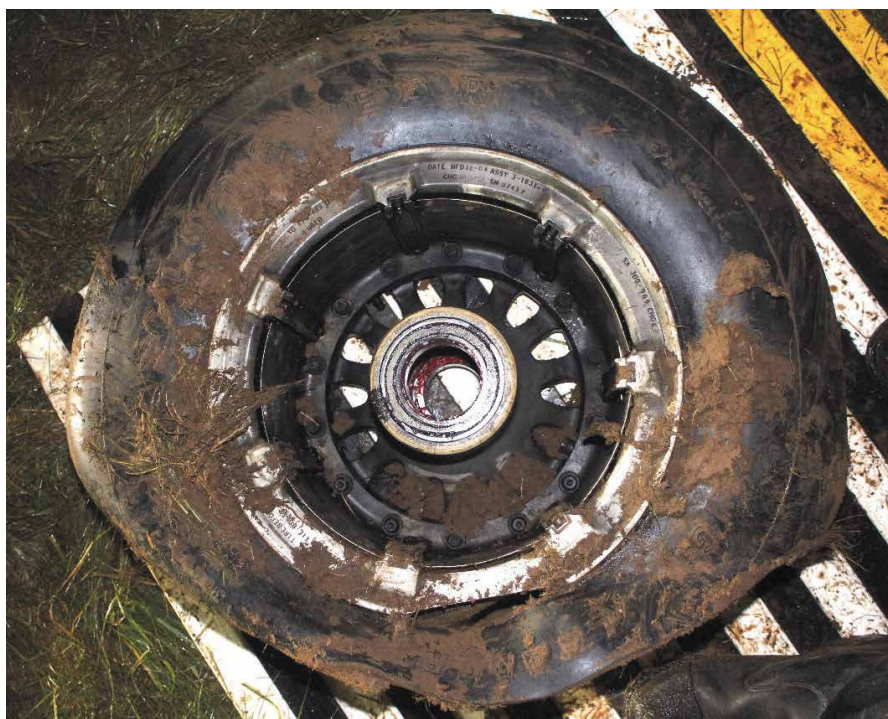
**Figure 7**

The wear pattern on the tyres showed the tread surface abraded through leaving ragged edges and missing material. Abrasion then carried on symmetrically though the sidewalls over an approximately 140° arc down to the wheel rims. There was also abrasion of some of the wheel rims where they had contacted the runway surface. None of the tyre beads de-seated and the fusible plugs and valves were not affected. Figure 7 shows the damage to one of the main wheel and tyre assemblies. The other main wheels and tyres exhibited the same extent of damage.

Main wheel and tyre damage

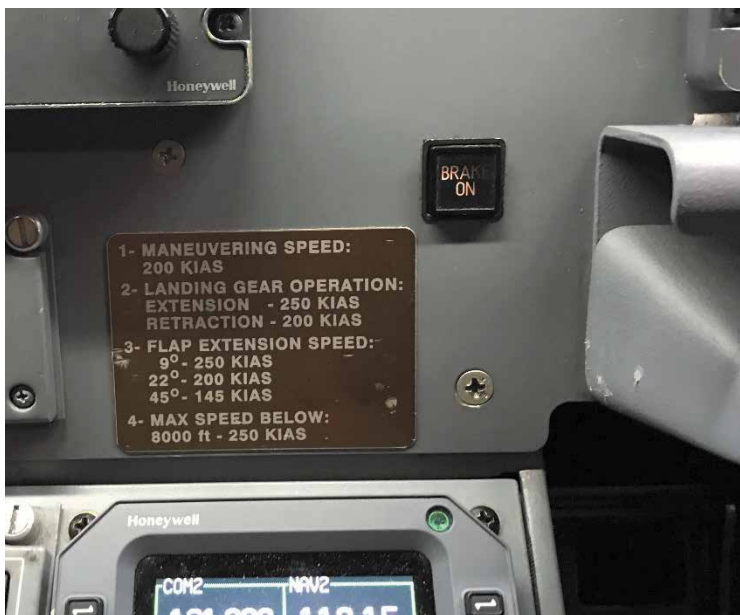
**Figure 8**

The aircraft had been shut down and made safe by the crew with the parking brake left in the OFF position. During examination of the aircraft, the parking brake was operated and, with aircraft electrical power on, the parking brake indicator on the centre panel illuminated. However, the nomenclature on the light did not appear to be as well defined as would be expected, consistent with one of its filaments having failed. Figure 8 shows the parking brake indicator.

Parking brake indicator

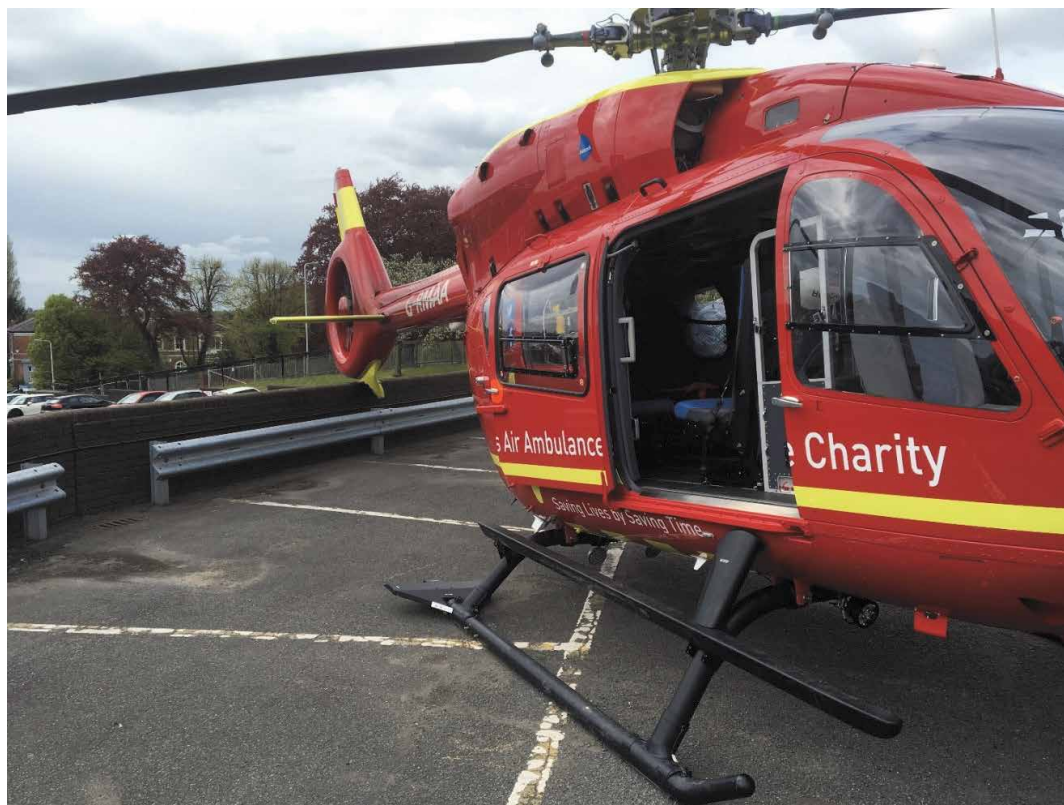
**Figure 2**

G-RMAA after the incident with the frangible section of the tail boom in contact with the low wall

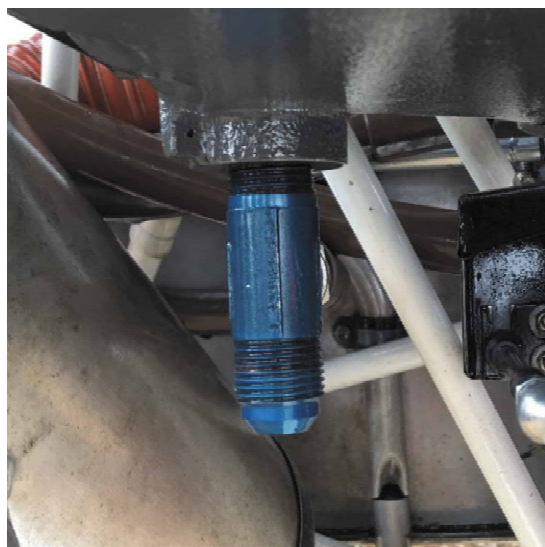
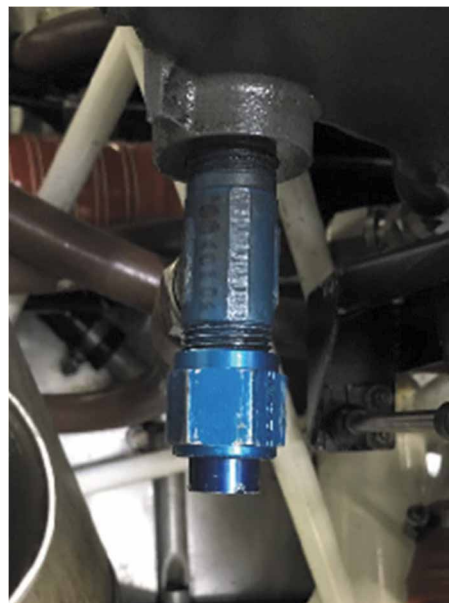
**Figure 1**

Grob 115E engine oil sump drain  
(Left image shows cap missing; right image shows cap installed)

The maintenance organisation is reviewing their procedures and, as part of their continuous airworthiness management, is liaising with the manufacturer about an alternative cap that can be wire locked. In the interim, they have introduced an independent check to ensure that the cap is correctly refitted.

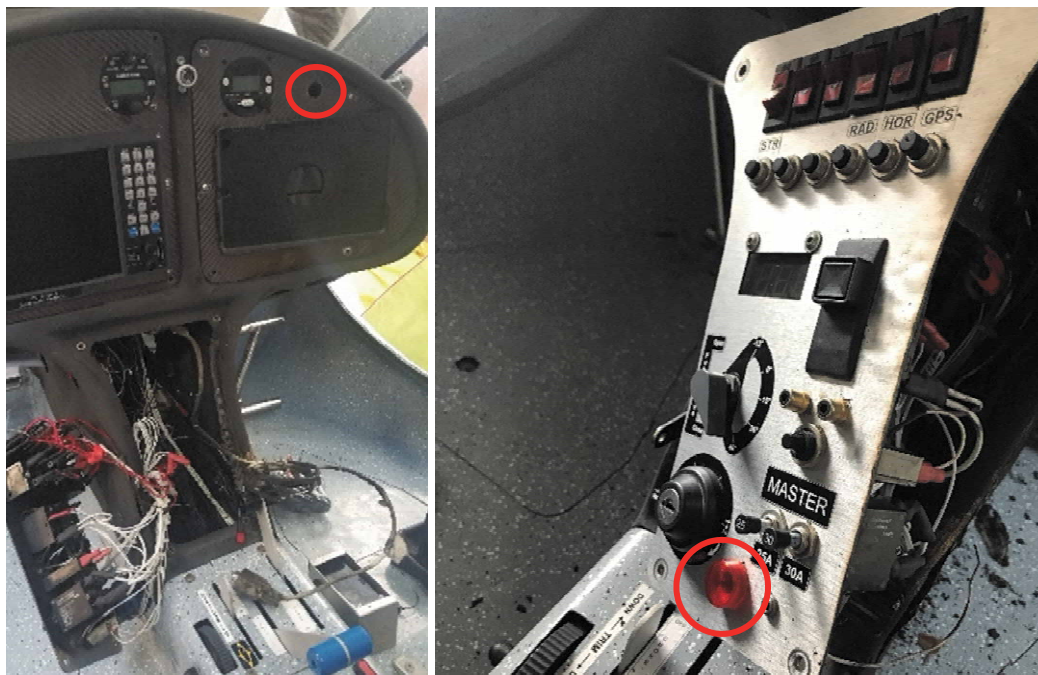
**Figure 1**

The aircraft was recovered to a repair organisation for examination and the instrument console was disassembled. There was evidence that the console had been modified previously to fit new avionics equipment and the charge indicator lamp had been moved. The original location was the upper right of the panel, but it had been moved to the lower central section (Figure 1). The repair organisation's assessment was that the standard of wiring was very poor. Wires were over length, had insufficient support, there was a risk of entrapment or chafing and improper terminals had been used.

Instrument console

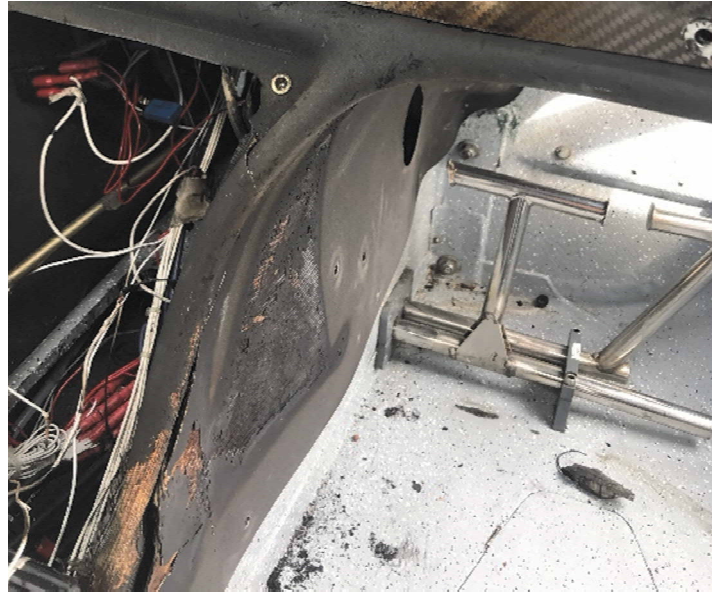
**Figure 2**

The charge indicator lamp is connected to the voltage regulator through a 22AWG (0.64 mm) wire which is nominally sized for current up to 3 amps. Should the lamp supply wire short to earth, the current could be up to 50 amps; the full regulator output of 20 amps and up to 30 amps from the battery. The wire to this lamp had burned through and several adjacent wires showed evidence of heat damage. The structure of the instrument console is a woven carbon / resin composite which showed evidence of fire damage. The damage showed that in some places, the resin had been totally consumed and only the carbon mat remained (Figure 2).

Fire damage to the instrument console

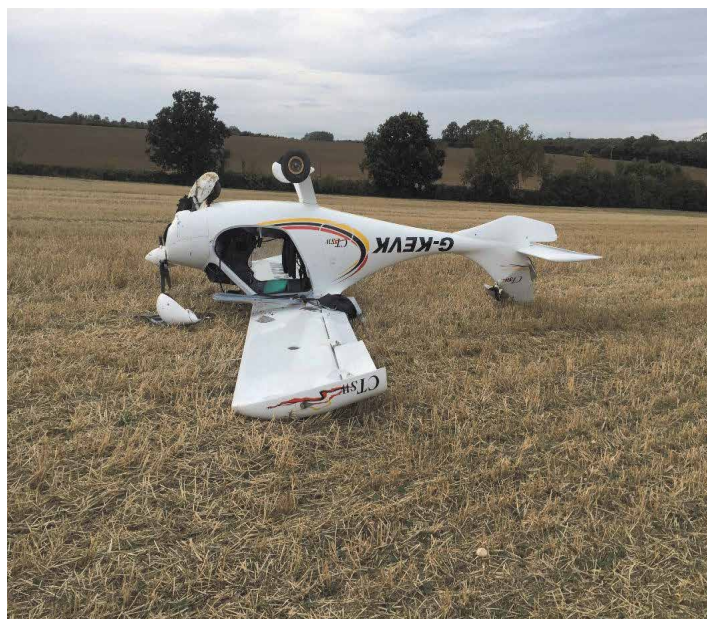
**Figure 1**

The final position of the aircraft

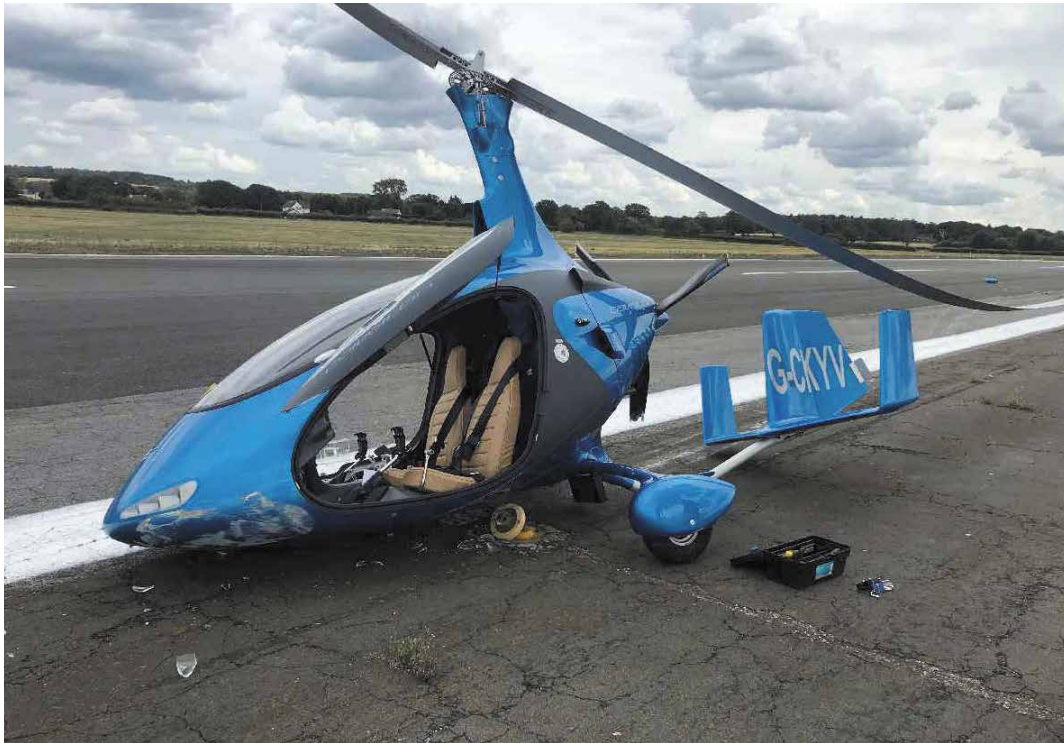
**Figure 1**  
Aircraft on the runway
