AAIB Bulletin

3/2022

Published 10 March 2022

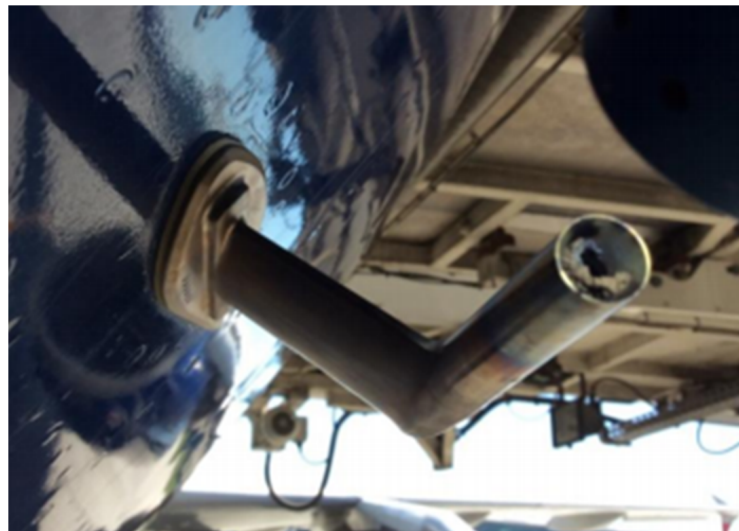
Figure 2

An inspection of the pitot/static probes found that the left pitot probe, which feeds the commander’s PFD, was blocked. The blockage appeared to be formed of a solid soil type material (Figure 2). The pitot probe was replaced, and the system tested and proven serviceable. At this point the operator judged that this was an isolated occurrence in an area of the airfield where insects had historically been problematic for aircraft. Since the previous occurrences, much of the hedgerow had been removed for other reasons.

G-EUUO pitot probe blockage

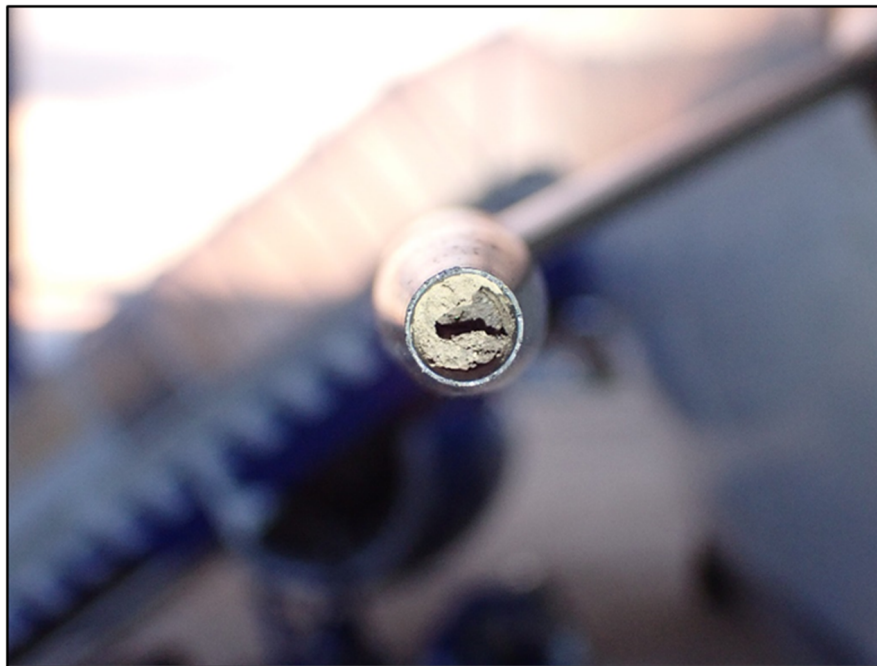
Figure 3

Inspection of the aircraft pitot probes showed that both the right and centre probes were blocked. The nature of this debris (Figure 3) was similar to that found on G-EUJO and G-TTNN. However, with the aircraft having been parked at a different location to the other two aircraft, the operator now considered that this was a wider issue, and the event was notified to the AAIB and the aircraft quarantined for inspection.

G-YMMR blocked pitot probe

As two of G-YMMR's probes had been found to be blocked (right and centre), all three probes were removed. The Total Air Temperature probes and static ports were inspected and found to be clear. The pitot/static system was flushed, and new probes fitted at the left, centre and right locations. No further debris was found during the system flushes. No previous reports of pitot/static system or ASI system defects had been reported on the aircraft and, following testing, it was released back to service.

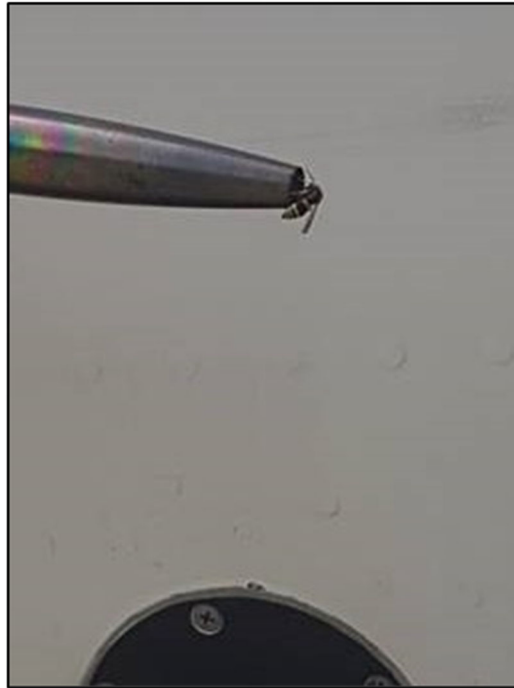
Figure 4

- A Boeing 777-300, G-STBJ, parked on stand TA6, was found to have its right pitot probe blocked and an insect, suspected to be a bee or wasp, was photographed on the end of the pitot probe (Figure 4). The right probe was removed for further inspection.

Insect entering G-STBJ pitot probe

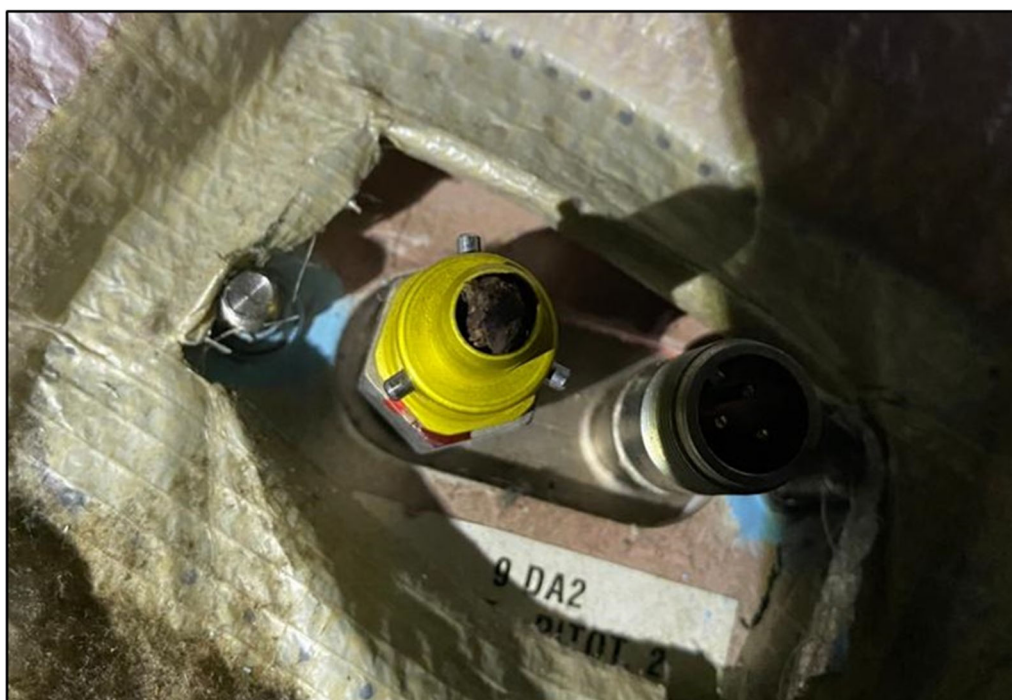
Figure 5

The incident occurred on the outbound sector of a Heathrow-Milan-Heathrow flight. During the latter stages of the climb out from Heathrow, the aircraft's ECAM system alerted the flight crew to a failure of the co-pilot's pitot probe heater. In accordance with Flight Crew Operating Manual (FCOM) procedures, they switched the co-pilot's air data supply from its normal source, Air Data Computer 2 (ADC2), to ADC3. At no stage did they observe any associated unusual or unreliable indications on their flight instruments. Flight despatch for the return sector was undertaken using the same air data source configuration, this was in accordance with the Operator's Master Minimum Equipment List authorisations. Post-flight investigation by maintenance staff at Heathrow found, during removal, evidence of debris and contamination at the quick-disconnect union on the rear of the co-pilot's pitot probe (Figure 5). During the rectification work, further debris and contamination was found in the commander's pitot probe. No contamination or debris was found in the standby probe.

G-VKSS co-pilot's pitot probe debris

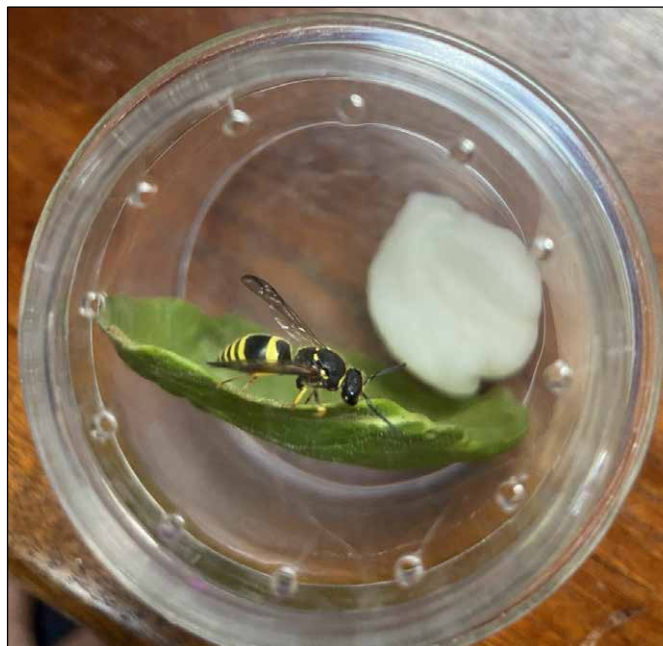
Figure 6

Whilst conducting a pre-departure DVI, an insect was spotted in the commander's pitot probe. The probe was sealed and removed by the engineers who then captured and secured the live insect (Figure 6). The insect was handed over to the AAIB and then transferred to the Natural History Museum (NHM) to try and identify the species.

Live species collected from pitot of G-DBCG

The live wasp from G-DBCG was identified as a female *Ancistrocerus parietum* (see Table 3), commonly called the Wall Mason wasp (also known as the Notched Mason wasp). This identification was in keeping with a previous identification by the NHM specialist who, from the photograph of the insect entering G-STBJ's probe shown in Figure 4, tentatively identified the species as being from the subfamily, *Eumeninae* (Potter and Mason wasps). DNA tests on the larvae found in the blocked pitot probe from G-STBJ confirmed that the species was *Ancistrocerus parietum*.

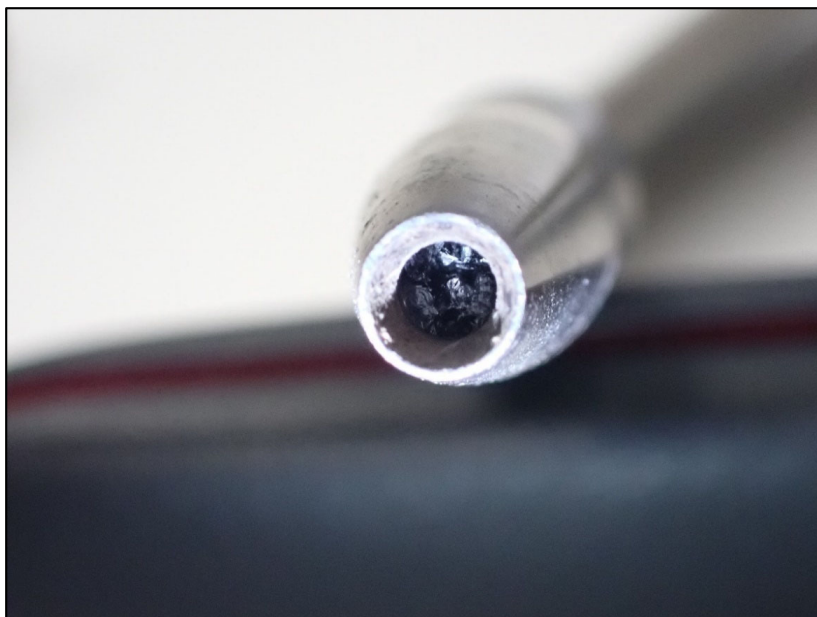
Figure 19

Following an in-situ visual assessment of the pitot tubes by the AAIB it was determined that insects were most likely the cause of the blockage. In order to determine the likely species causing the problem, the probes were removed to enable closer examination of the blockage material and the inside of the probe. The airport biodiversity team asked a corporate beekeeper to help with the identification, and the blockage was assessed to most likely be caused by a foraging species such as solitary bees. The hard cap that had been formed at the tip of the pitot was prised off and was characteristic of the cap that some species of solitary bees or wasps create on their nests. Because the probe had been through a heat cycle, the debris inside the pitot probe had been reduced to charred material (Figure 19).

G-YMMR - charred debris inside the pitot probe

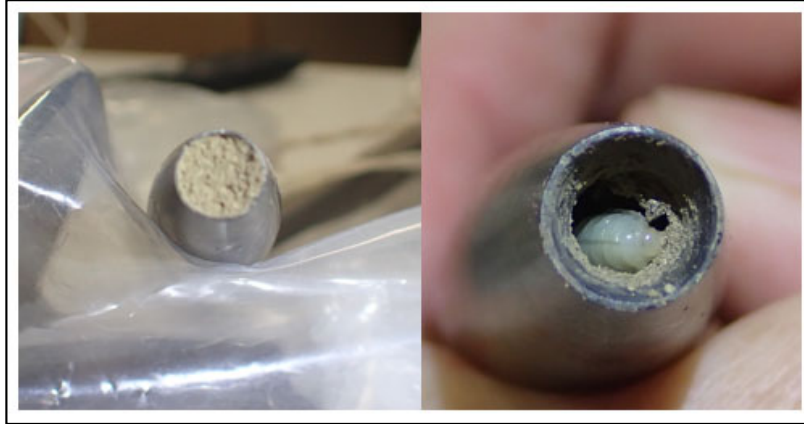
Figure 20

The blockage in the right pitot probe looked externally very similar to the blocked probes from G-YMMR. However, internally, because the blockage had been detected pre-engine start (and the pitot had not been through a heat cycle) the larva in the nest was still alive (Figure 20). The larva was collected and sent for analysis to identify the species.

G-STBJ – blockage and larva in pitot

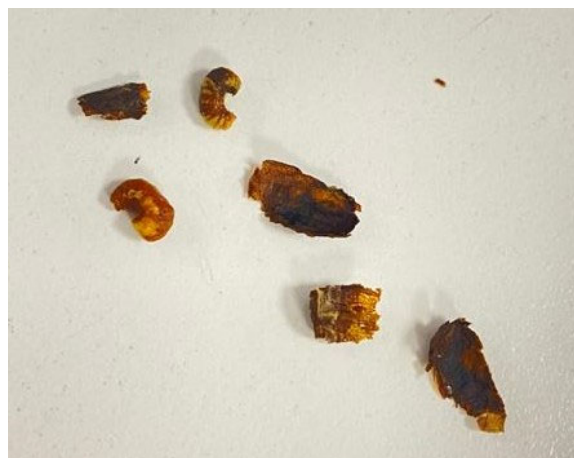
Figure 21

G-VKSS – Nest material and larvae from pitot system

DNA tests on the larvae from G-VKSS confirmed that the species was *Megachile pilidens*, also known as the Hairy-toothed small leafcutter bee (Table 4). *Megachile pilidens* occurs widely in Europe, North Africa and into Central Asia but is not generally found in Britain or Ireland. As with other *Megachile* species, this is a leafcutter bee, cutting leaf sections to line the insides of cavities and create cells in which to raise young. Sightings¹⁵ in Western Europe have associated the species with rocky or stony habitats.

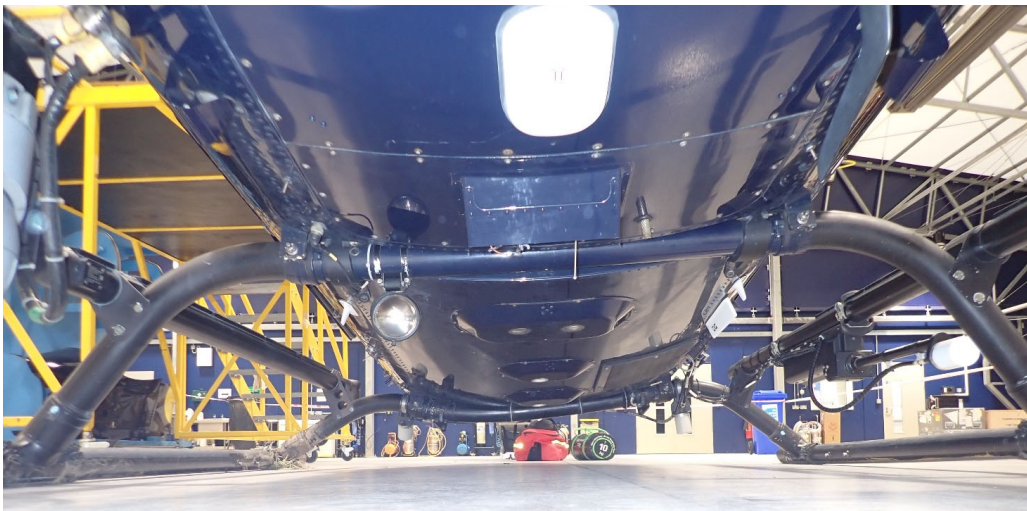
Figure 9

The helicopter was moved to a hangar after it had landed. External examination identified significant deformation of the aircraft landing gear (Figure 9). The aft crosstube had bowed, resulting in both skids moving outboard. The right skid had deflected further than the left. Other than the aft crosstube damage, no other physical damage was identified with the aircraft.

G-MPSB landing gear (viewed from front looking rear)

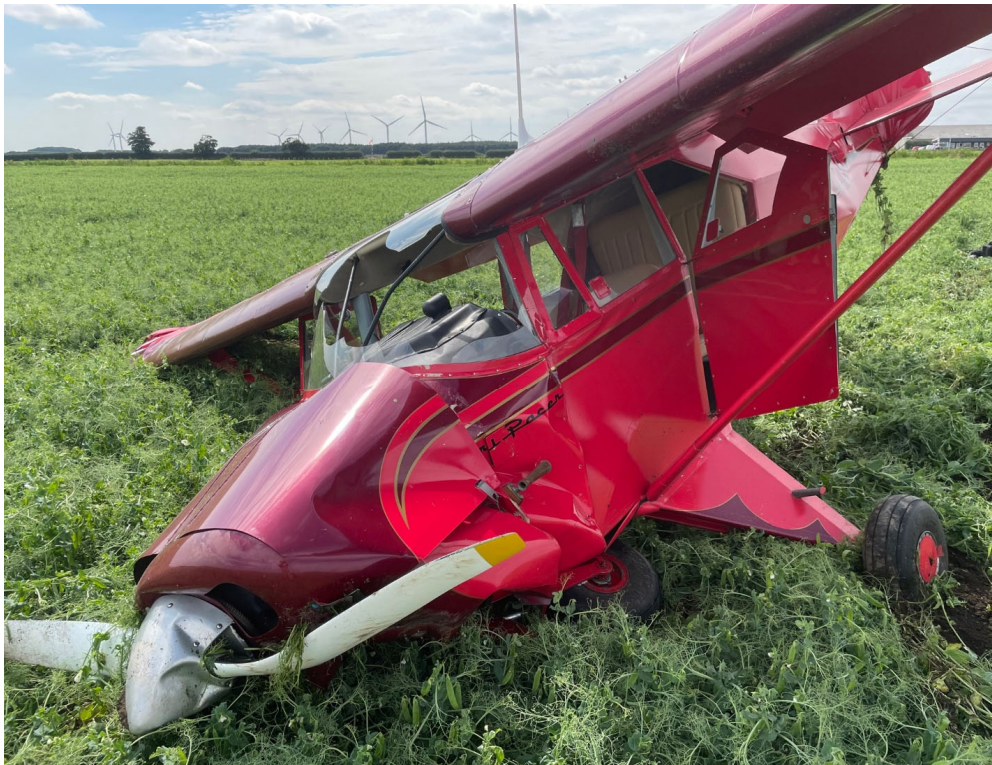
It missed a ditch to the north of the runway but struck the ground in a field beyond, causing substantial damage to the aircraft (Figure 1).

Figure 1
G-ARDS after the accident
