Construction noise and vibration Monthly Report – November 2021

London Borough of Hillingdon

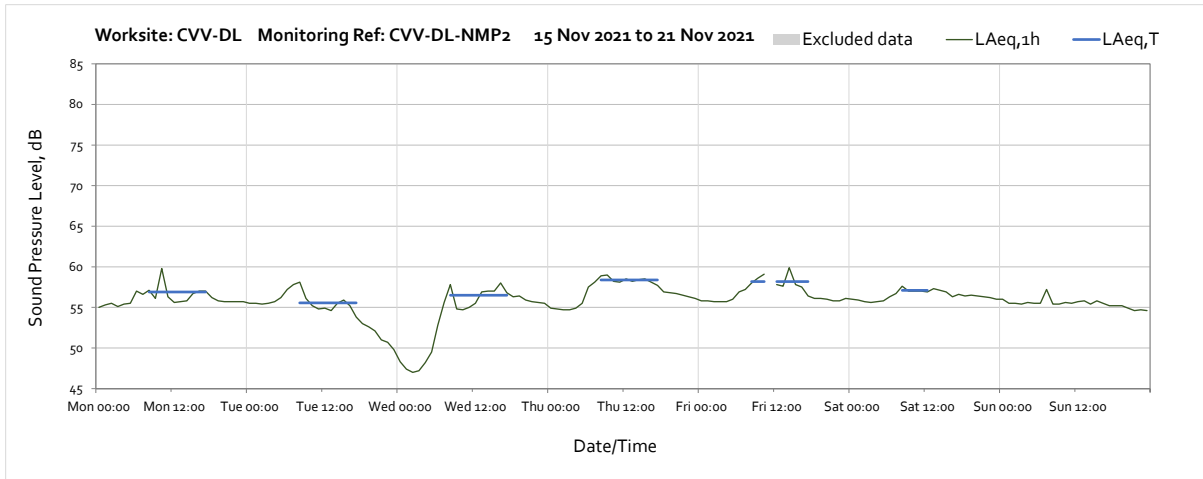
Monitoring Ref: CVV-DL-NMP2

Note: Missing data between 11:00 and 12:00 on Friday 19th November 2021 was due to field calibration.

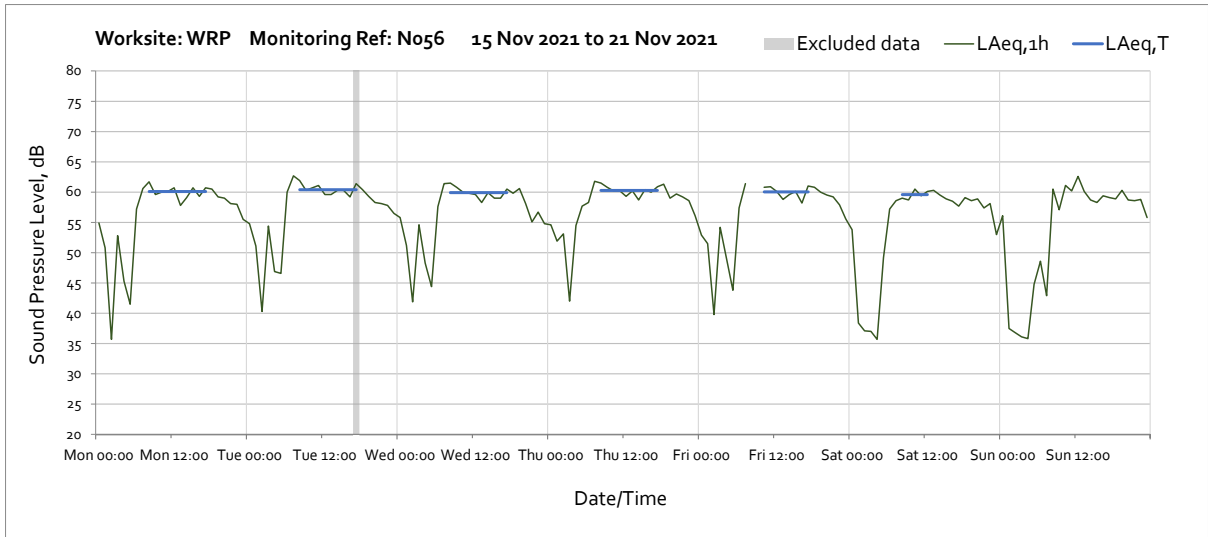
Worksite: West Ruislip Portal (WRP) – Monitoring Ref: N056

Note: Missing data between 08:00 and 10:00 on Friday 19th November 2021 was due to memory card fault at the monitoring station.

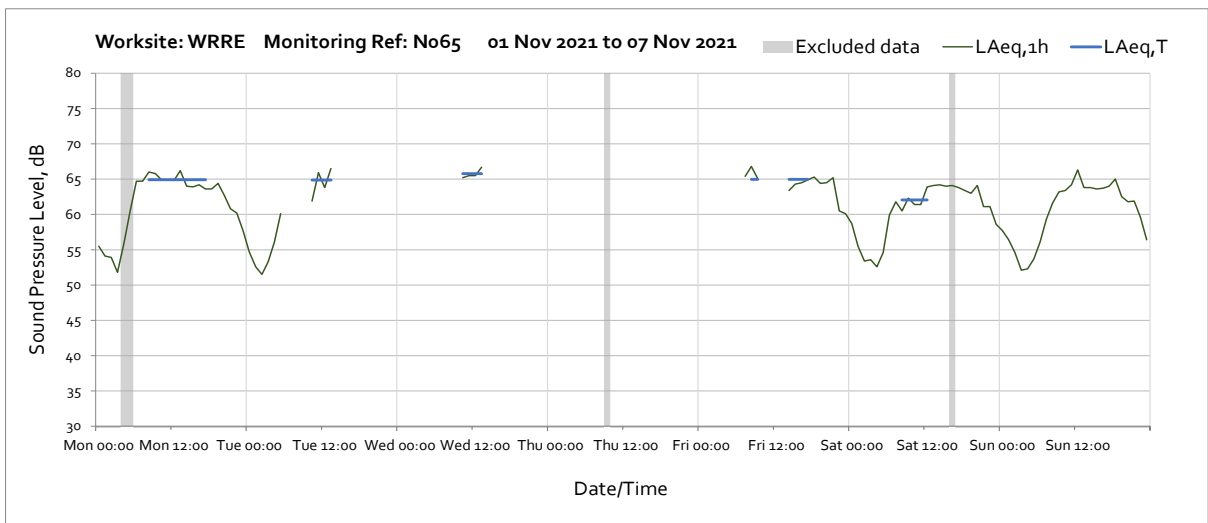
Worksite: West Ruislip Retained Embankment (WRRE) - Monitoring Ref: N065

Note: Missing data throughout the week was due to loss of battery power at the monitoring station.

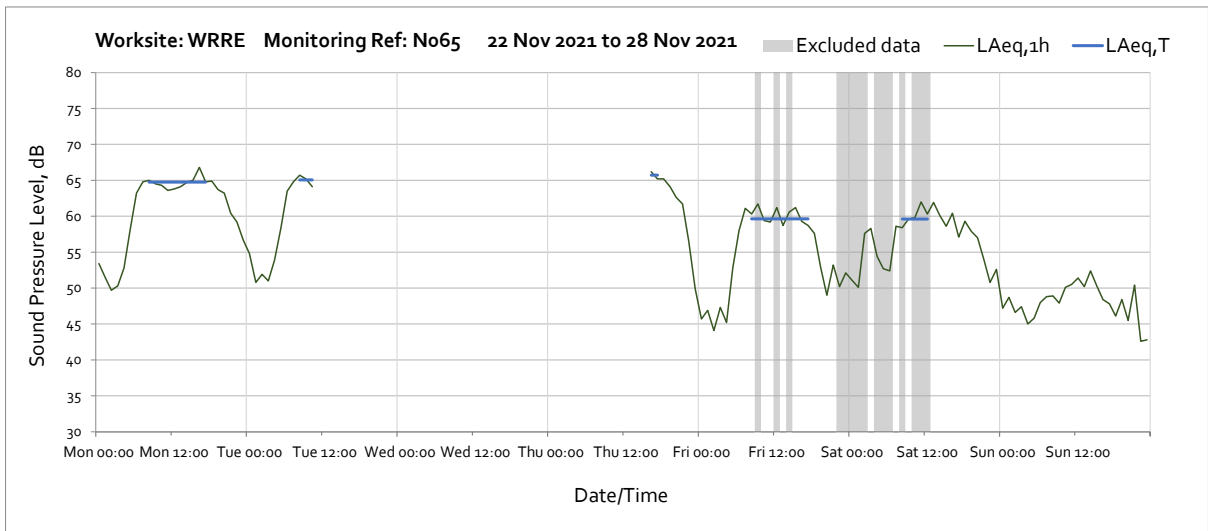
Note: Missing data between 11:00 on Tuesday 23rd November 2021 and 16:00 on Thursday 25th November 2021 was due to loss of battery power at the monitoring station.

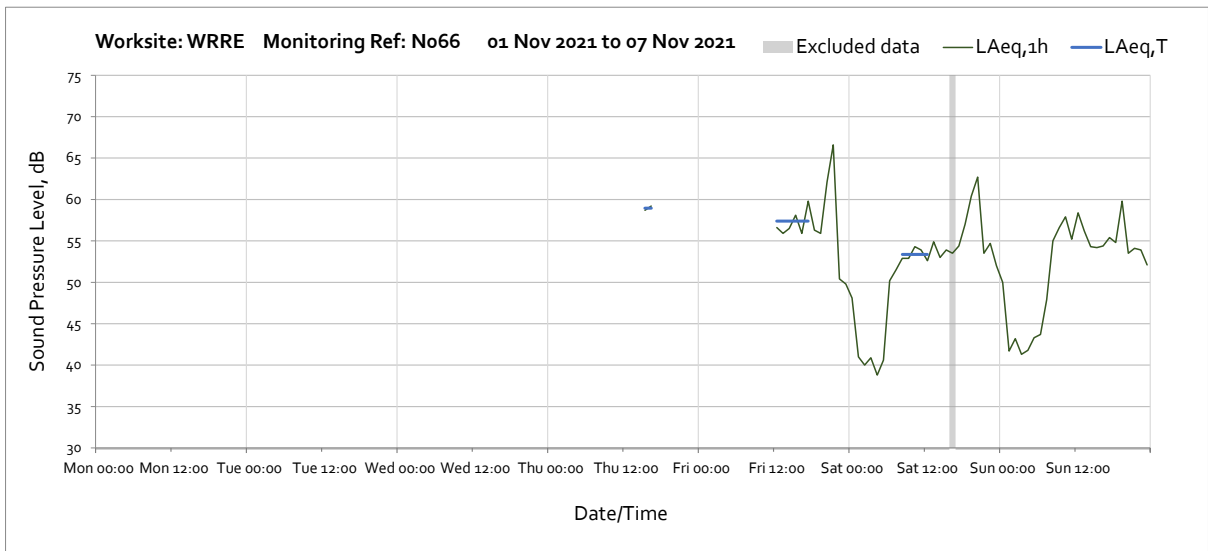
Worksite: West Ruislip Retained Embankment (WRRE) – Monitoring Ref: N066

Note: Missing data from 00:00 on Monday 1st November 2021 until 15:00 on Thursday 4th November 2021 and from 17:00 on Thursday 4th November 2021 until 12:00 on Friday 5th November 2021 was due to loss of battery power at the monitoring station.

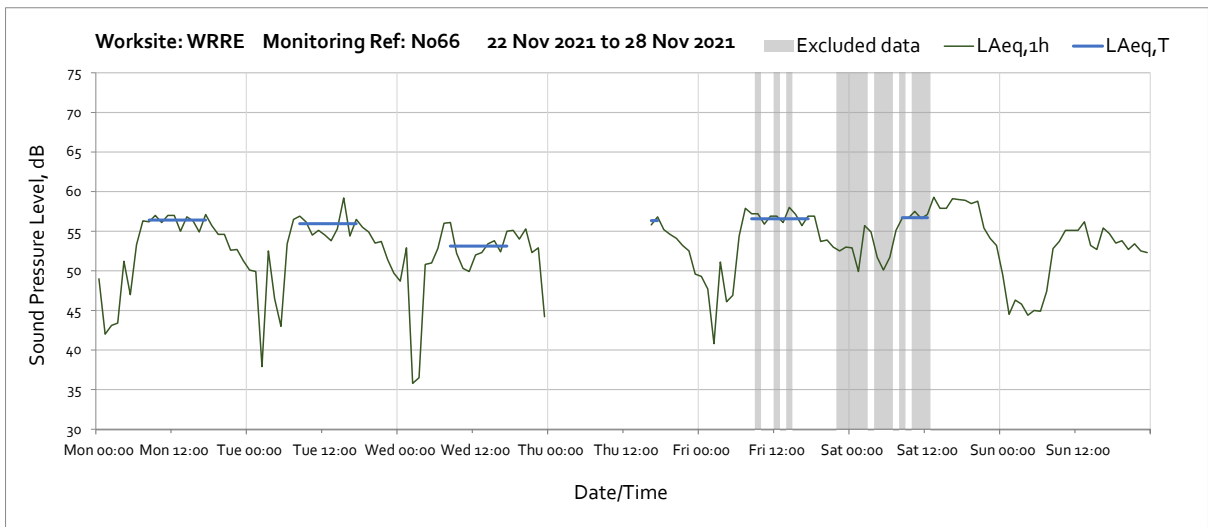
Note: Missing data between 00:00 and 16:00 on Thursday 25th November 2021 was due to loss of battery power at the monitoring station.

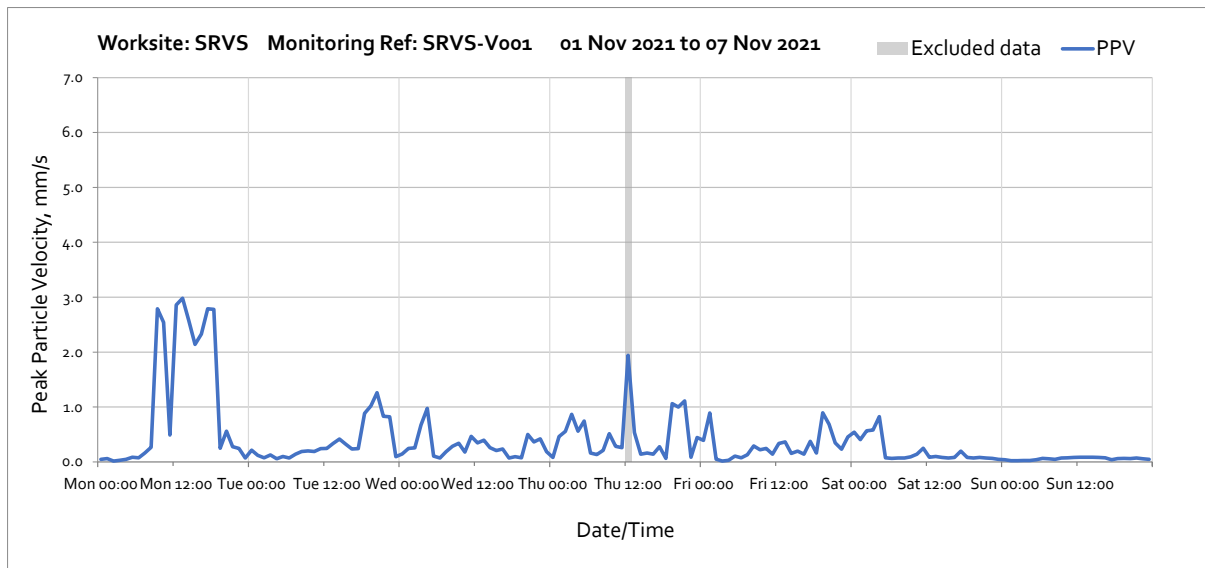
Worksite: South Ruislip Ventilation Shaft (SRVS) – Monitoring Ref: SRVS-V001

| Complaint Reference Number | Worksite Reference | Description of Complaint | Results of Investigation | Actions Taken |
|---|---|--|---|--|
| HS2-21-42900-C HS2-21-42889-C | SRVS | Complaint about excessive vibration causing workshop to rattle and things | Due to the absence of a second operator subcontractors were hitting the concrete piling platform with the grab to remove clay from the skip. This caused high vibration levels and is not | A review meeting with the subcontractor was held the next morning |

| Complaint Reference Number | Worksite Reference | Description of Complaint | Results of Investigation | Actions Taken |
|---|---|---|--|---|
| | | to fall off the shelves. | something allowed for in the Section 61 for the works, the Environmental manager called multiple times to stop the activity causing the disturbance, with the activity paused each time and resumed shortly after with same methodology. | regarding the failure to stop works. |

Note: High vibration levels measured in between 09:00 and 18:00 on Monday 1st November 2021 were due to the impact of the grab with concrete pilling platform.

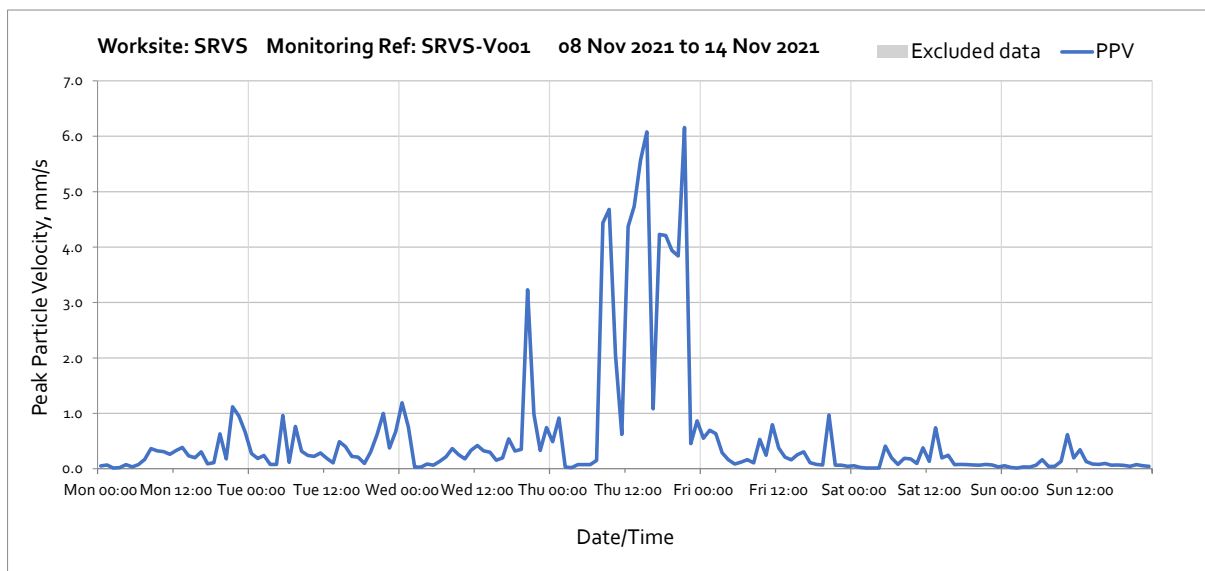
Note: High vibration levels measured across the week were due to the impact of the grab with concrete pilling platform therefore work methodology subsequently changed.

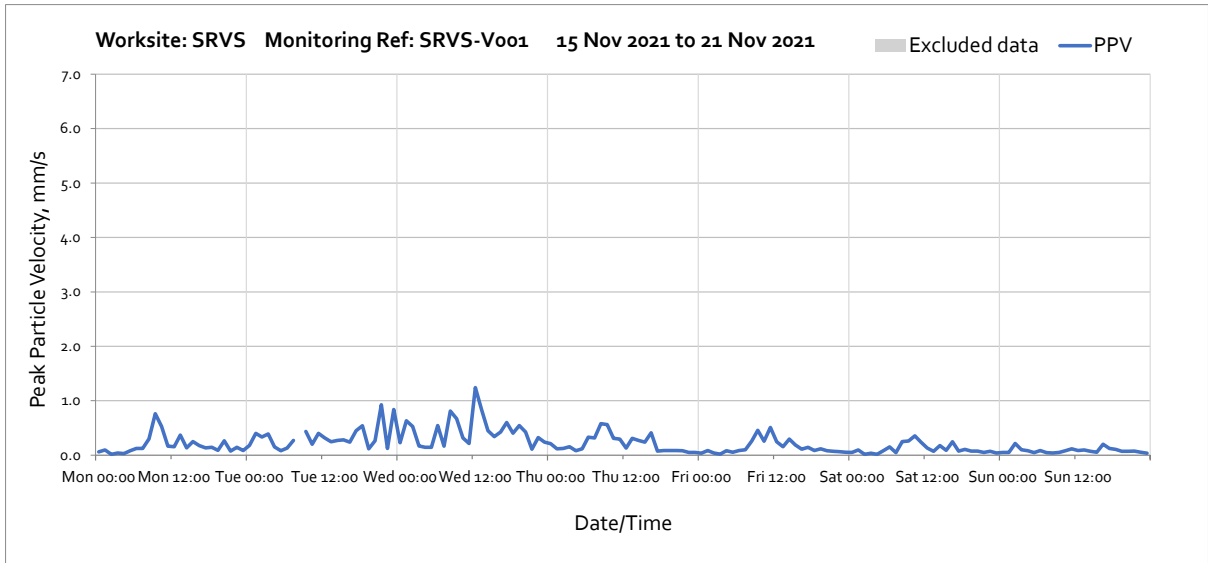
Note: Missing data at 08:00 on Tuesday 16th November 2021 was due to loss of connection at the monitoring station.
