ACCIDENT

Aircraft Type and Registration:	Rolladen-Schneider LS8-18, G-CJNB
No & Type of Engines:	No engines
Year of Manufacture:	1998 (Serial no: 8227)
Date & Time (UTC):	5 September 2021 at 1240 hrs
Location:	Seighford Airfield, Staffordshire
Type of Flight:	Private
Persons on Board:	Crew - 1 Passengers - None
Injuries:	Crew - 1 (Serious) Passengers - N/A
Nature of Damage:	Extensive damage to the fuselage and wings
Commander's Licence:	UK Sailplane Pilot's Licence
Commander's Age:	62 years
Commander's Flying Experience:	113 hours (of which 20 were on type) Last 90 days - 19 hours Last 28 days - 1 hour
Information Source:	Aircraft Accident Report Form submitted by the pilot and additional information provided by others

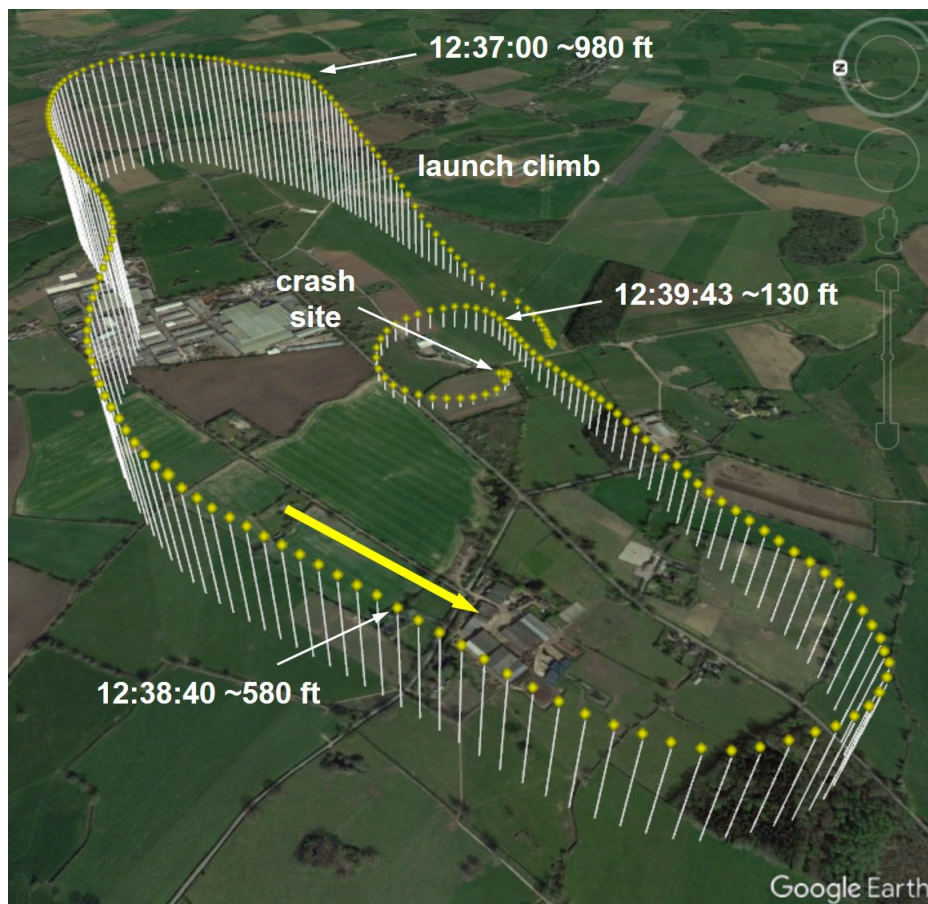
Figure 1

Accident flight profile showing the circuit, approach and orbit (heights are aal)

The flight logs show a normal winch launch and circuit up to the approach back to the airfield. The approach was flown at an average ground speed of approximately 55 kt¹. After crossing the airfield boundary hedge, at a height of 130 ft above the ground, the glider

started a left turn. Just prior to commencing a left turn the ground speed reduced to 40 kt. The turn continued with a diameter of approximately 350 m. The ground speed increased during the turn to approximately 60 kt.

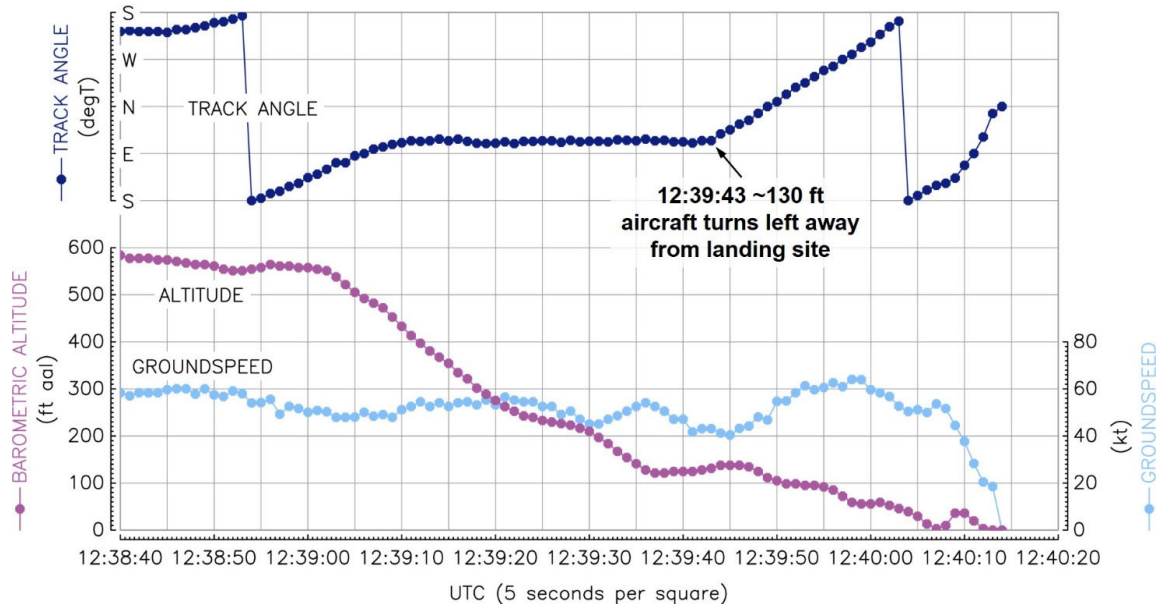
Figure 2

Chart showing the glider's altitude, ground speed and heading during the approach

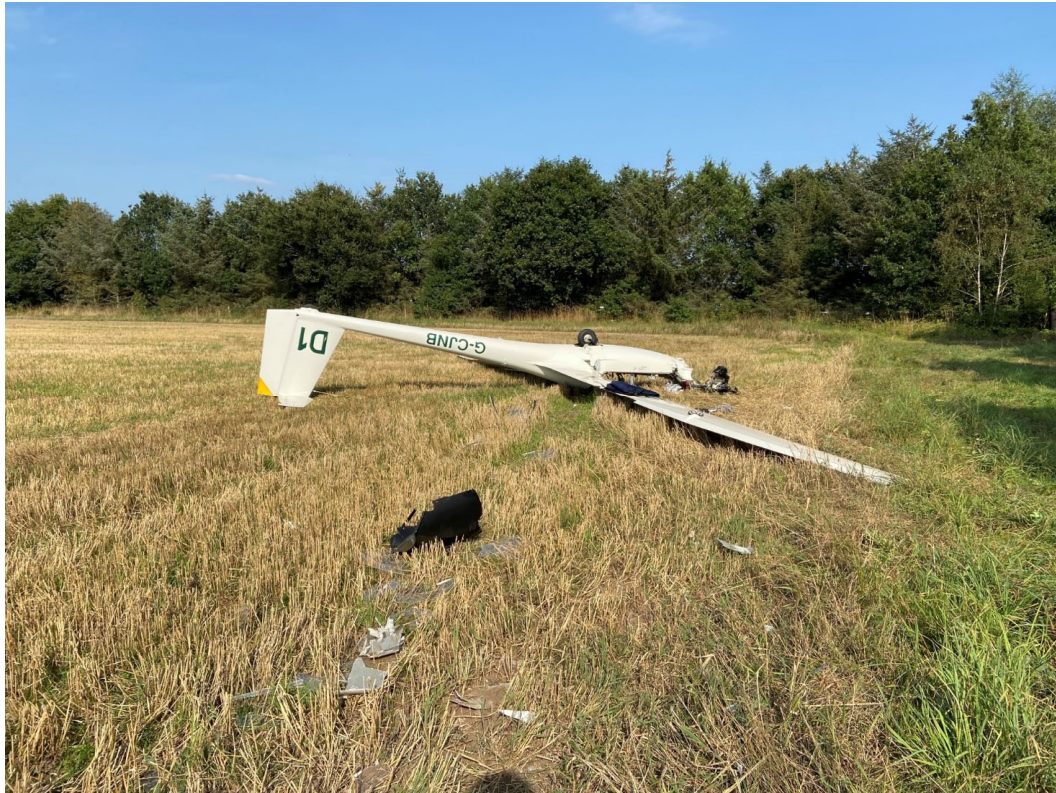
Figure 3 shows the glider after the accident; the airfield is just beyond the trees in the background.

The accident site and glider were examined by several experienced members of the gliding club. They reported that the fuselage was very badly damaged forward of the wing and was also broken behind the wing. The right wing had a small diameter impact mark which penetrated the leading edge at about two-thirds span, and there were two large creases in the trailing edge inboard of the impact damage. It was thought this damage was caused by an impact with a tree branch. There was impact damage on the left wingtip but the wing itself was less damaged than the right one. On the underside of the left tip, there were marks showing it had dragged across the ground. The left wingtip extension was detached and closer inspection showed that it had torn the fitting from the main wing. The tail, fin and rudder were essentially undamaged.

There was a one to two-inch-deep ground mark just behind the eventual resting place of the glider. The shape of this and the surrounding debris, including multiple canopy fragments, suggested that this is where the nose struck in a very steep attitude and with little forward speed.

G-CJNB after the accident

All the damage appeared to be consistent with the glider colliding with trees and rotating across the field to its eventual resting point. There was no evidence of any pre-existing damage which could have contributed to the accident.
