SERIOUS INCIDENT

Aircraft Types and Registrations: (in date order of occurrence)	Airbus A320-232, G-EUUG Airbus A320-251N, G-TTNH Boeing 777-236, G-YMMR Airbus A330-343, G-VKSS
Other Aircraft Affected:	Boeing 787-9, G-ZBKJ Boeing 777-336ER, G-STBJ Boeing 787-8, G-ZBJF Airbus A319-131, G-DBCG
Date & Time (UTC):	Between 9 June 2021 and 19 July 2021
Location:	London Heathrow Airport, UK
Types of Flight:	Commercial Air Transport (Passenger)
Injuries:	None
Nature of Damage:	Various pitot tubes blocked
Information Source:	AAIB Field Investigation

Synopsis

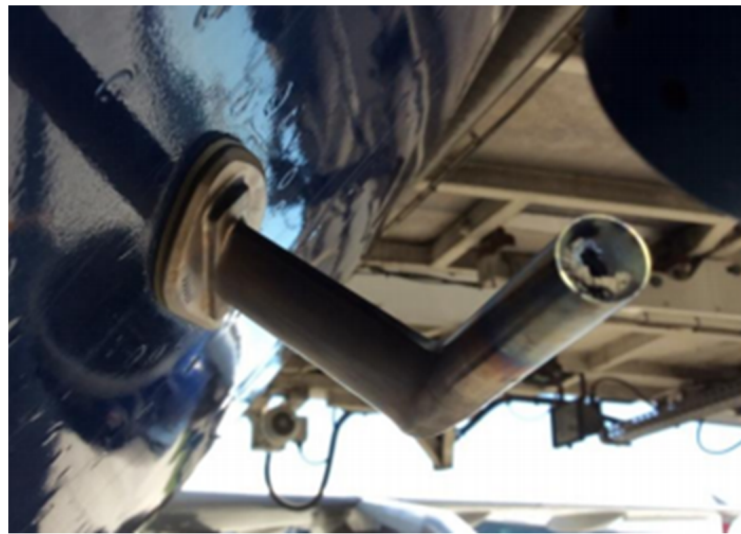
Figure 2

An inspection of the pitot/static probes found that the left pitot probe, which feeds the commander’s PFD, was blocked. The blockage appeared to be formed of a solid soil type material (Figure 2). The pitot probe was replaced, and the system tested and proven serviceable. At this point the operator judged that this was an isolated occurrence in an area of the airfield where insects had historically been problematic for aircraft. Since the previous occurrences, much of the hedgerow had been removed for other reasons.

G-EUUO pitot probe blockage

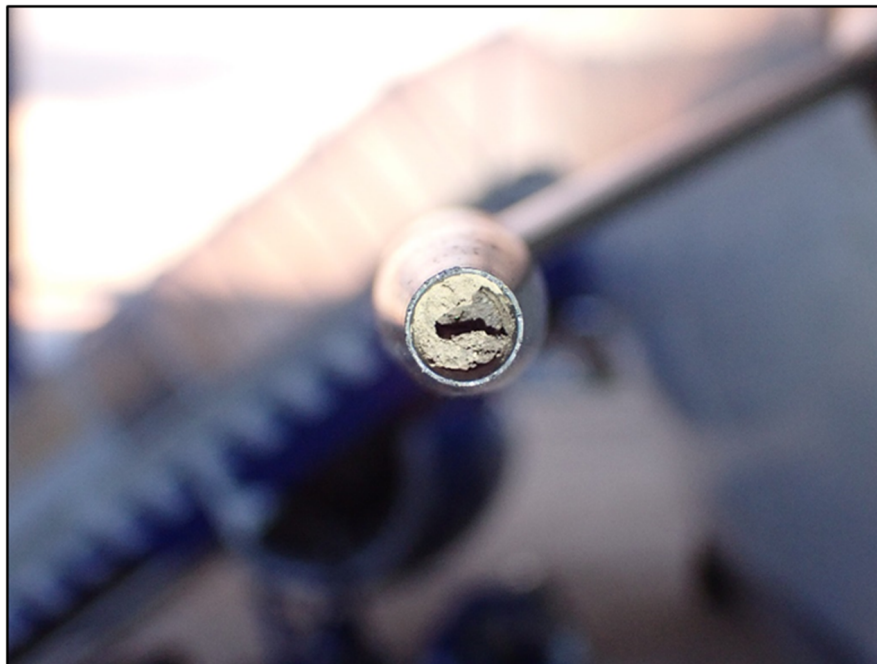
Figure 3

Inspection of the aircraft pitot probes showed that both the right and centre probes were blocked. The nature of this debris (Figure 3) was similar to that found on G-EUJO and G-TTNH. However, with the aircraft having been parked at a different location to the other two aircraft, the operator now considered that this was a wider issue, and the event was notified to the AAIB and the aircraft quarantined for inspection.

G-YMMR blocked pitot probe

As two of G-YMMR's probes had been found to be blocked (right and centre), all three probes were removed. The Total Air Temperature probes and static ports were inspected and found to be clear. The pitot/static system was flushed, and new probes fitted at the left, centre and right locations. No further debris was found during the system flushes. No previous reports of pitot/static system or ASI system defects had been reported on the aircraft and, following testing, it was released back to service.

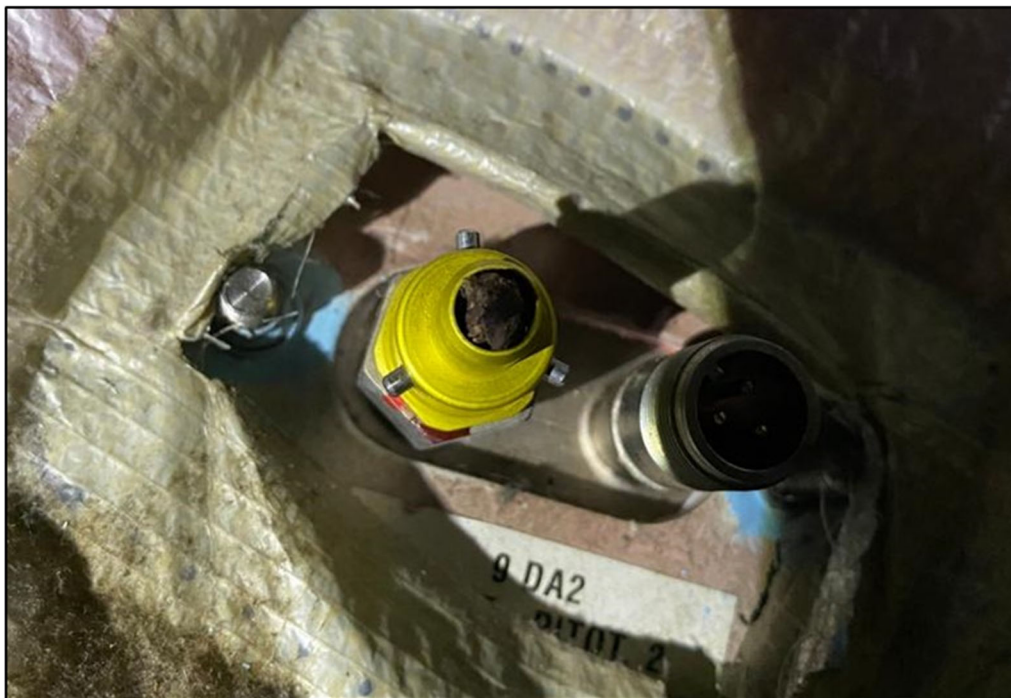
Figure 5

The incident occurred on the outbound sector of a Heathrow-Milan-Heathrow flight. During the latter stages of the climb out from Heathrow, the aircraft's ECAM system alerted the flight crew to a failure of the co-pilot's pitot probe heater. In accordance with Flight Crew Operating Manual (FCOM) procedures, they switched the co-pilot's air data supply from its normal source, Air Data Computer 2 (ADC2), to ADC3. At no stage did they observe any associated unusual or unreliable indications on their flight instruments. Flight despatch for the return sector was undertaken using the same air data source configuration, this was in accordance with the Operator's Master Minimum Equipment List authorisations. Post-flight investigation by maintenance staff at Heathrow found, during removal, evidence of debris and contamination at the quick-disconnect union on the rear of the co-pilot's pitot probe (Figure 5). During the rectification work, further debris and contamination was found in the commander's pitot probe. No contamination or debris was found in the standby probe.

G-VKSS co-pilot's pitot probe debris

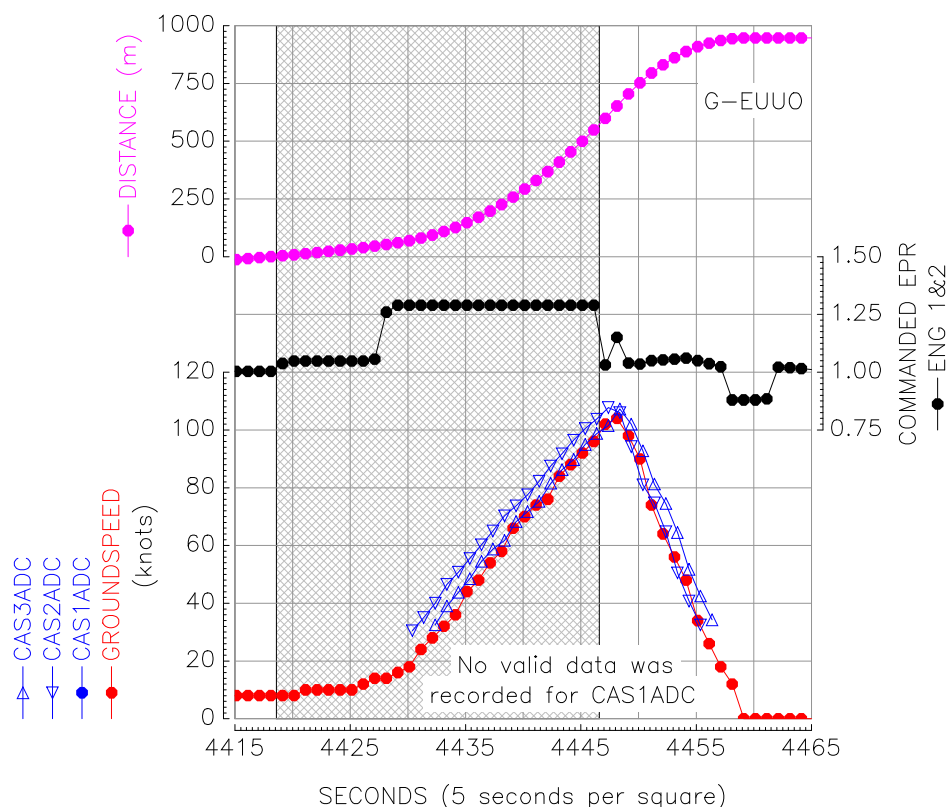
Figure 16

During the event, the recorded CAS1ADC airspeed was zero, indicating that the sensed airspeed by the commander's pitot was below 30 kt (the minimum airspeed that is considered valid by the associated ADC). The takeoff was rejected at 104 kt airspeed (a groundspeed of about 96 kt).

G-EUOO DAR data for the rejected takeoff
(shaded area is from start to abort)

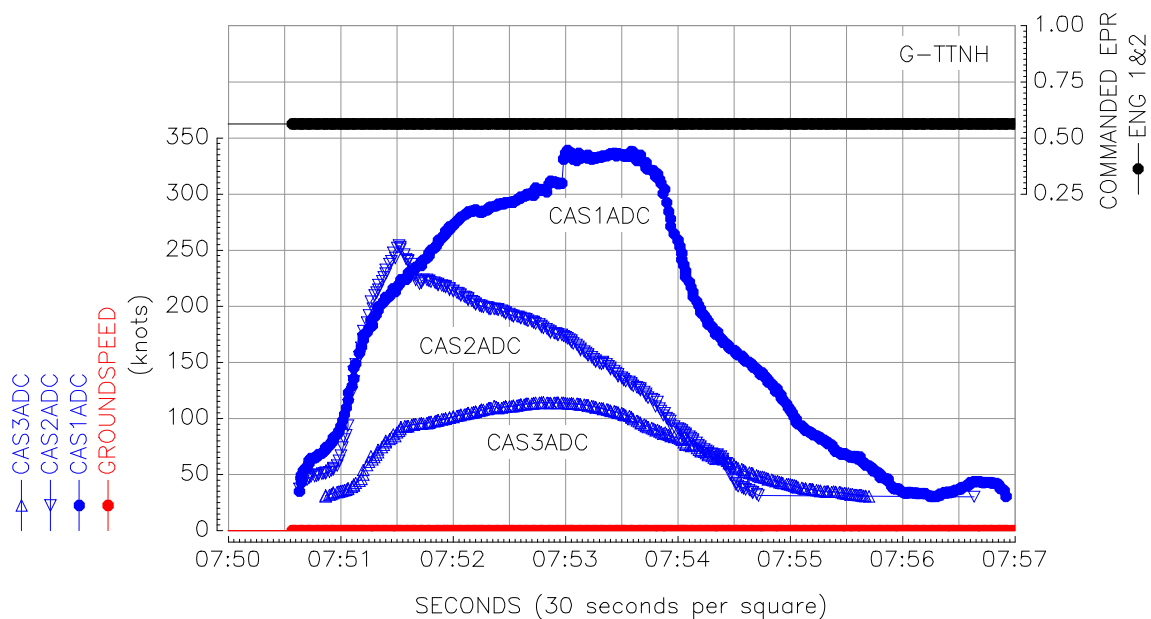
Data from the aircraft's DAR after pushback is presented in Figure 17 and shows that all three pitot probes were sensing airspeeds in excess of 100 kt even though the aircraft was not moving.

Between times 0754 hrs and 0757 hrs, whilst the aircraft was stationary, 11 ECAM alerts were generated (detailed in Table 2) that were associated with either a touchdown or landing roll (< 80 kt) phase of flight.

G-TTNH DAR data after pushback whilst aircraft was stationary

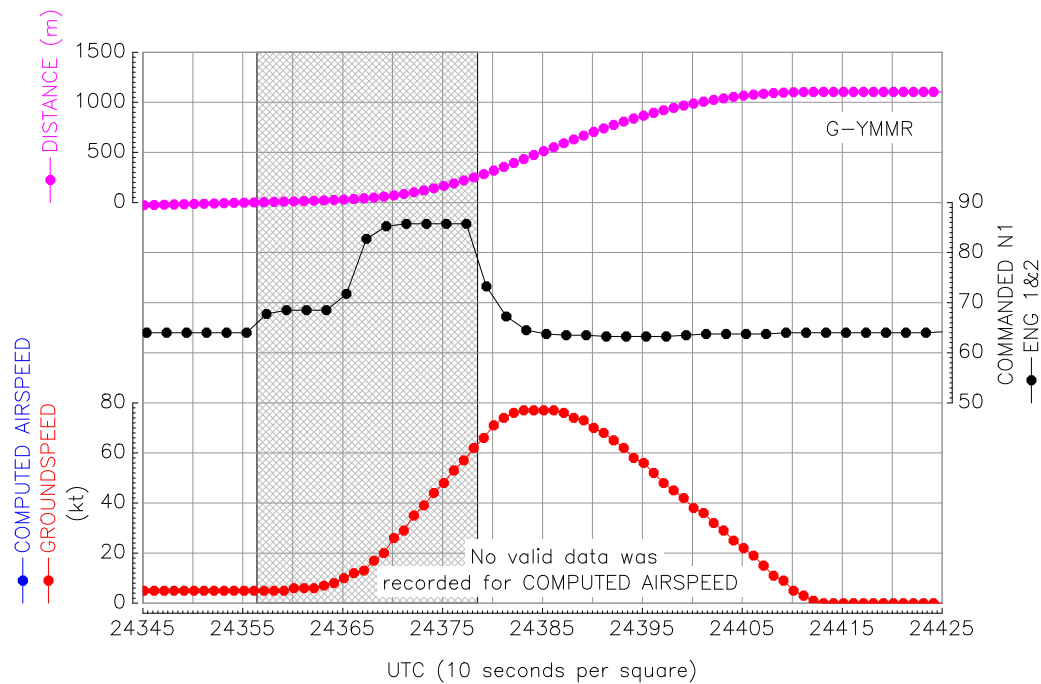
Figure 18

Data from the aircraft's FDR for the rejected takeoff is shown in Figure 18. For this aircraft, the FDR only records the CAS which is displayed on both crew's PFD and the values recorded are only valid if greater than 30 kt. Throughout the rejected takeoff the CAS remained invalid. The takeoff was rejected 275 m into the takeoff ground roll at a groundspeed of about 64 kt.

G-YMMR FDR data for the rejected takeoff
(shaded area is from start to abort)

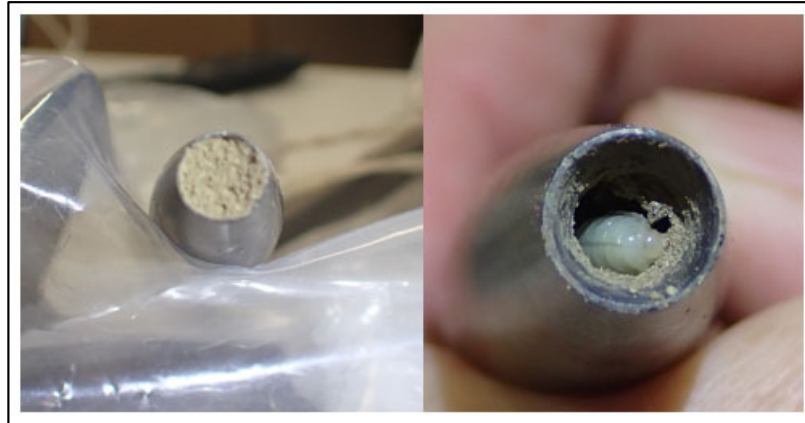
Figure 20

The blockage in the right pitot probe looked externally very similar to the blocked probes from G-YMMR. However, internally, because the blockage had been detected pre-engine start (and the pitot had not been through a heat cycle) the larva in the nest was still alive (Figure 20). The larva was collected and sent for analysis to identify the species.

G-STBJ – blockage and larva in pitot

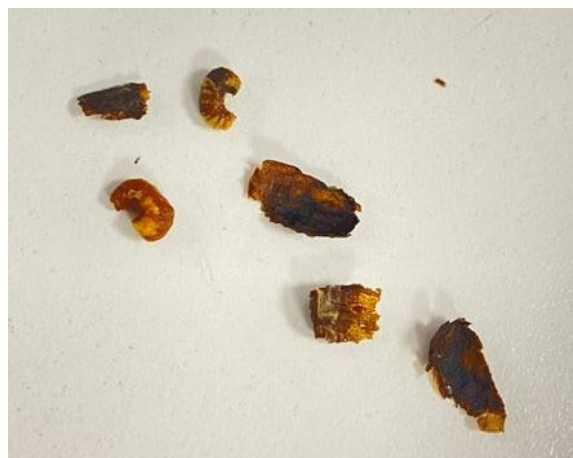
Figure 21

As well as being discovered at a different location within the pitot probe, further away from the heater, the debris was different in constitution in that the material was compacted but not cemented as in the previous cases. On removal, inspection showed that the debris contained small shards of leaf material and dead larvae (Figure 21).

The aircraft manufacturer advised that, as the pitot was not completely blocked, there may have been enough residual flow onto the pressure sensor to enable the sensor to function without noticeable effects.

G-VKSS – Nest material and larvae from pitot system

DNA tests on the larvae from G-VKSS confirmed that the species was *Megachile pilidens*, also known as the Hairy-toothed small leafcutter bee (Table 4). *Megachile pilidens* occurs widely in Europe, North Africa and into Central Asia but is not generally found in Britain or Ireland. As with other *Megachile* species, this is a leafcutter bee, cutting leaf sections to line the insides of cavities and create cells in which to raise young. Sightings¹⁵ in Western Europe have associated the species with rocky or stony habitats.
