Synopsis

Derailment of a passenger train at Carmont, Aberdeenshire 12 August 2020

**This is a synopsis of the full RAIB report available at
www.gov.uk/raib**

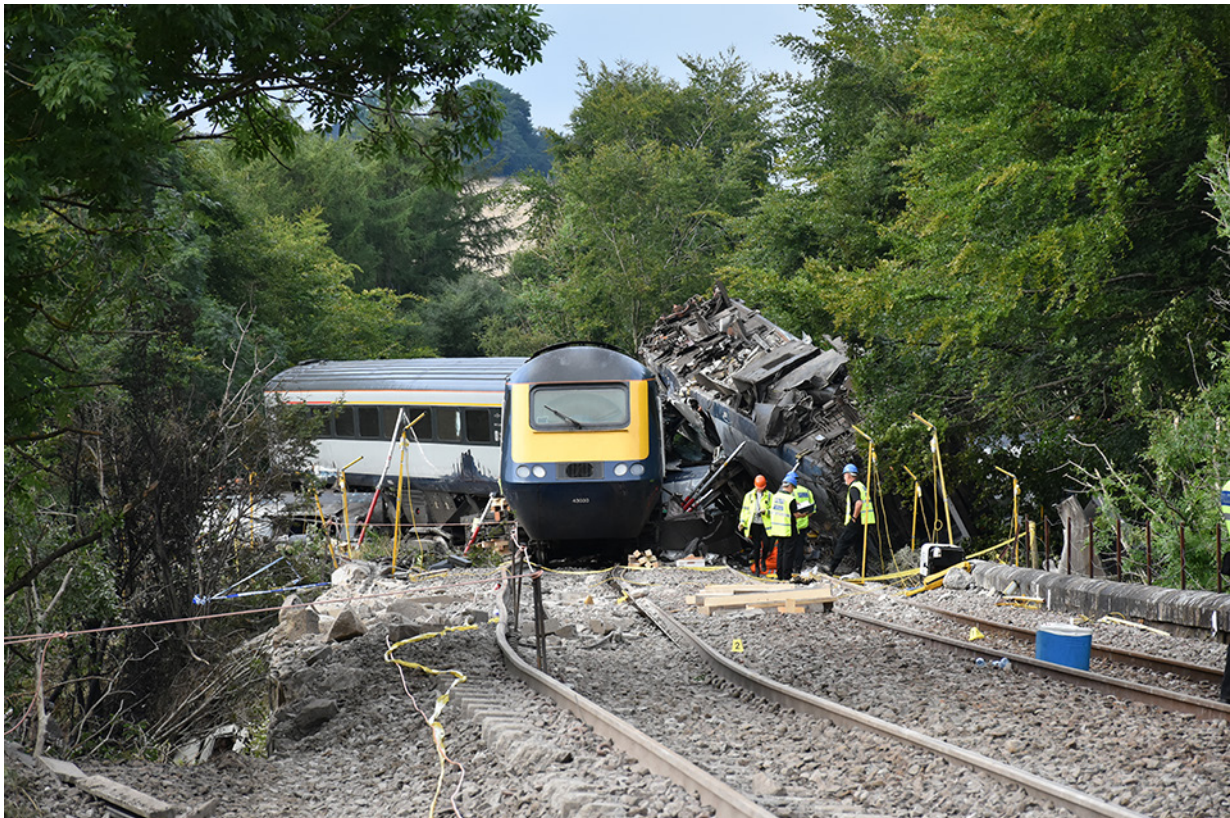
- S2 Train 1T08 was travelling at 73 mph (117 km/h), just below the normal speed for the line concerned. The collision caused the train to derail and deviate to the left, before striking a bridge parapet which caused the vehicles to scatter. Tragically, three people died as a result of the accident:

The aftermath of the accident (image taken on 13 August 2020)

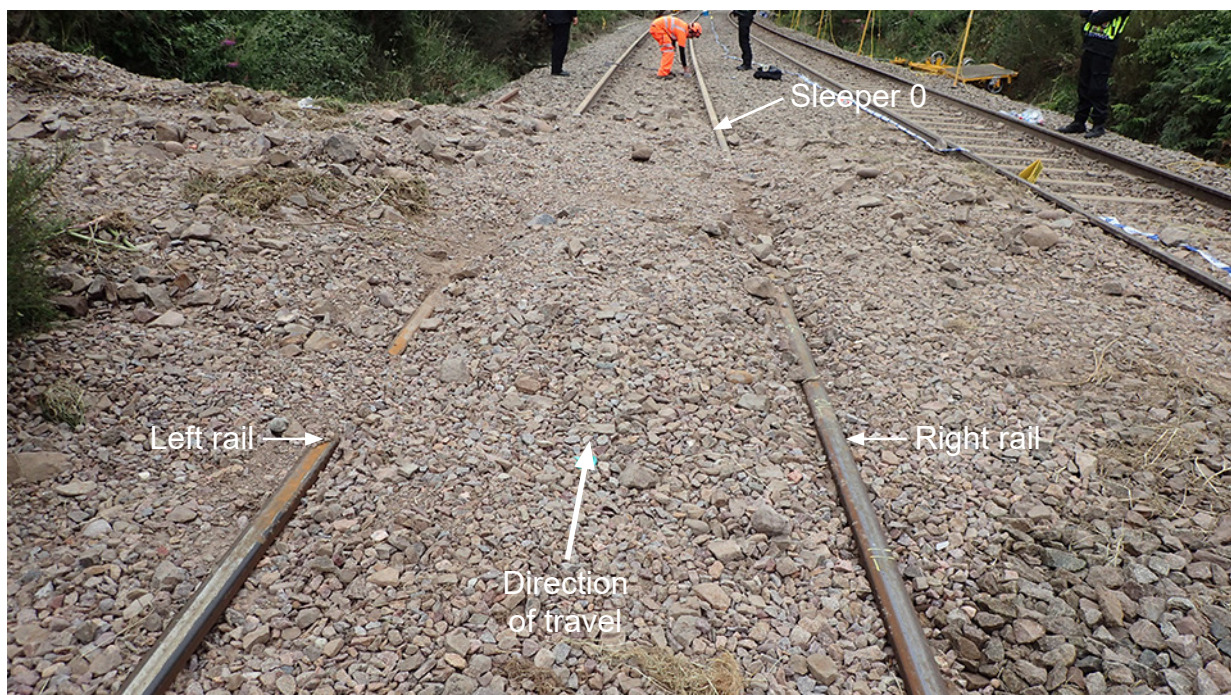
- S4 Train 1T08 derailed because it struck debris washed out from a 15 metre length of steeply sloping drainage trench. This is evidenced by CCTV images from the train, grooves cut through the debris, the absence of derailment marks on the track on the approach to the debris and marks indicating that the leading wheelset had derailed immediately after the debris field.
- S5 The debris mainly comprised gravel with some cobbles and covered the down line for a length of about 10 metres. Estimates made by RAIB after the derailment indicate the maximum depth of debris on the left and right railheads was probably around 170 mm and 135 mm respectively before the train ran through it.

Washout debris covering the track

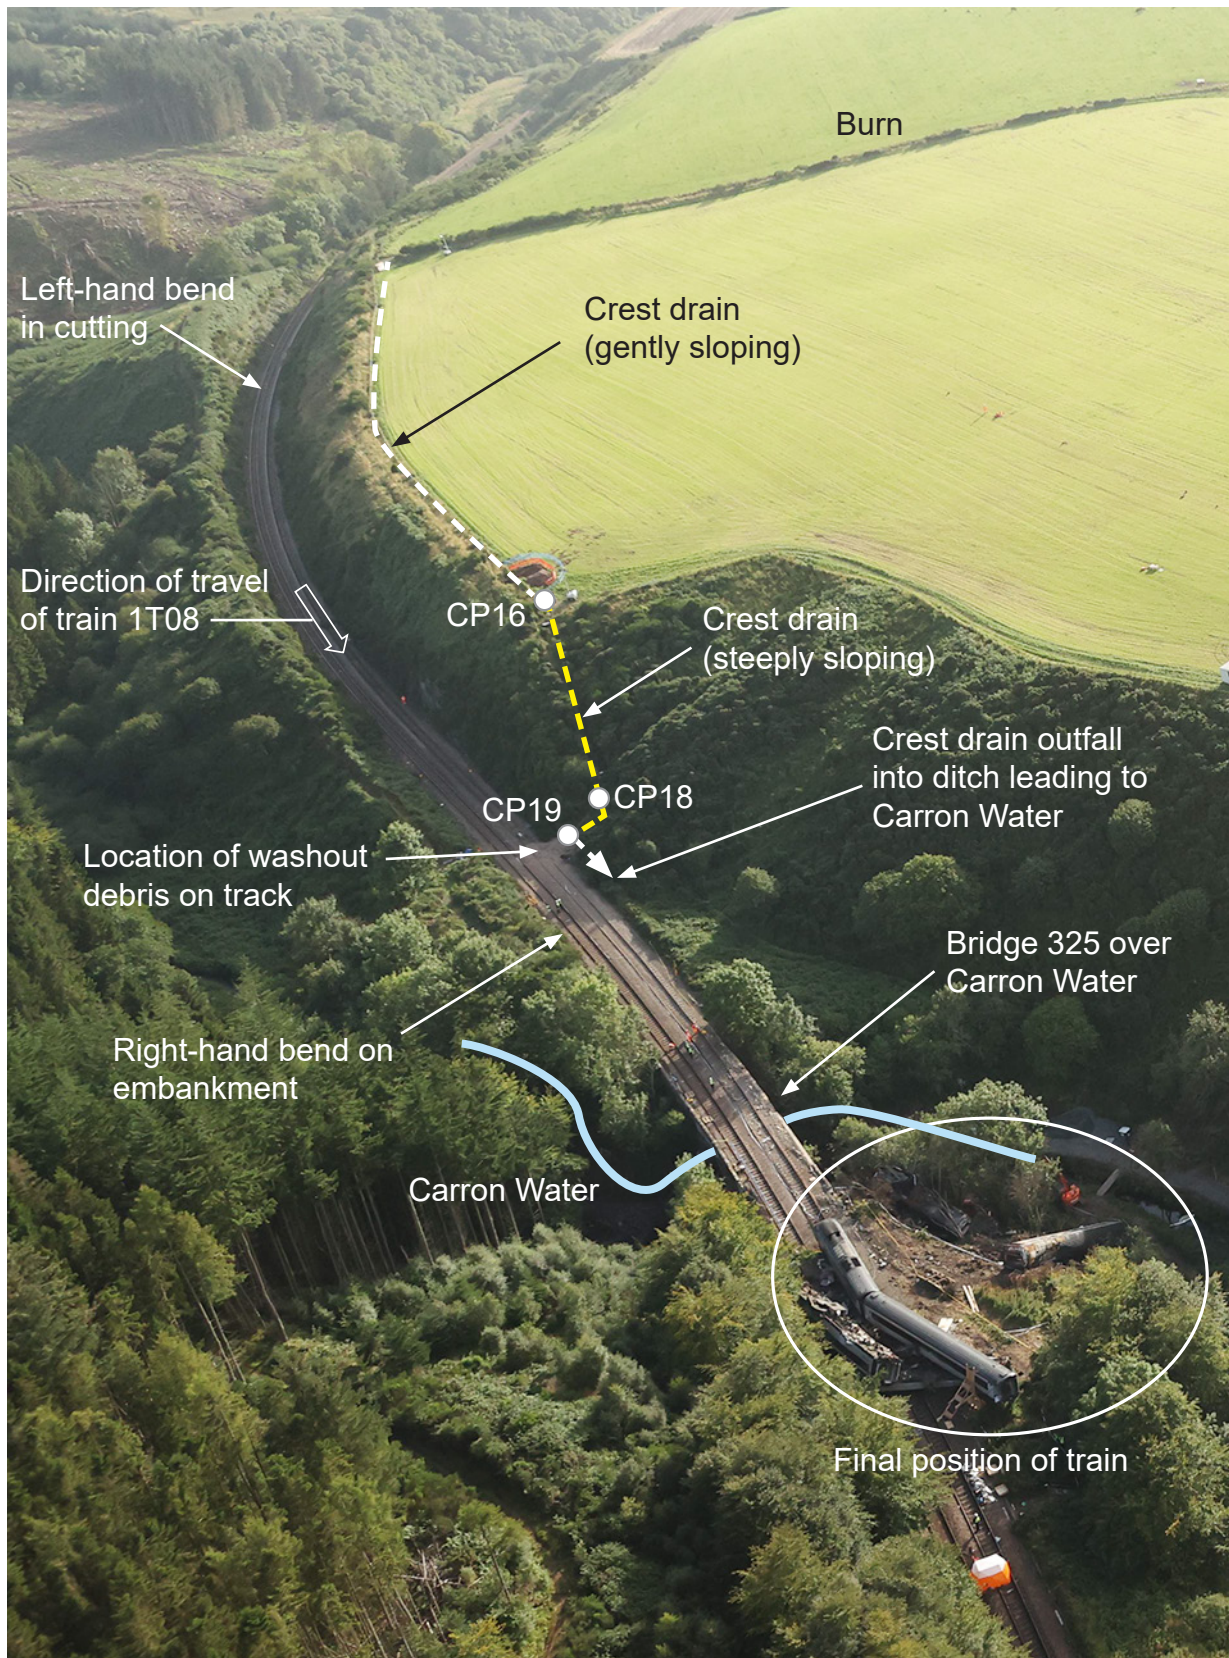
S12 The trench which contained the drainage pipe was filled with gravel (mainly between 20 mm and 40 mm in size) in accordance with normal practice for french drains. However, the use of this gravel in such a steeply sloping trench increased the likelihood of it being washed away should the water reach the drain as a concentrated flow.

Overview of the drainage system (locations marked 'CP' are catchpits)

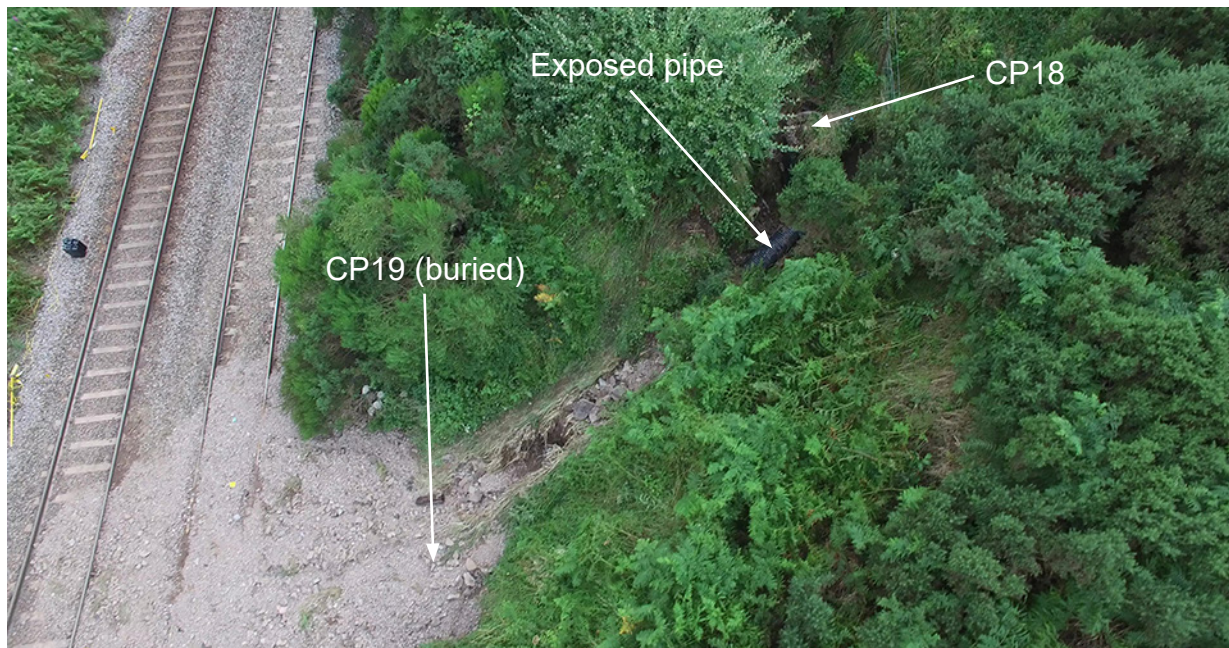
S8 The source of the debris that caused the derailment at Carmont was a 'french drain' and the ground immediately surrounding it. This drain had been installed during 2011 and 2012 (the 2011/12 drain) as part of a wider scheme to address a known problem with the stability of the earthworks in this locality. This drain comprised a 450 millimetre (approximately 18 inch) diameter perforated pipe buried in a gravel-filled trench which ran for 306 metres along the edge of a field at the top of a slope that ran down to the railway. The drain then sloped down relatively steeply (at an inclination of 1 in 3) for 53 metres to track level. Catchpits (access chambers, sometimes called manholes) were provided at intervals along the pipe to allow inspection and maintenance of the pipe.

The washout (locations marked 'CP' are catchpits)

- A new drainage system, with improved capacity, and with features intended to prevent another washout, was installed to replace the 2011/12 system.
- Guard rails were fitted on both up and down lines on the approach to bridge 325 when the track was re-laid after the accident. The protection includes gathering rails and, on the down line, extends beyond the site of the washout.

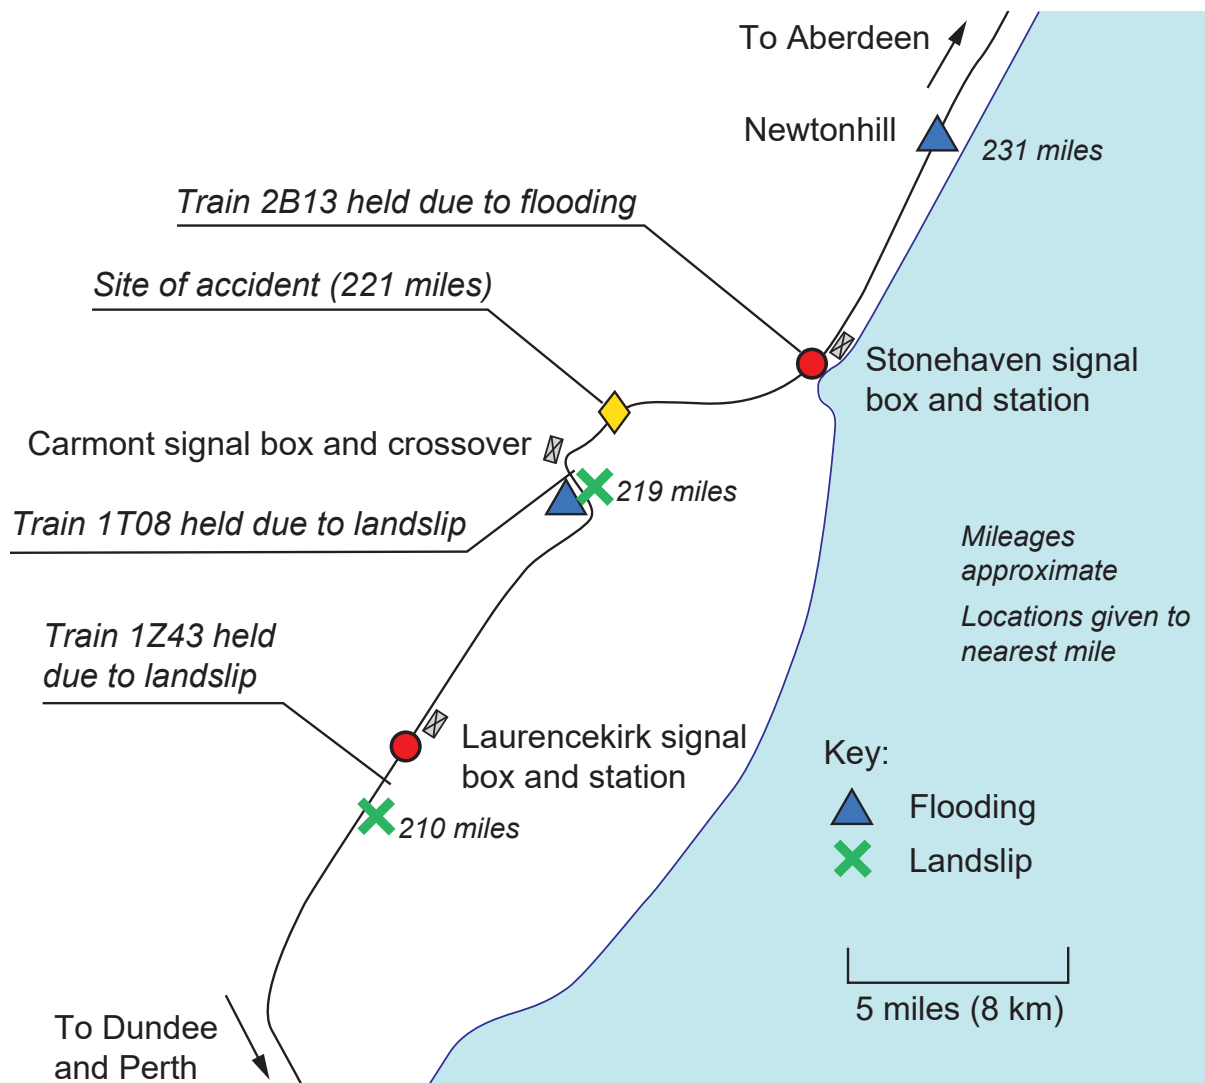
S37 RAIB found evidence that the Scotland route control team was under severe workload pressure on the morning of 12 August 2020, because of the volume of concurrent weather-related events in Scotland (such as the canal breach at Polmont). However, despite the severe nature of the disruption to Scotland's railway infrastructure, no additional resource had been obtained for the control room and the senior management 'gold command' structure had not been established to relieve the pressure on the controllers.

Train positions and known infrastructure failures around Carmont at 09:00 hrs on 12 August 2020

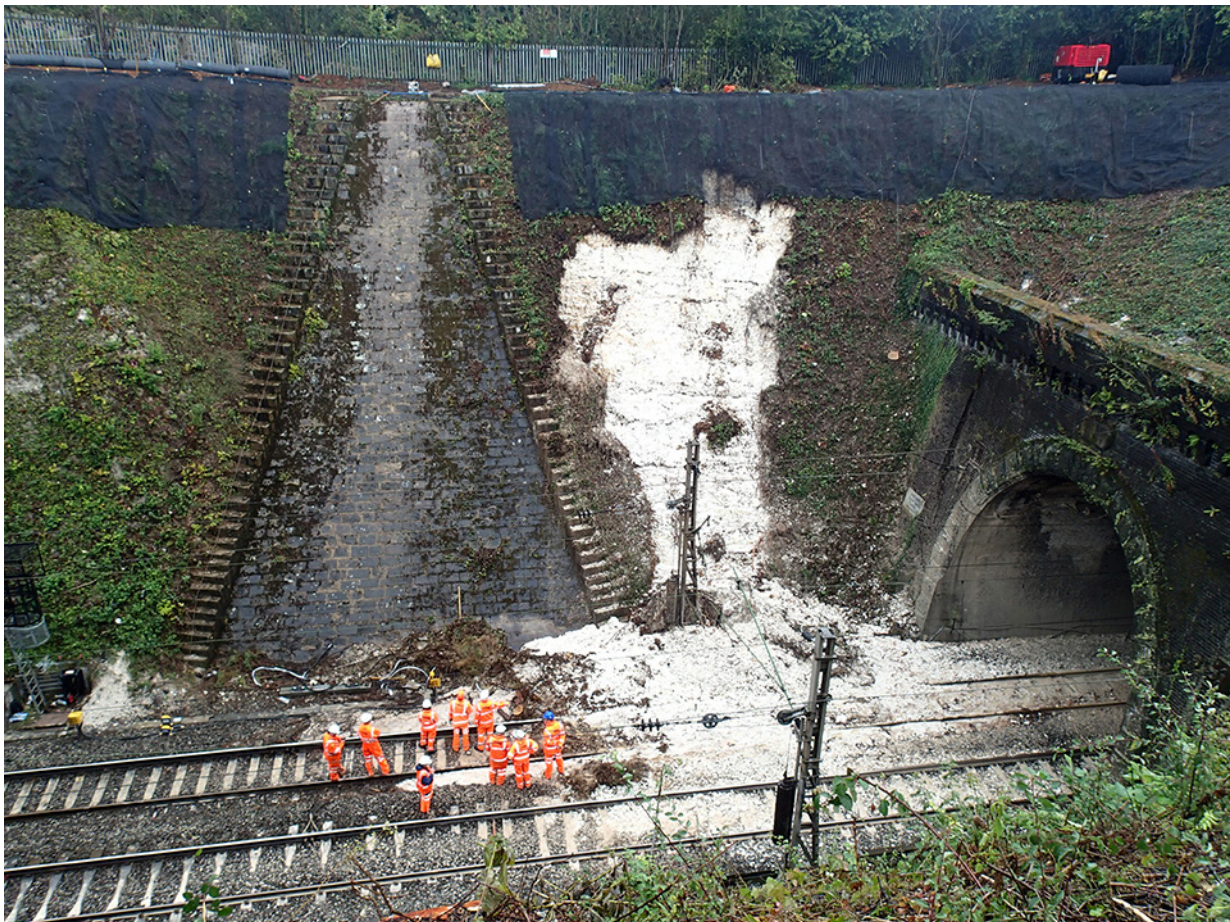
S58 Network Rail and RAIB concerns were heightened by the landslip just outside the portal of Watford tunnel, Hertfordshire, in September 2016 that caused the derailment of a train and a subsequent glancing blow, inside the tunnel, between the derailed train and a train on the opposite track. Discussions at the meeting of Network Rail's executive committee and the company's Safety, Health and Environment committee in November 2016 covered a range of issues, including:

The landslide at Watford tunnel, September 2016

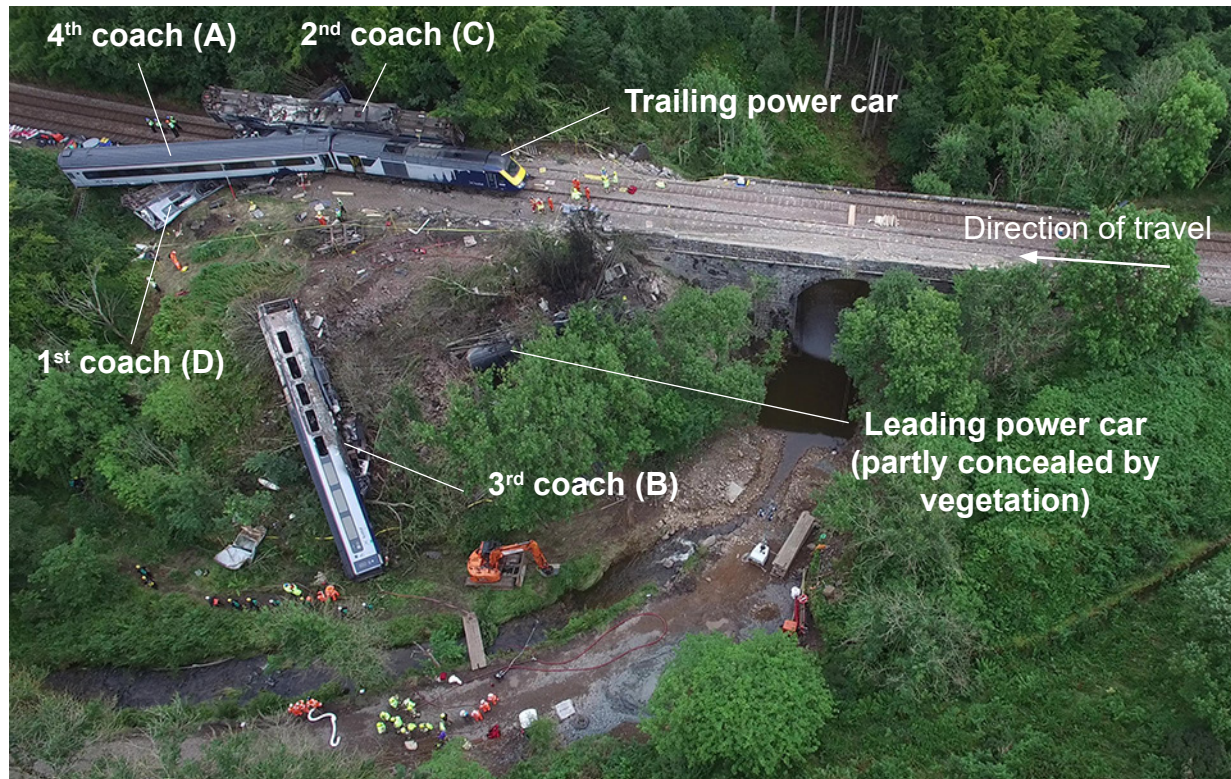
The derailed train

- b) The coaches were not fitted with any form of bogie retention in the vertical direction, and this allowed the vehicle bodies to lift off their bogies during the derailment. As a consequence of losing their bogies, three of the coaches were free to slide and roll in an uncontrolled manner (attached bogies tend to resist sliding because they dig into the ballast). The detached bogies also became obstacles in the path of the vehicle bodies, and the second coach probably suffered penetration damage as a result of striking detached bogies.

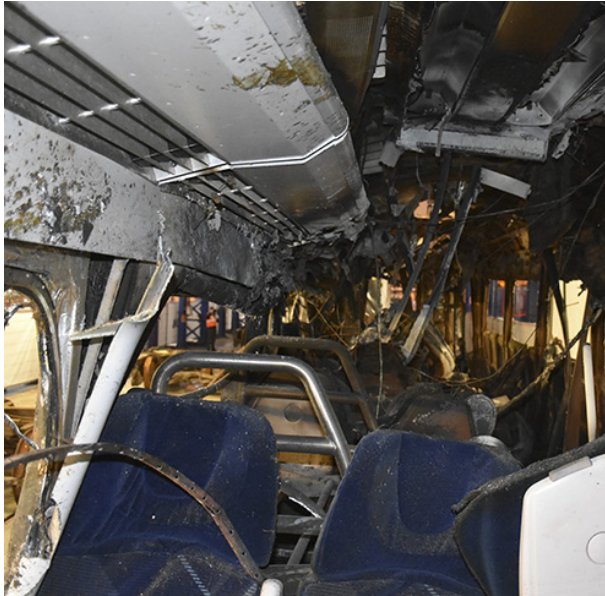
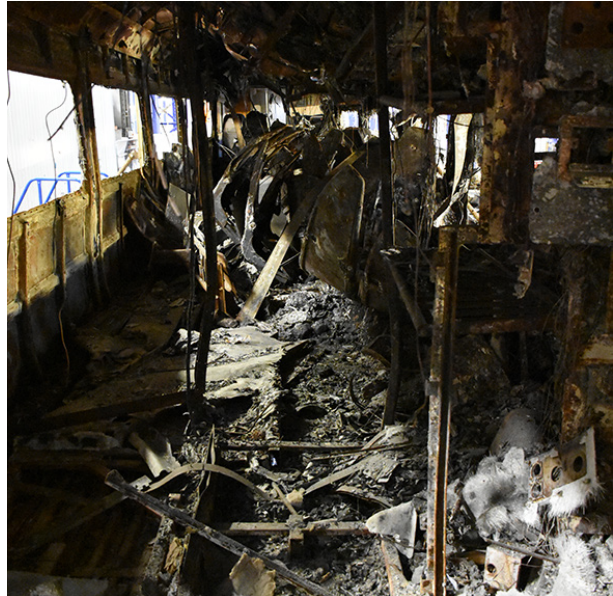
S81 The fire in the third coach originated in the batteries beneath the floor of the coach and almost certainly was caused by an electrical fault that arose due to the extent of damage to the underframe of the coach. The subsequent spread of the fire was a consequence of the coach coming to rest on its right-hand side on the slope, with its trailing end uppermost. This orientation meant that the fire naturally extended across the underframe and grew towards the trailing end of the coach. A rectangular hole in the floor on the left-hand side, designed to allow air from the air conditioning system into the passenger compartment, was the likely route of the fire into the coach's interior.

Fire damage in the third coach
