Rail Accident Investigation Branch

# Rail Accident Report

## **Derailment of a passenger train at Carmont, Aberdeenshire 12 August 2020**

Report 02/2022  
March 2022

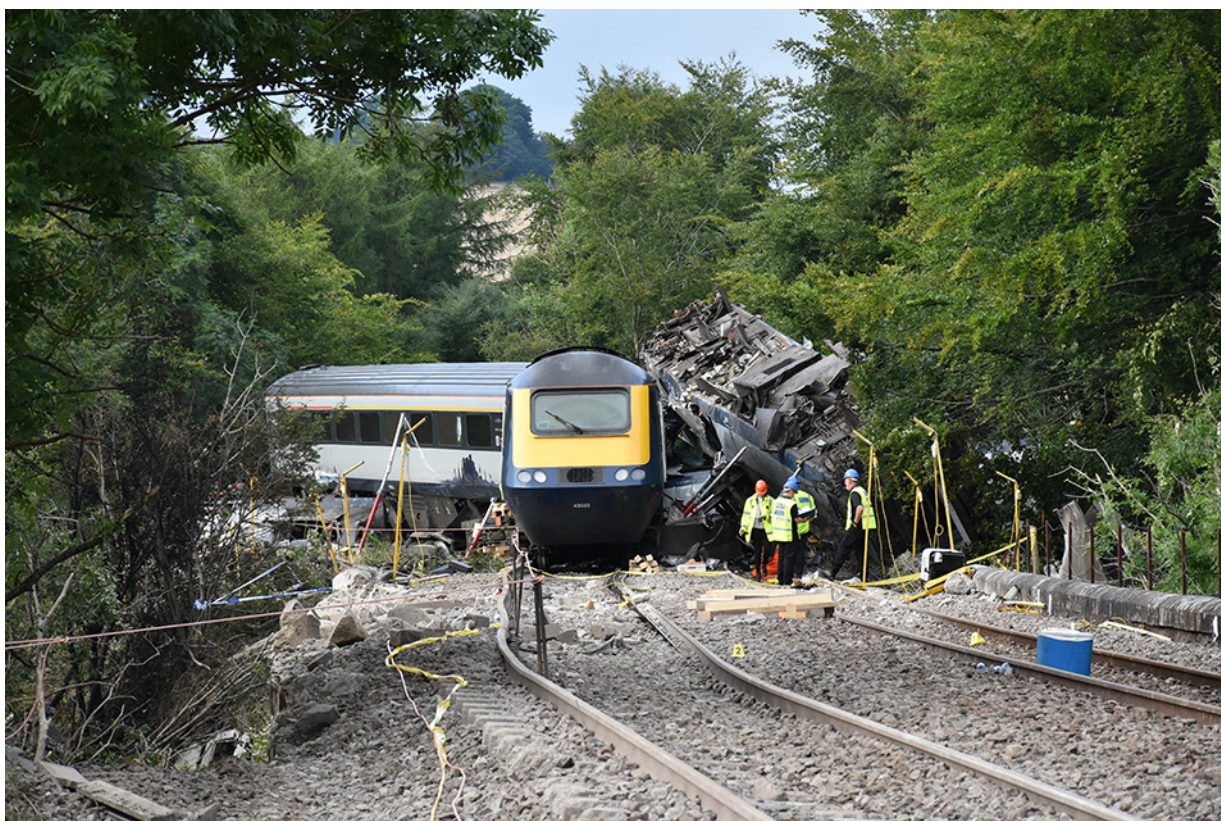
*The aftermath of the accident (image taken on 13 August 2020)*

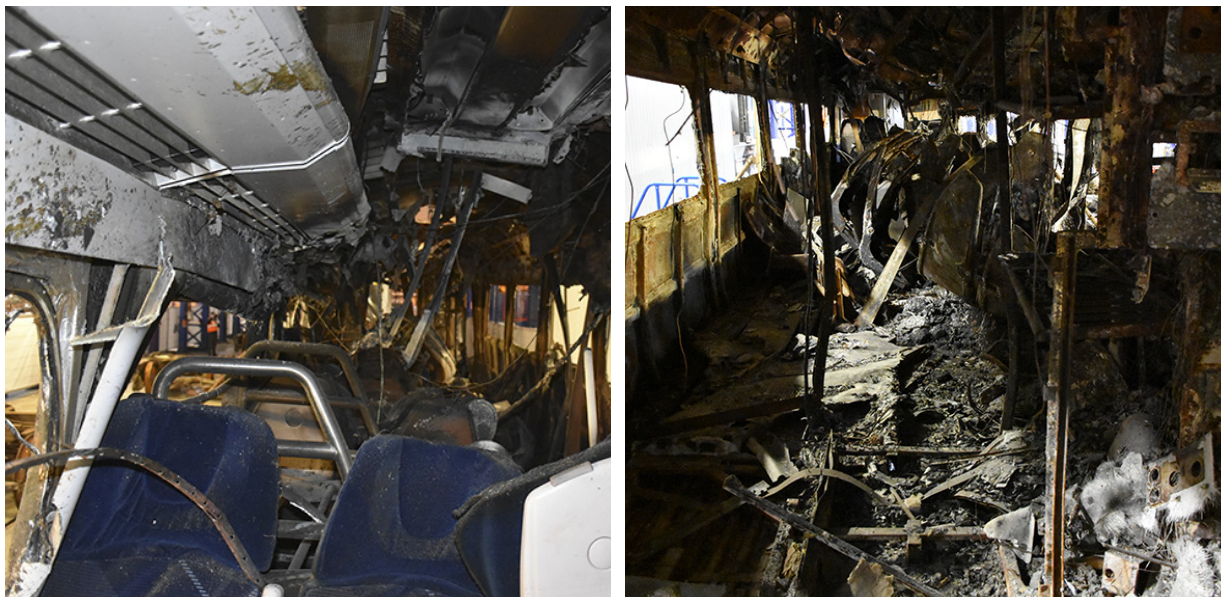
*Fire damage in the third coach*

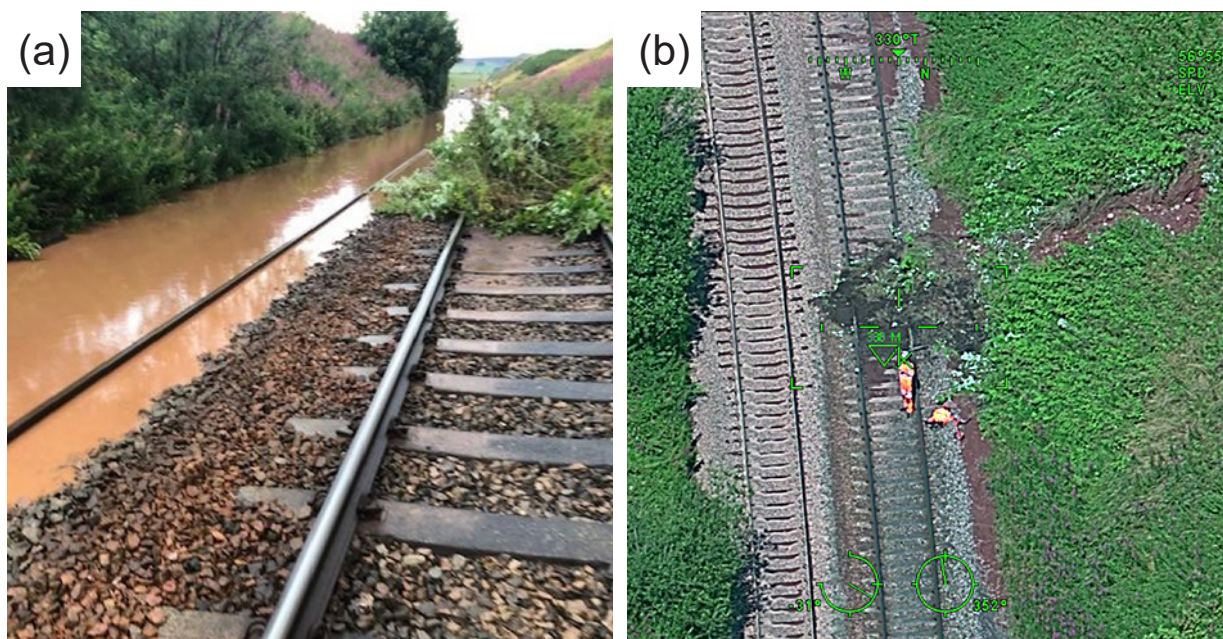
Figure 15: Landslip blocking the up line 1.6 km (1 mile) south of Carmont signal box near Ironies Bridge (a) at around 08:50 hrs on 12 August 2020 when the down line was also flooded, and (b) at around 11:00 hrs on 12 August 2020 after flooding had receded (Network Rail)

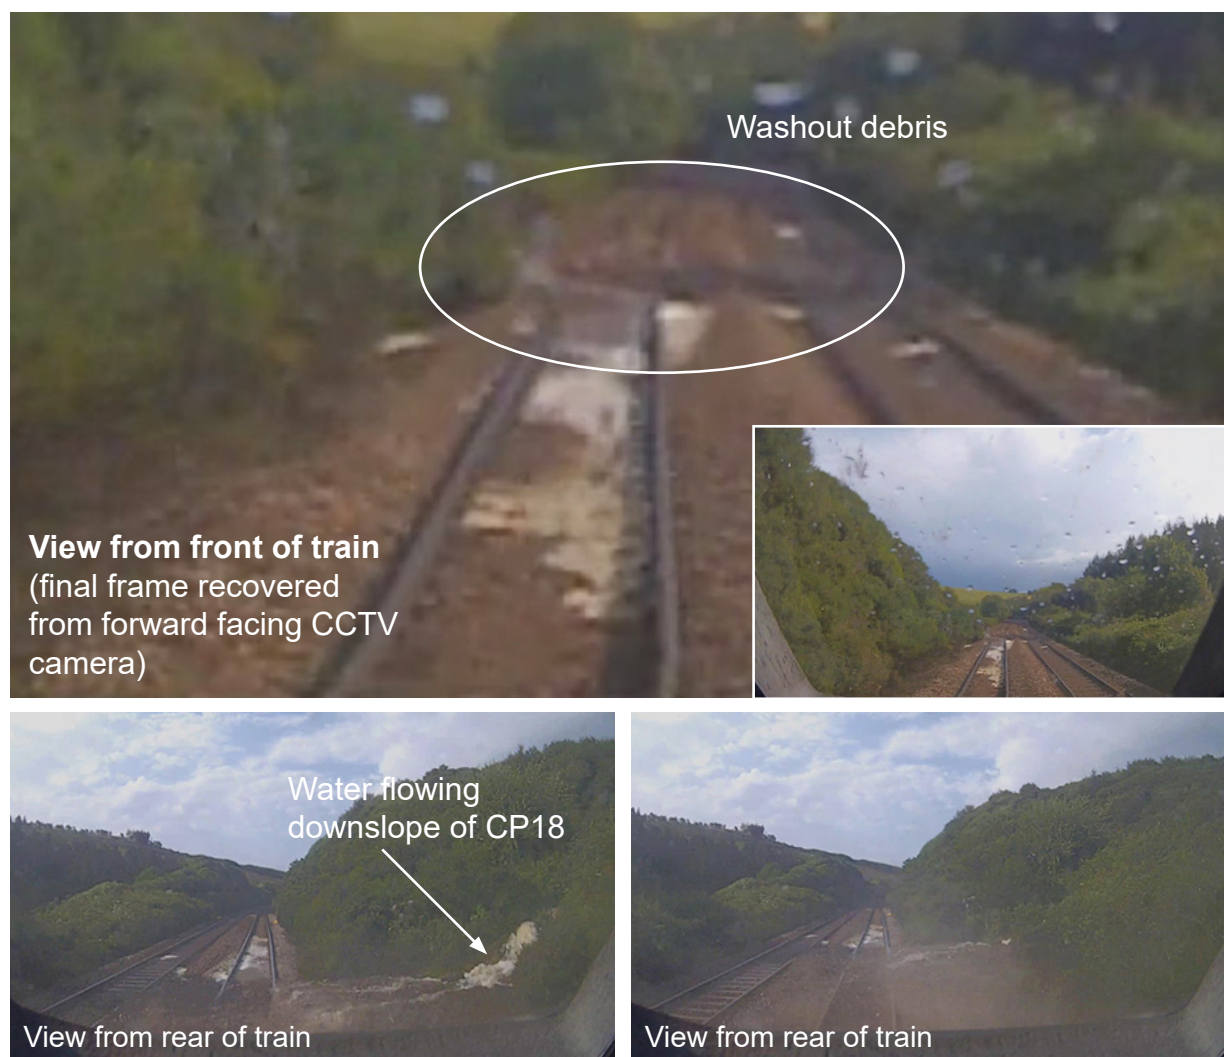
Figure 21: CCTV images from train 1T08 showing the washout (ScotRail)

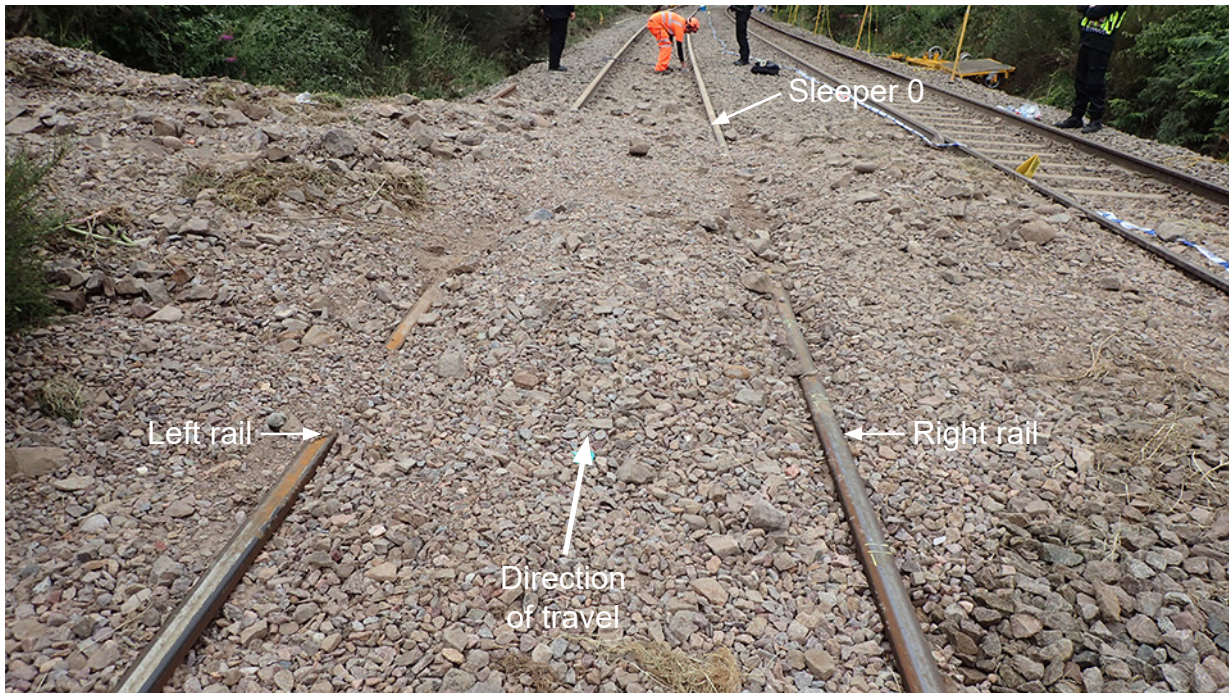
S62 The marks found on the track are consistent with the leading left-hand wheel of the leading power car being lifted up by debris between the wheel and rail and displaced to the left across the head of the rail before falling off the track entirely. At the same time the right-hand wheel dropped into the space between the two rails.

Figure 22: Washout debris covering the track and point of derailment at sleeper 0. Grooves cut by the wheels of train 1T08 through the debris are visible

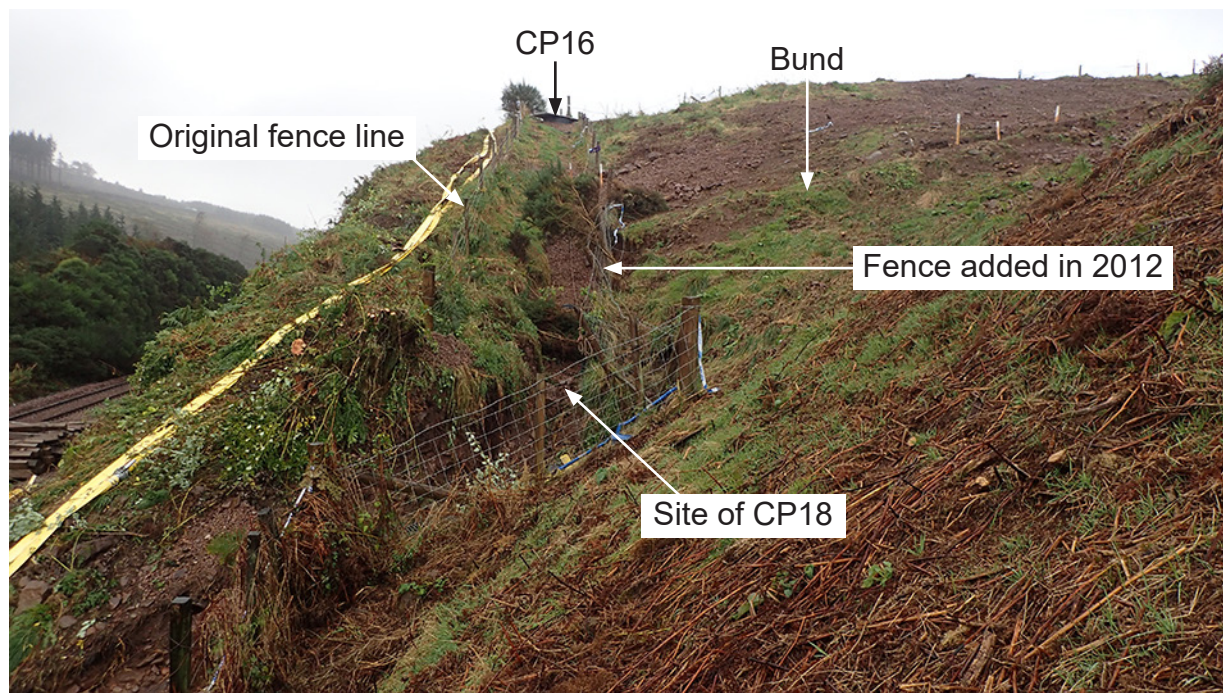
Figure 36: Funnel area post-accident after clearance of vegetation and removal of CP18

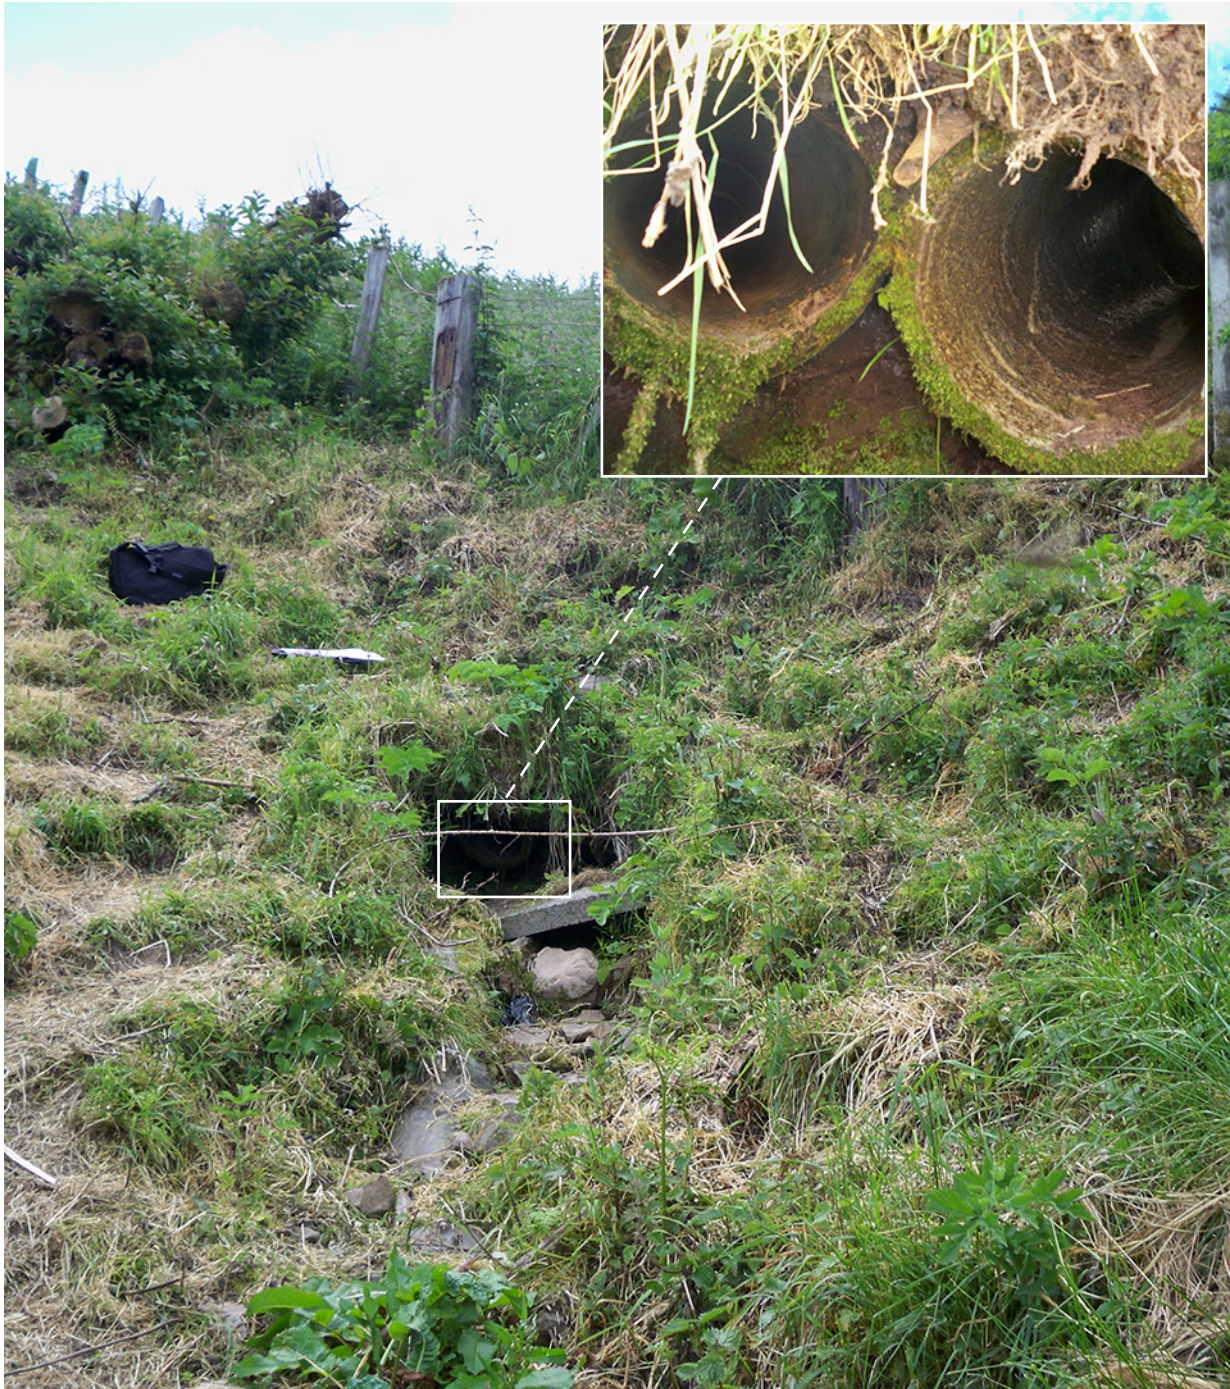
- 136 Drawing 002/001 included the note 'Existing pipe from the field to be connected into CP18' with an arrow pointing towards CP18. The note 'Existing pipe to be concreted into new catchpit' was included alongside CP18 on drawing 002/008. Alongside CP18, drawing 002/004 issue 02 'Inlet and outlet long sections' states '*Existing 2 No. 225 mm dia pipes to be connected into new catchpit*'. It appears one of these pipes was the historical crest drain running parallel to the 2011/12 drain and on the railway side of it (appendix G and figure 32). The second is the pipe leading from the pre-2010 ditch at the bottom of the funnel feature. Witness evidence confirms that the designer's intention was to capture whatever water flowed down the pre-2010 ditch and the associated pipe system and feed it into the new drainage system at CP18.

*Figure 48: Pipes entering channel in pre-2010 drainage system at as-designed position of CP18 (Arup, June 2010). Inferred that left-hand pipe is from historic crest drain and right-hand pipe from pre-2010 drainage ditch as shown on figure 32*

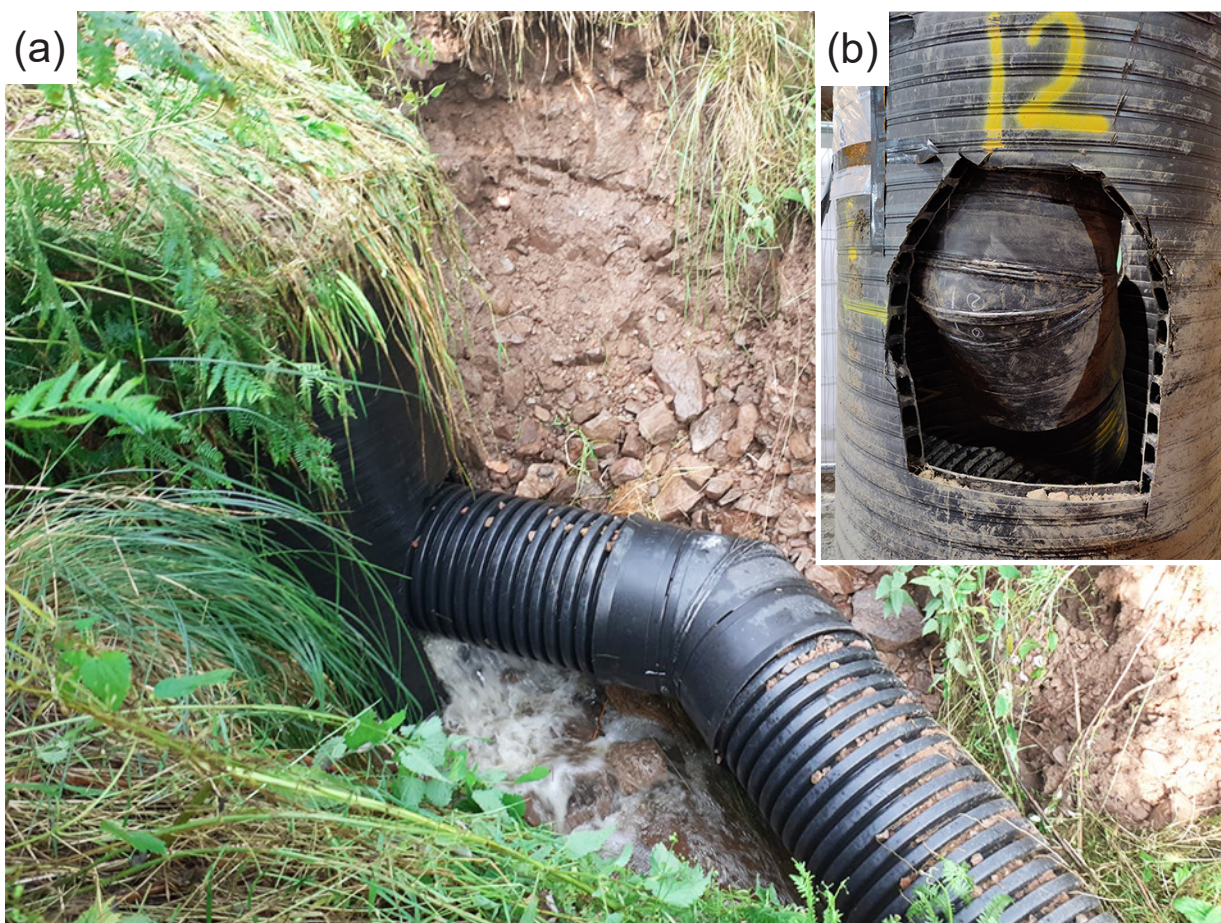
- 150 At CP18, the enlarged hole on the downslope side of the catchpit was significantly bigger than required to accommodate the drainage pipe. AECOM's analysis concluded that, until surface water flow caused washout of the gravel, escape of water through the gap between the pipe and the enlarged hole would have been constrained by gravel restricting the amount of outflow and by the damming effect of the locally dug fill (figure 30). This would have led to a build-up of water in the gravel sufficient to force the escaping water to re-enter the pipe through the pipe perforations, with no water escaping to the surface. This would not have caused a washout, although it had the potential to trigger a washout if surface water flows over the drain were just less than needed to cause a washout. The washout upslope of CP18 demonstrates that surface flows were sufficient to cause a washout without the assistance of water escaping from around the drainage pipe.

Figure 51: Downstream face of CP18 showing enlarged hole (a) on 12 August 2020, and (b) after removal (Note: a loose section of pipe has been subsequently placed inside the catchpit)

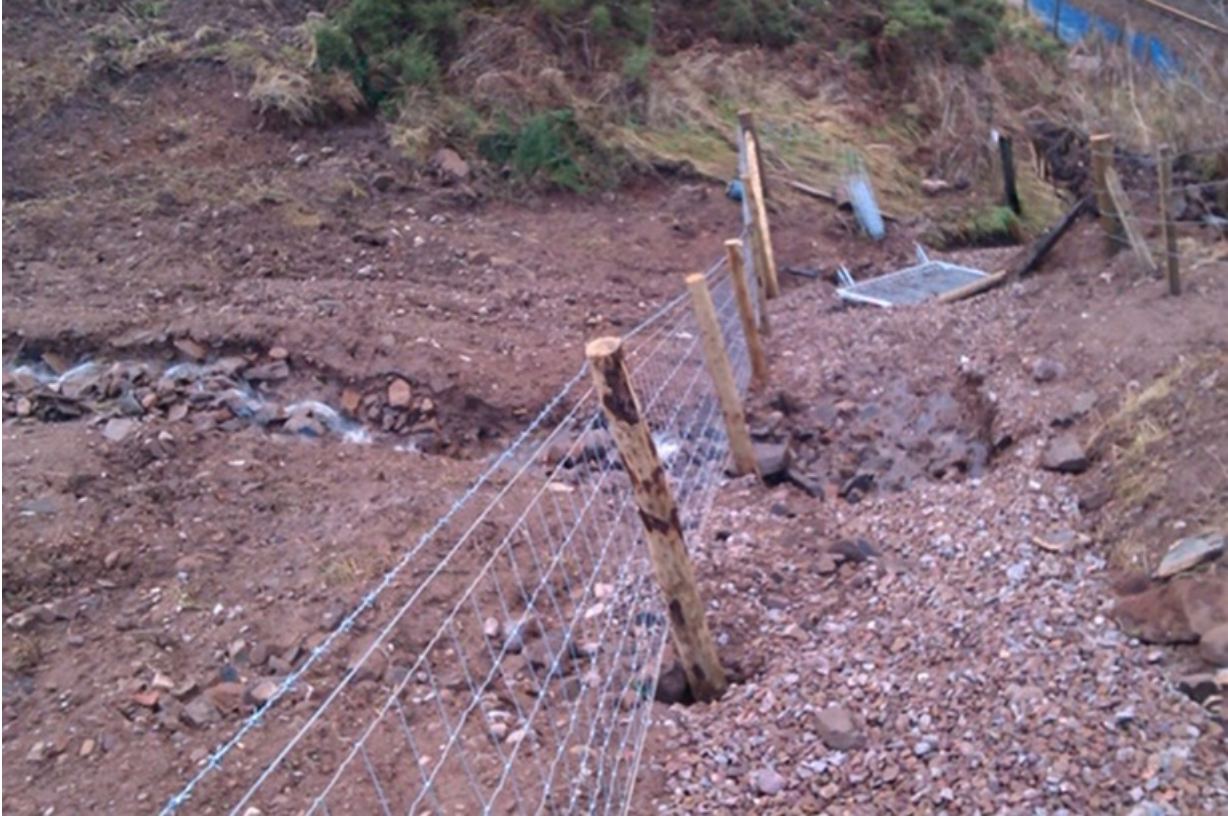
- S21 In December 2012, shortly after the drain was completed, but before the associated fencing work was finished, the landowner visited the sloping section of drain following a period of heavy rain. During this visit, he took a photograph of the steeply sloping section of drain upslope of catchpit 18 showing water flowing from a side channel and slight erosion to the gravel surface of the 2011/12 drain. The landowner stated that he passed this photograph to Carillion or Network Rail. No evidence has been found relating to receipt of the image or action being taken in response to it. It is likely that this erosion was visible when Network Rail and Carillion staff inspected the site in March 2013.

- S22 It is very unlikely that the slight erosion of the gravel surface would have been immediately recognised as a precursor to a sudden washout affecting railway safety. However, this was clear evidence of a problem requiring action such as repair, monitoring and/or reference to the drain designer. This was a missed opportunity to recognise the effect of the bund on water flows.

Figure 52: Surface of drain looking towards CP18 and railway in December 2012, before completion of the fencing (landowner)

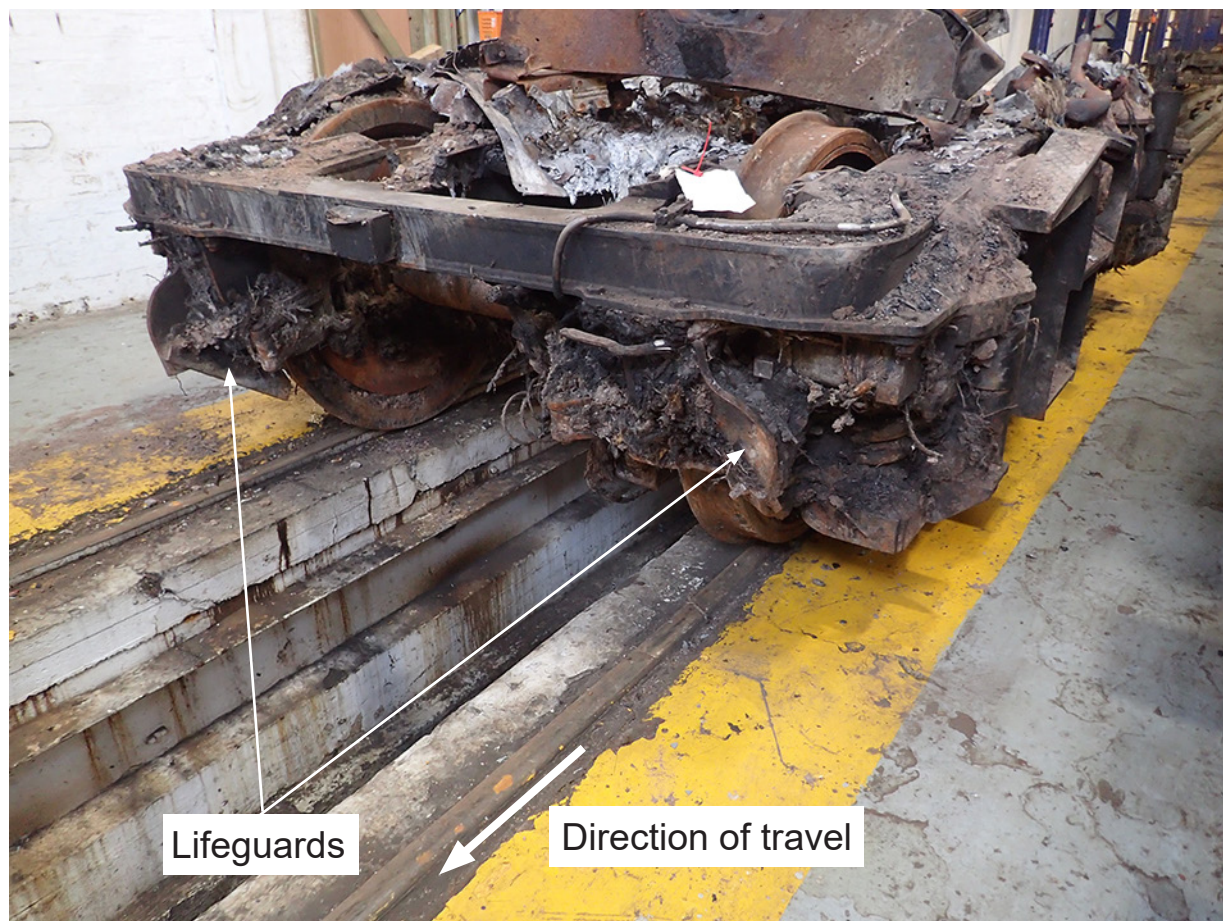
Figure 60: Damaged lifeguards on the leading bogie of the leading power car

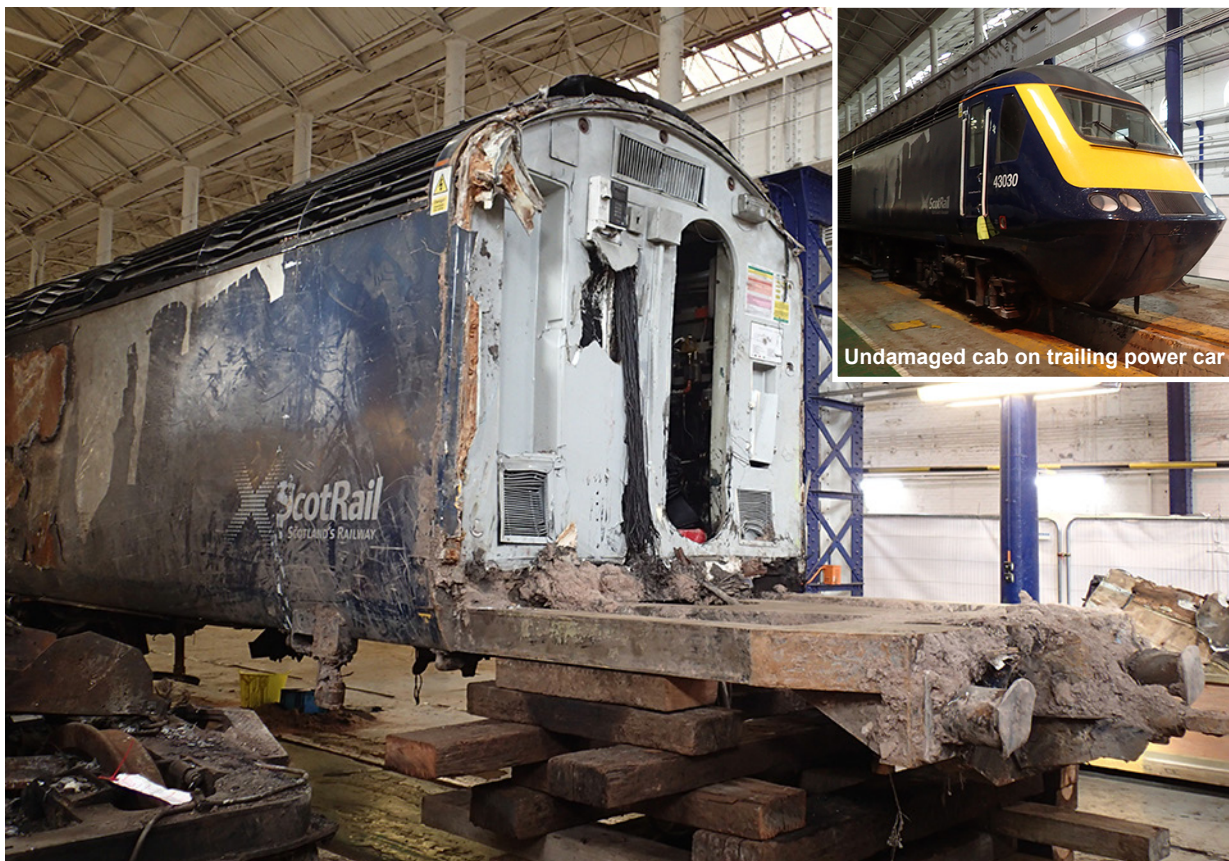
Figure 72: Front of leading power car (cab became detached during accident)

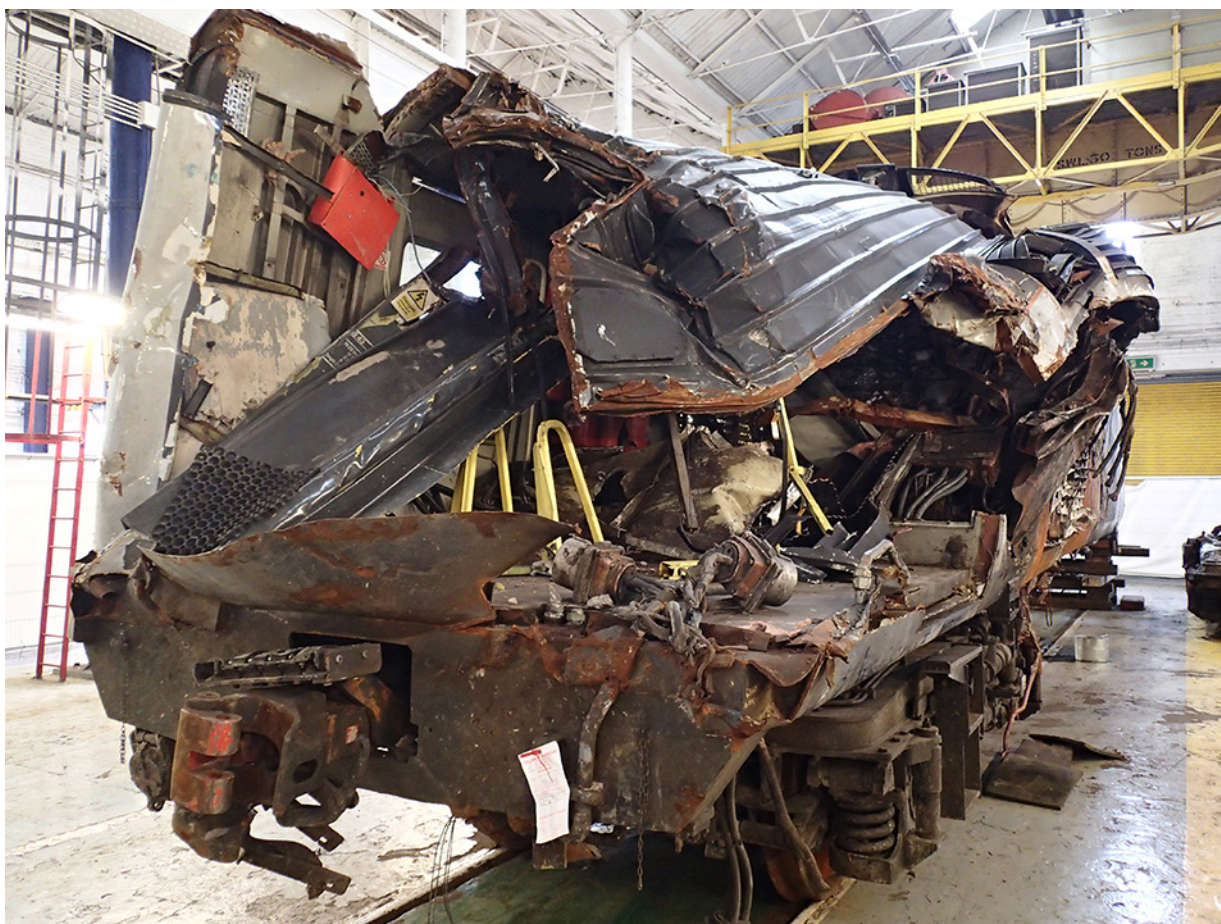
Figure 73: Damage to rear of leading power car

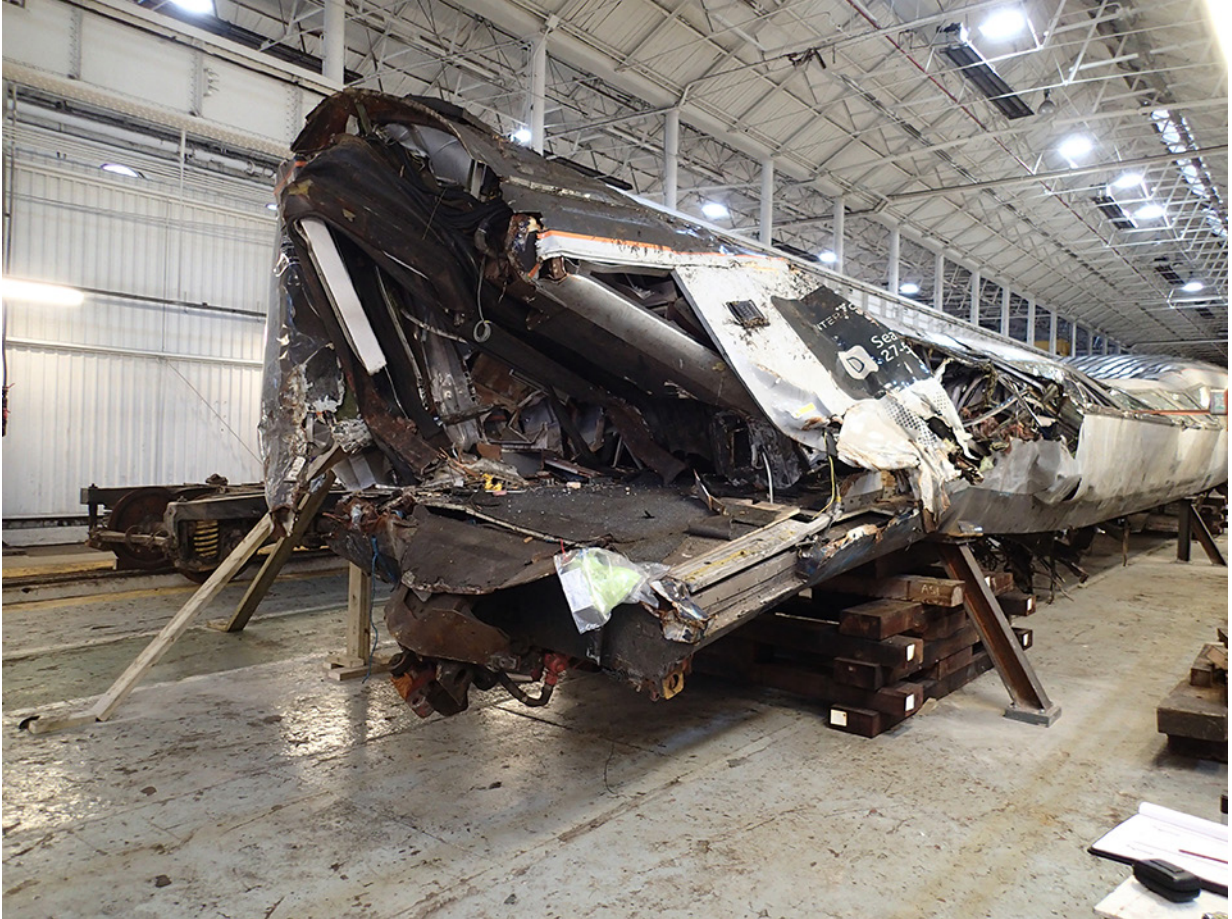
Figure 74: Damage to leading end of coach D

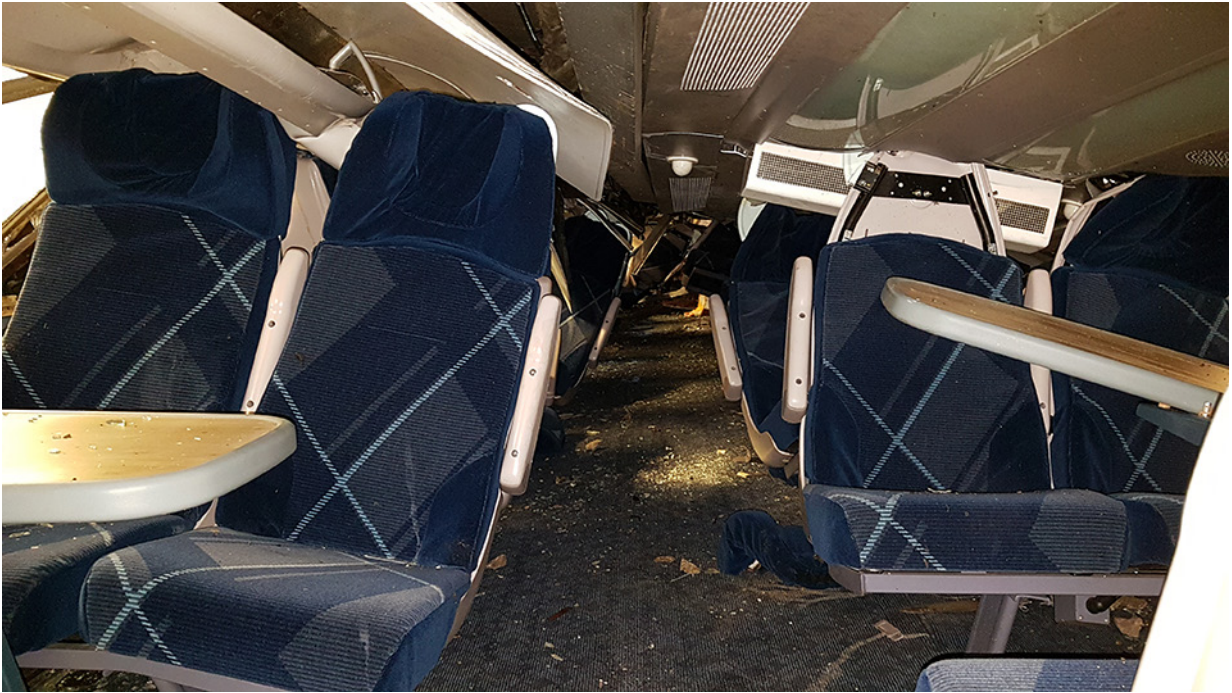
Figure 75: Interior damage at leading end of coach D

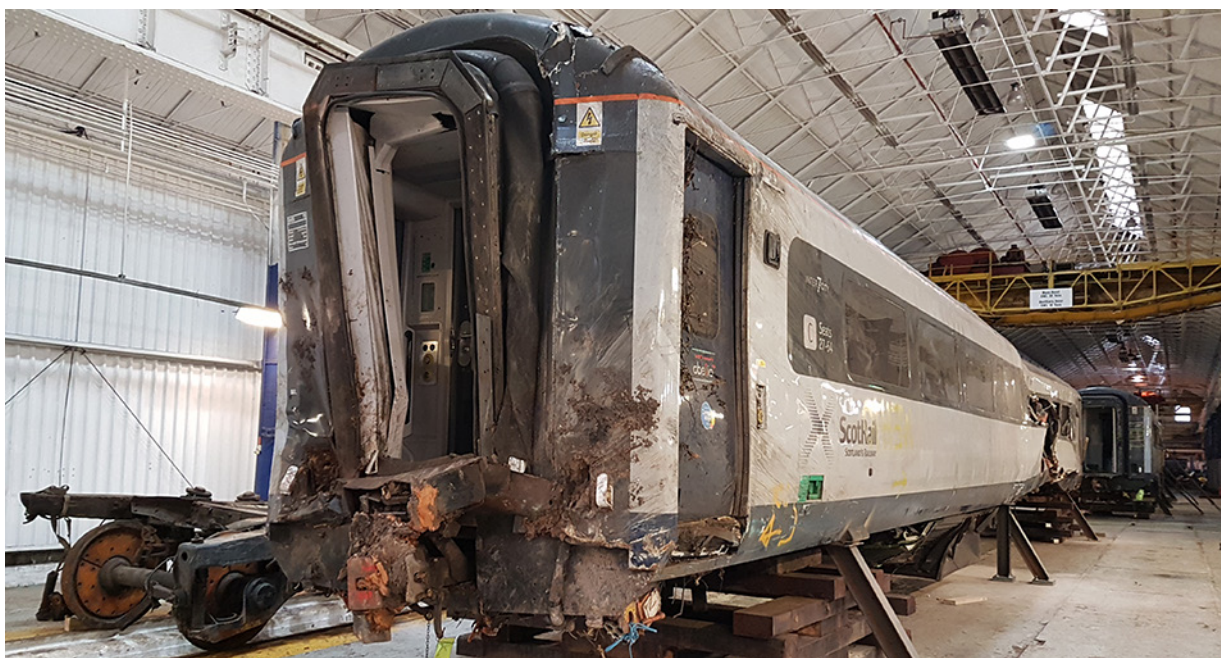
Figure 76: Leading end of coach C

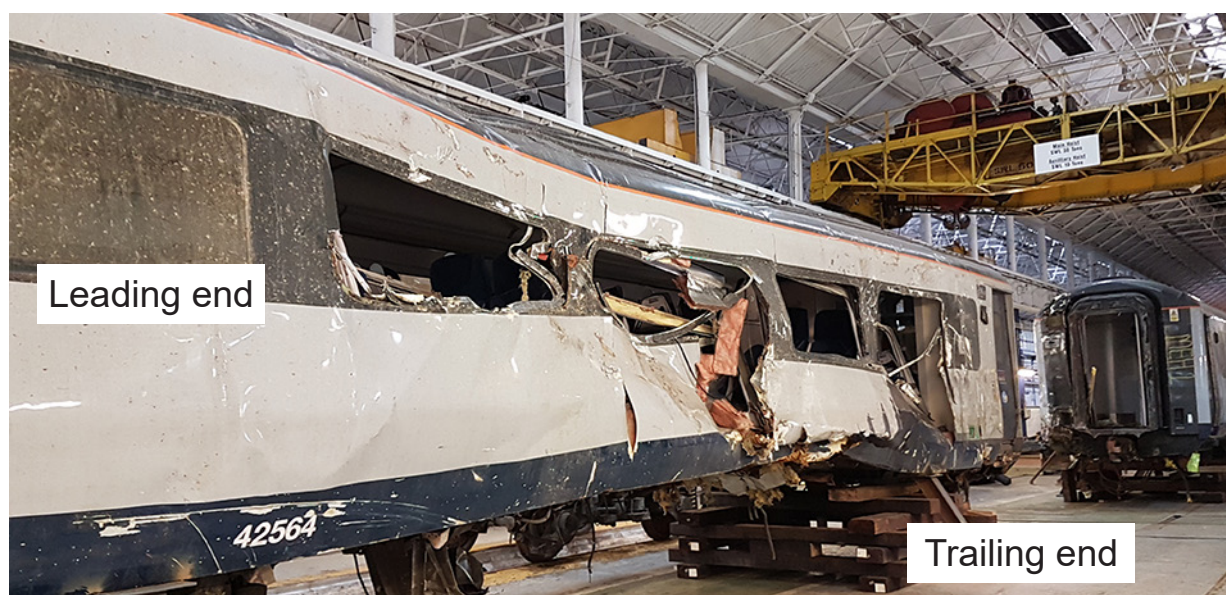
Figure 77: Penetration damage at trailing end of coach C (left side)

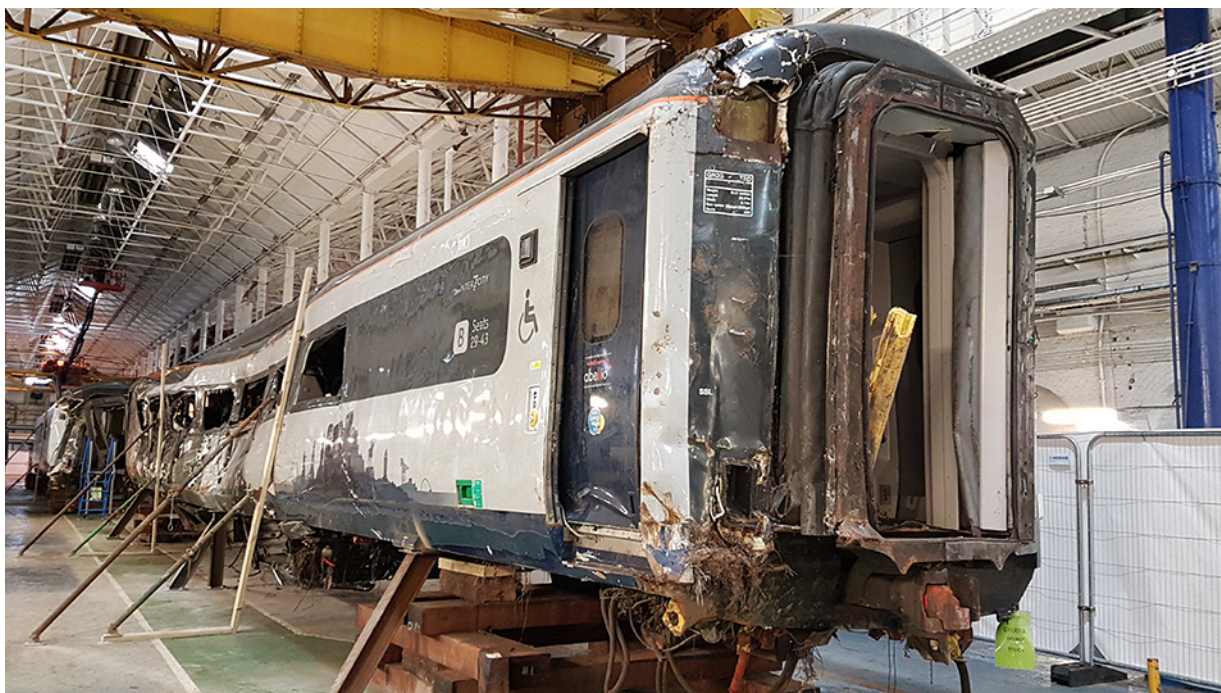
Figure 78: Damage to leading end and right side of coach B

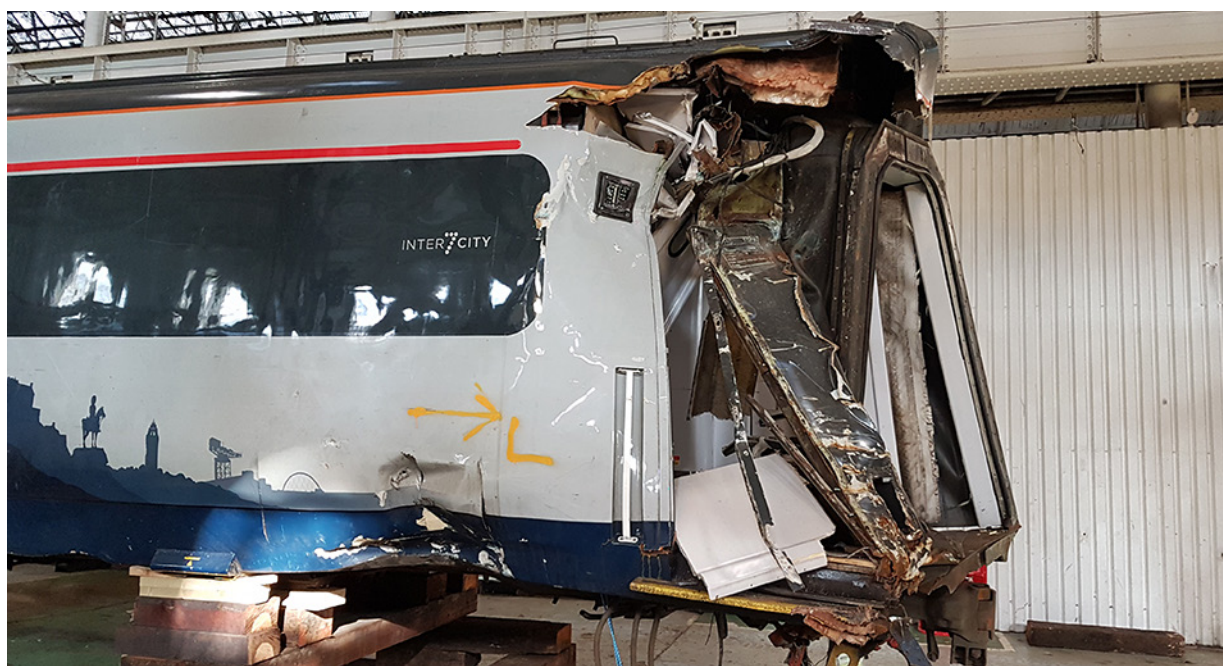
Figure 79: Damage to leading end of coach A

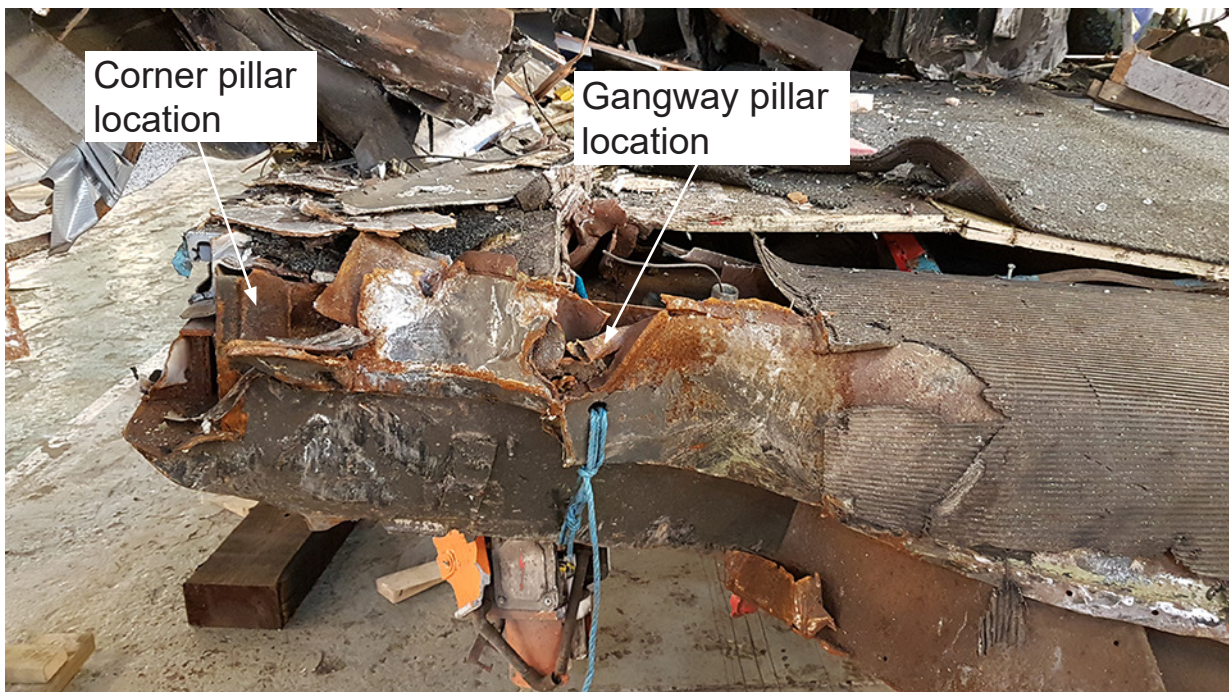
Figure 80: Corrosion on coach D at leading right-hand side of underframe at pillar locations

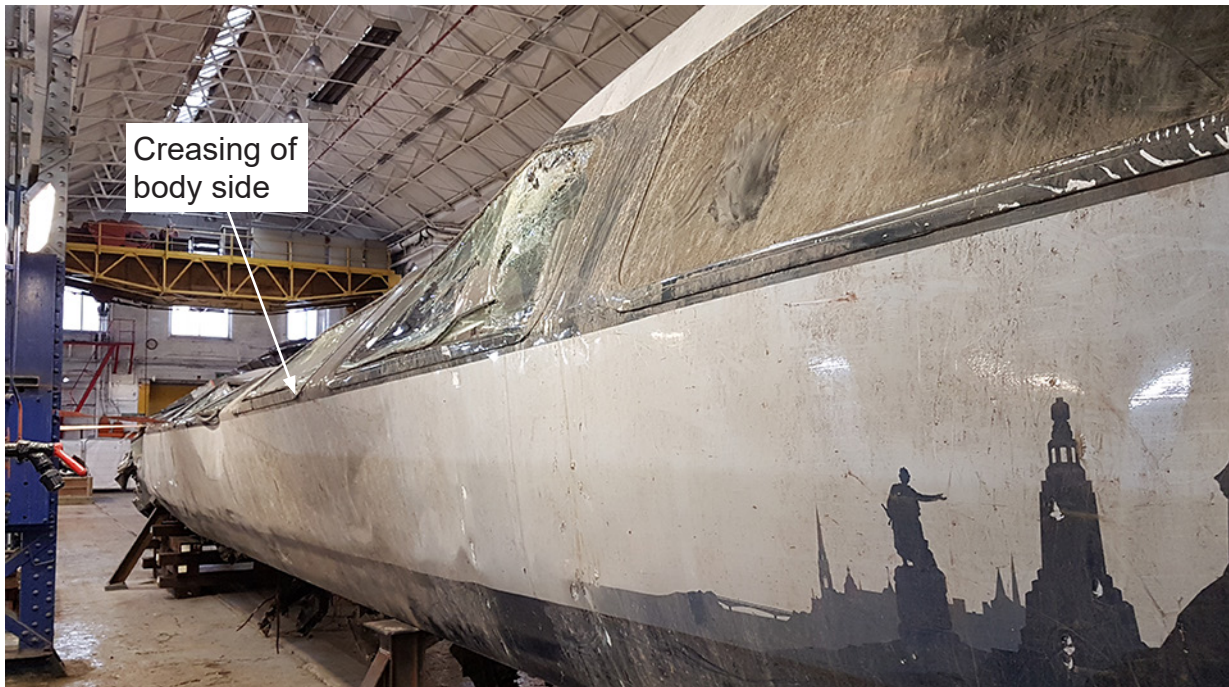
Figure 81: Creasing along left-hand bodyside of coach D

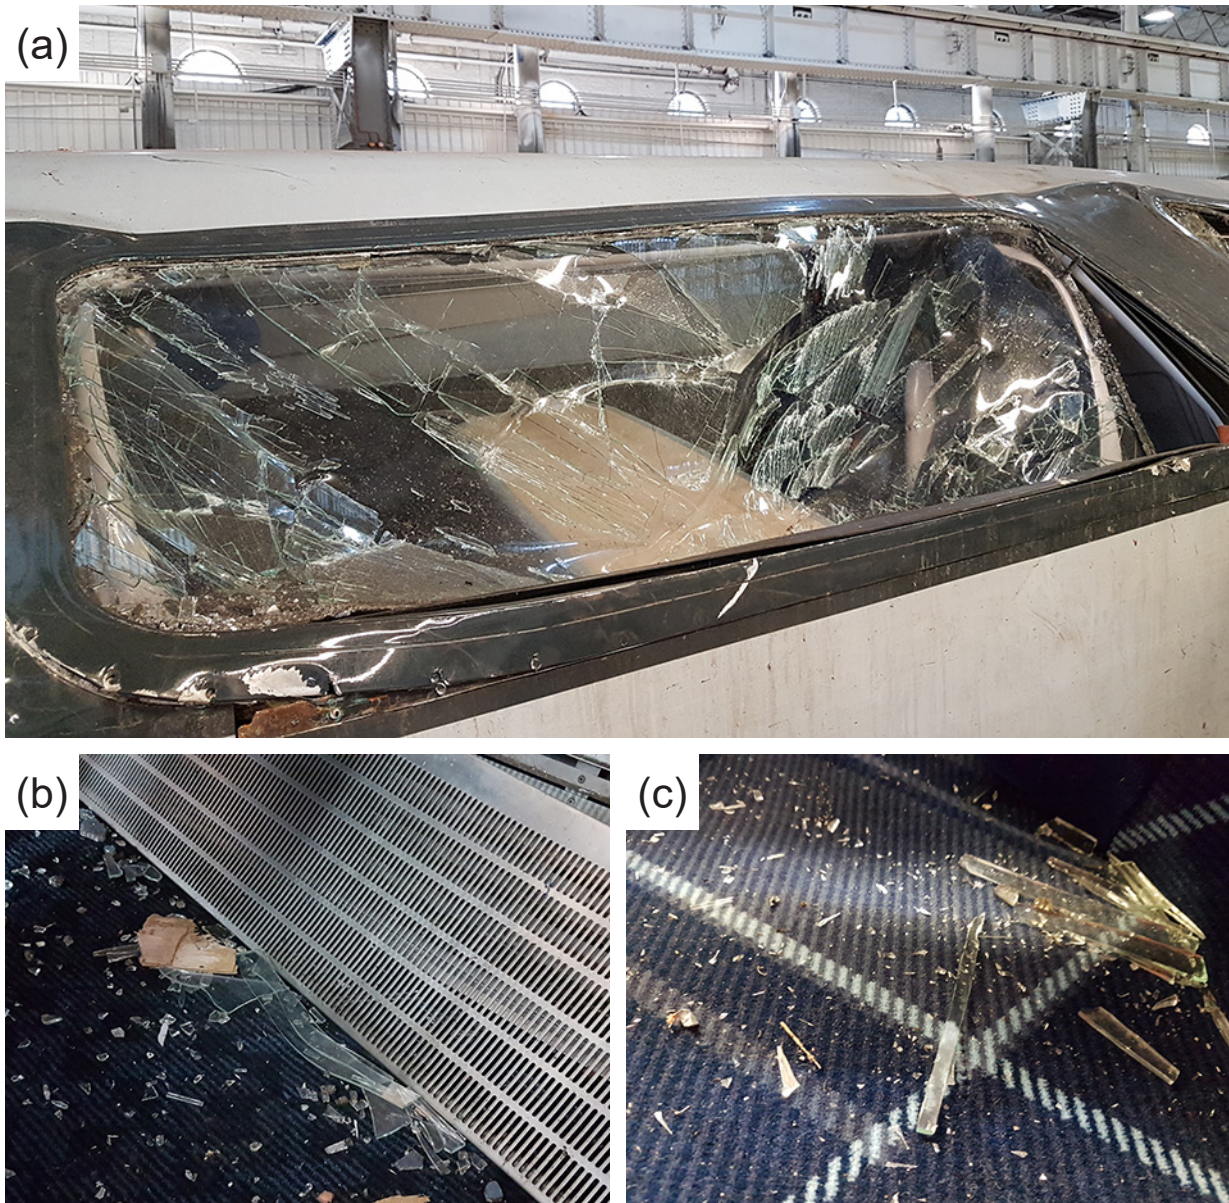
Figure 85: A broken window on coach D with remnants of inner laminated pane (a), ingress of large shards on the floor (b) and on a seat (c)
