Rail Accident Investigation Branch

# Rail Accident Report

## **Derailment of a passenger train at Carmont, Aberdeenshire 12 August 2020**

Report 02/2022  
March 2022

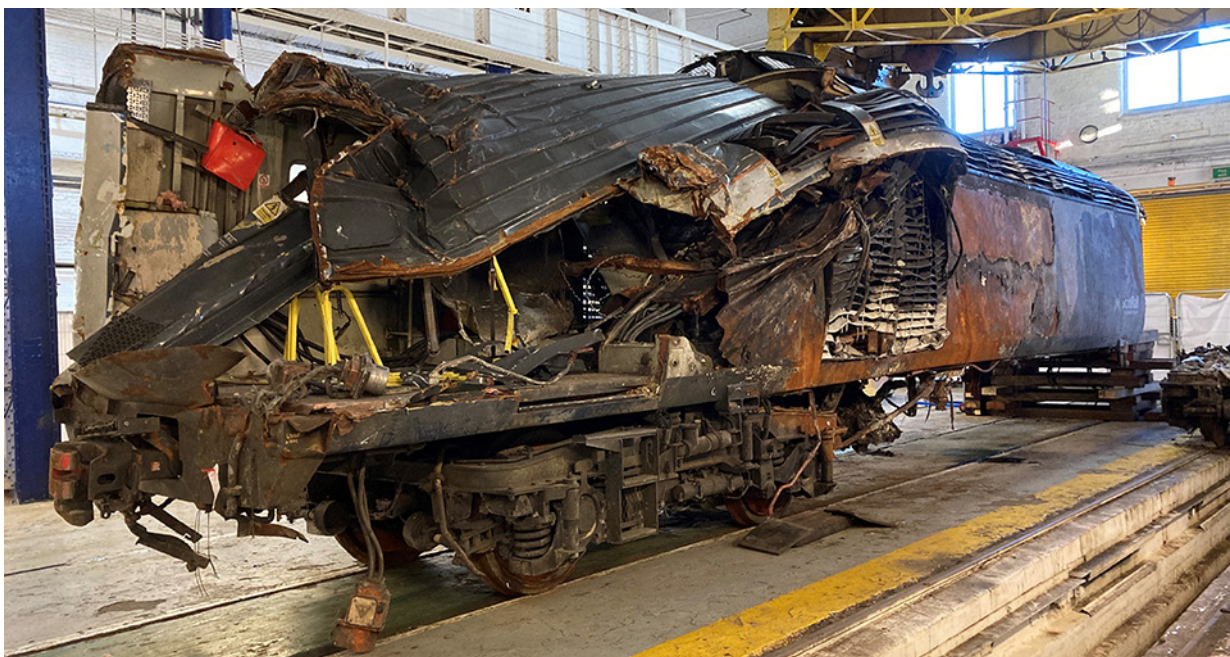
Figure 87: Fire-damaged leading power car

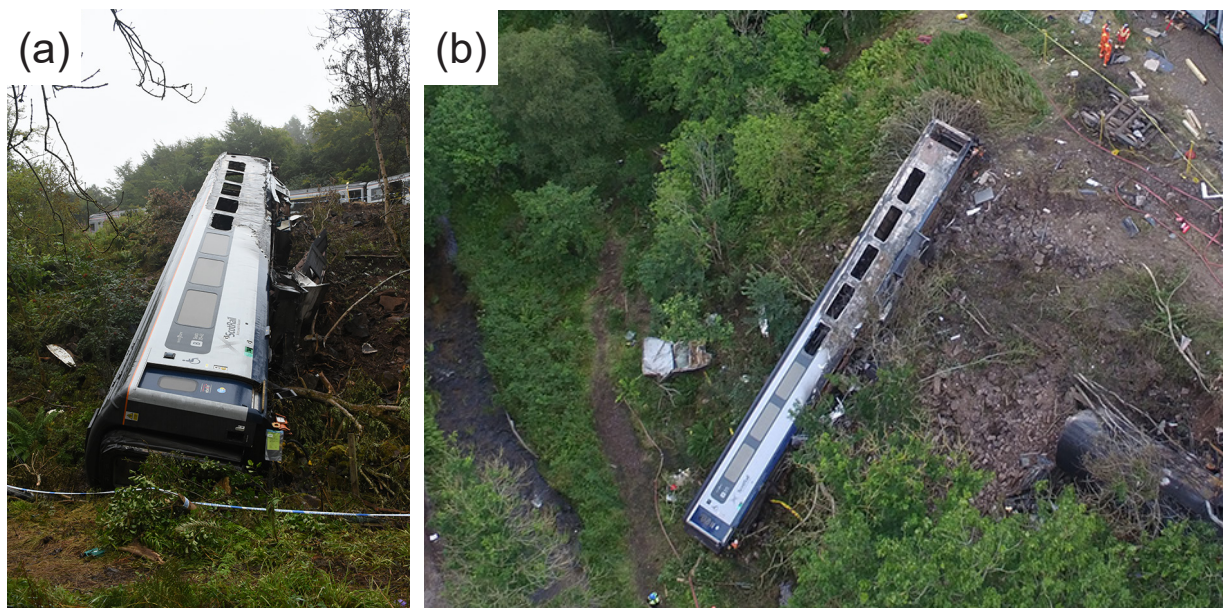
Figure 91: Coach B showing fire damage viewed (a) from bottom of embankment and (b) from overhead

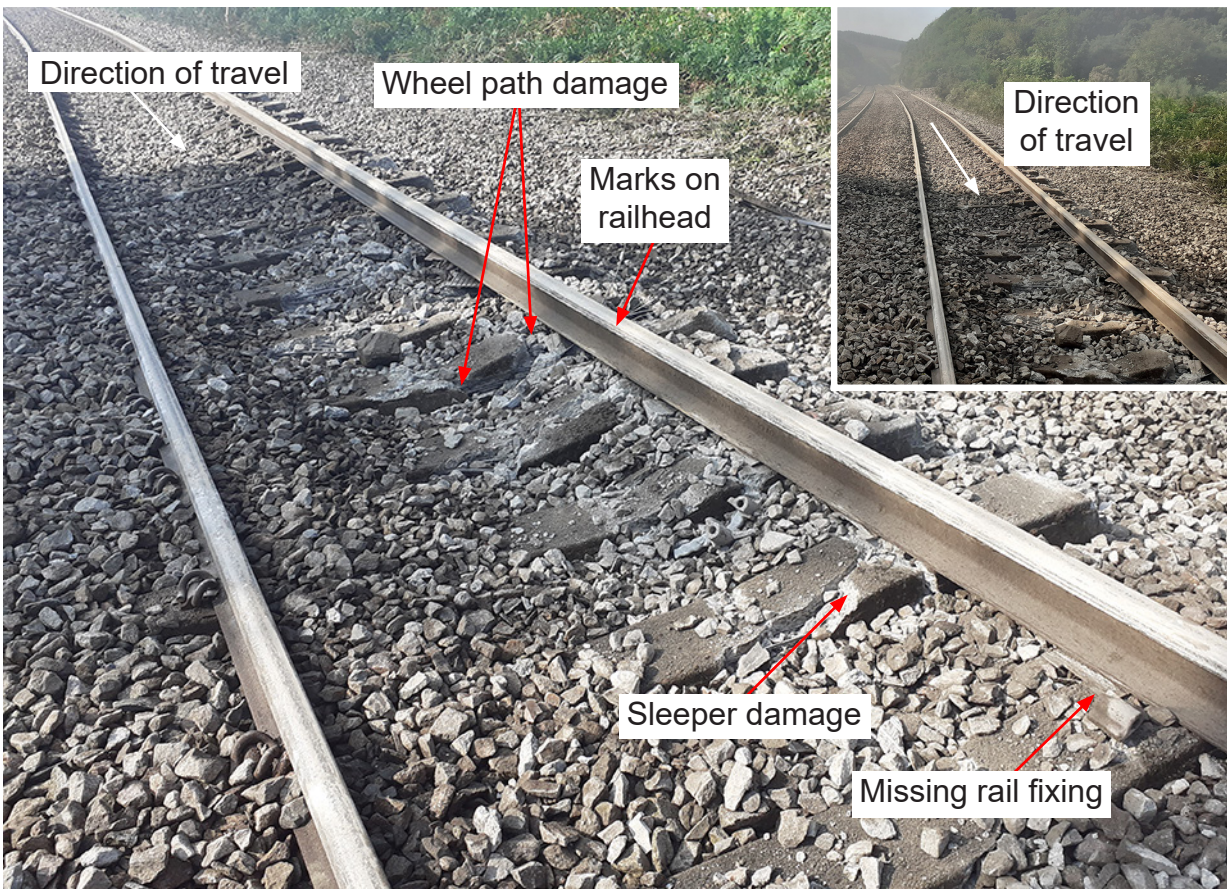
Figure F.1: Track damage looking south from sleeper 80 back towards washout location at 10:35 hrs on 12 August 2020 (Story Contracting)

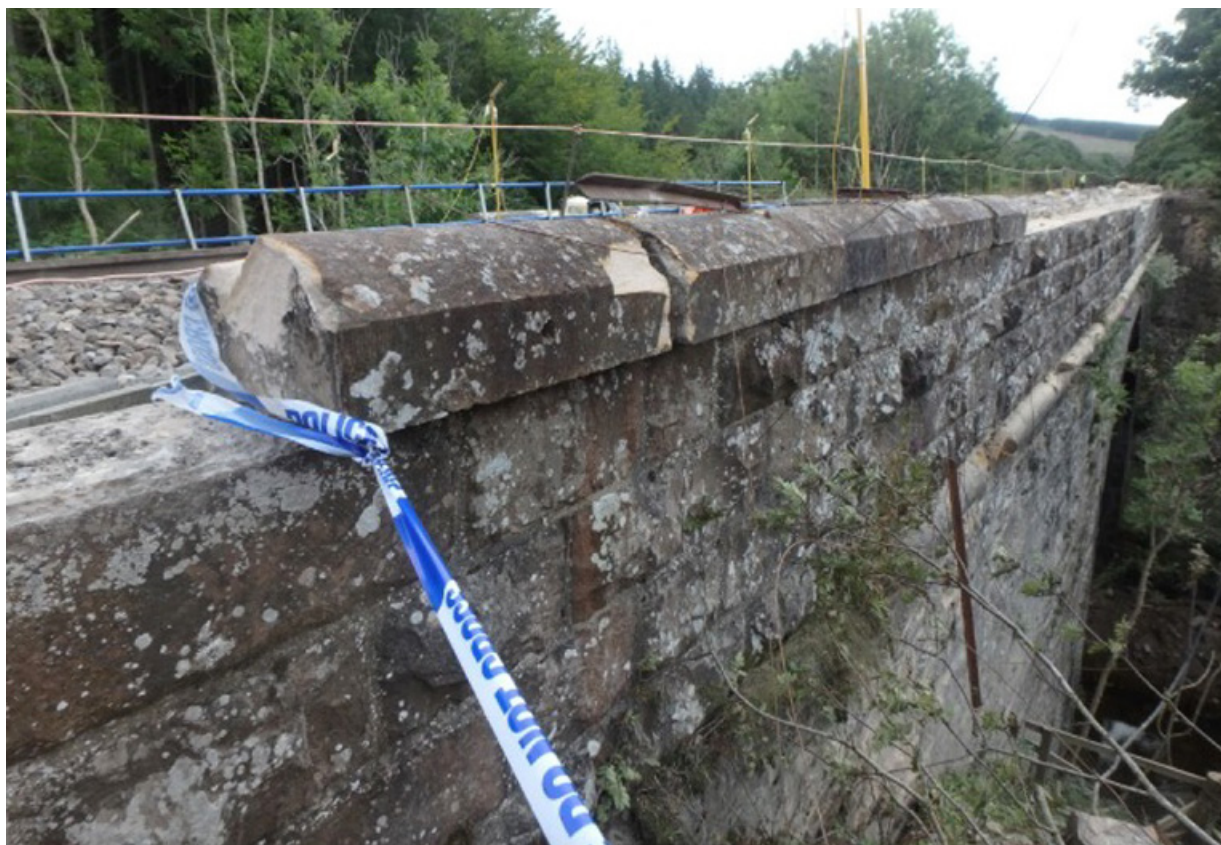
Figure F.6: Down-side parapet looking south showing remaining coping stones (Amey)

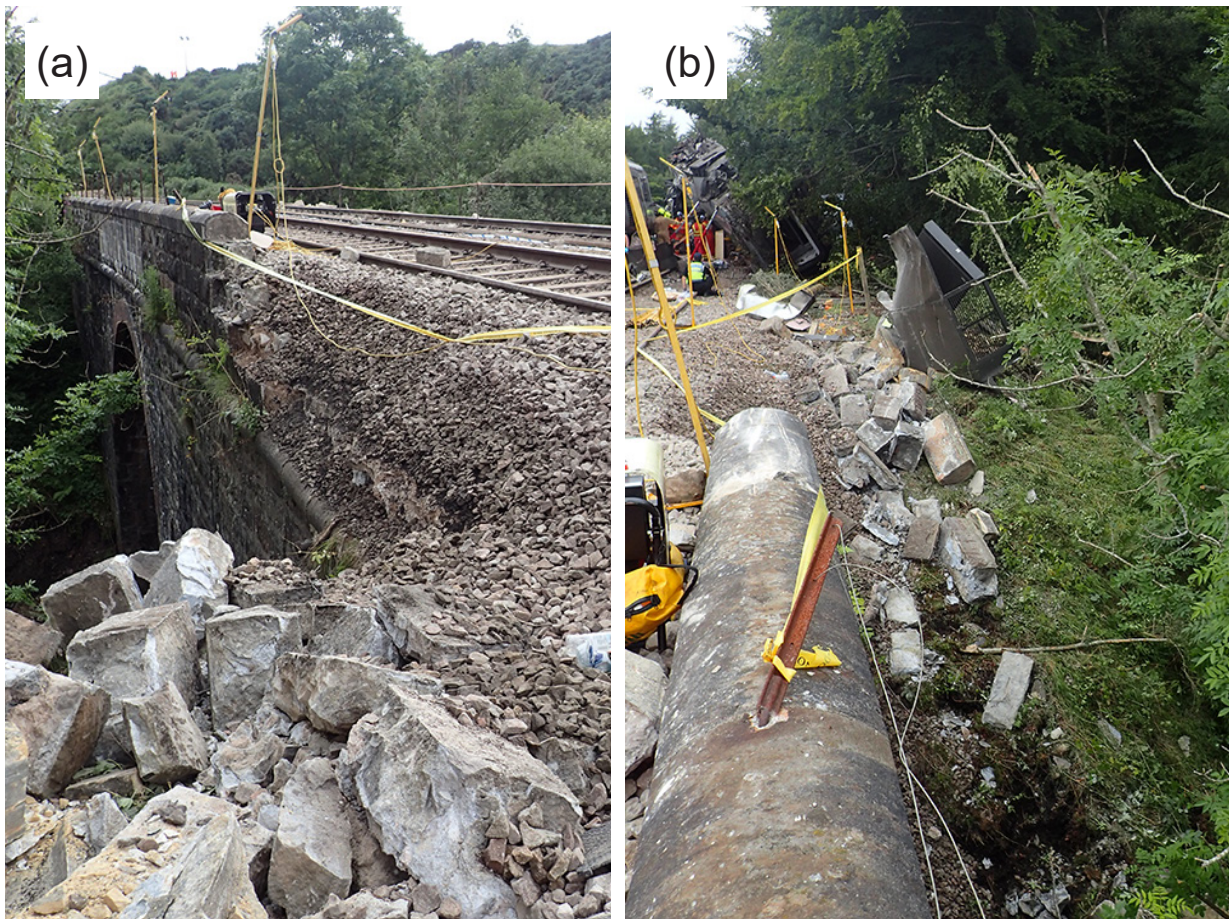
Figure F.8: Up-side parapet damage (a) looking south and (b) looking north

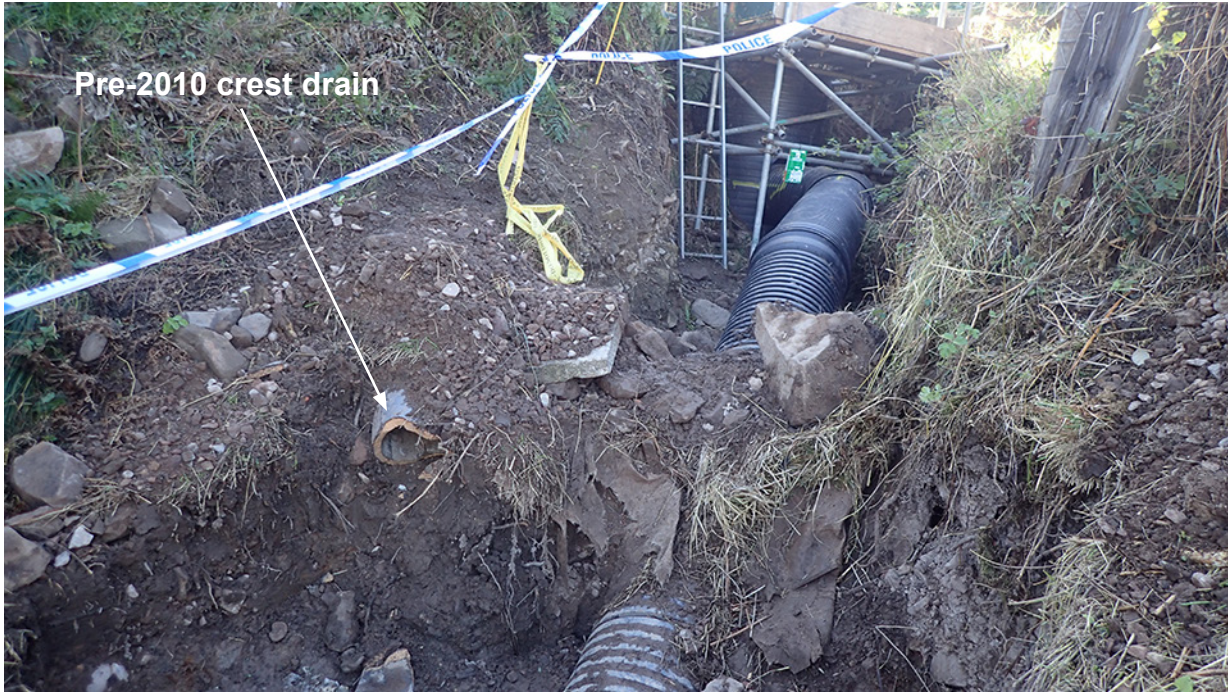
Figure G.4: Image looking upslope from near CP19 towards CP18 showing damaged end of pre-2010 crest drain close to the as-designed position of CP18. Photograph taken during post-accident investigations with scaffolding over as-built position of CP18 visible in background

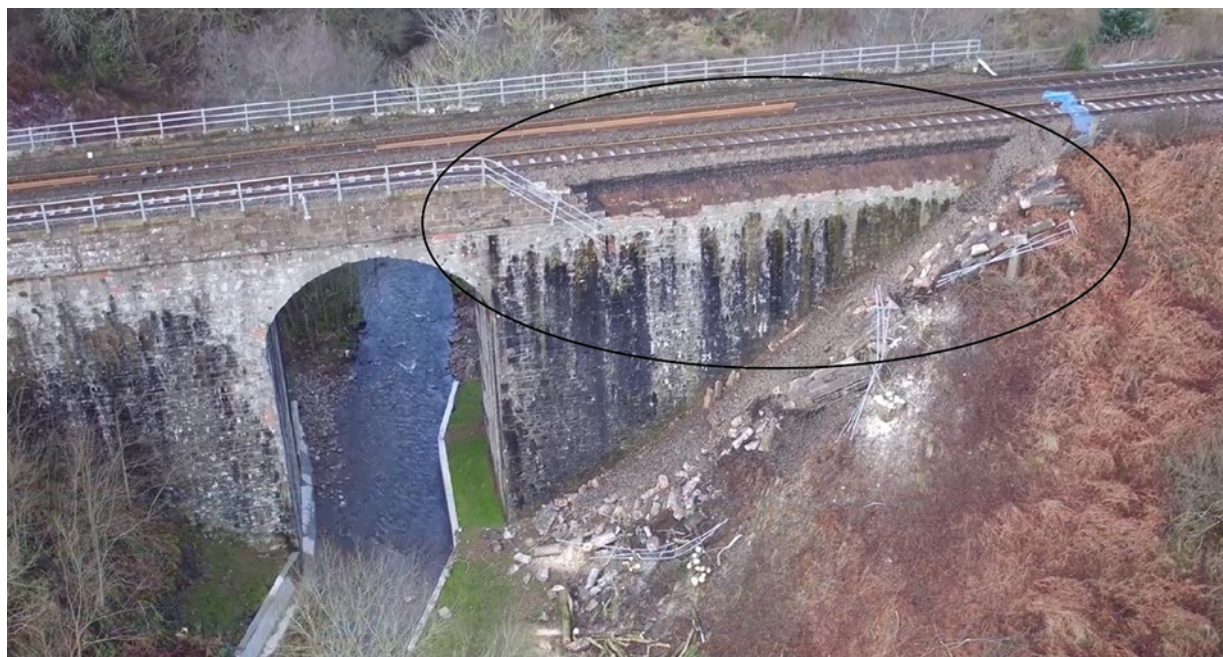
Figure M.1: South-east corner of bridge 328 following the failure of part of its parapet wall on 15 January 2021 (Network Rail)
