Archaeological Sites within Merrivale Training  
Area, Dartmoor National Park, Devon:  
A condition survey on behalf of Defence  
Infrastructure Organisation

January 2022

Southwest Landscape Investigations

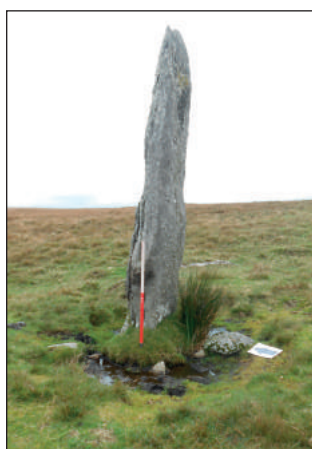
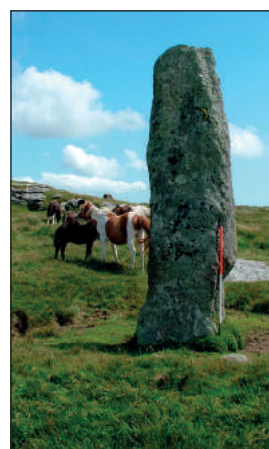
**439571 (SM No: 1008013)** Beardown Man standing stone. The photograph taken for the 2005 Baseline Survey (Fig. 5) shows the base of the stone to have been reinforced with aggregate material as a conservation measure. The 2022 photograph shows that this material has totally washed and eroded out probably as a result of animal poaching. Reinstating the base material would be desirable, but at the very least these changes should be considered during future inspections and the need for actions assessed on the basis of this gradual decline.

*Fig. 5. 439571 (SM No: 1008013) Beardown Man standing stone: (left) showing the eroded base of the stone in January 2022; (right) showing the stone in 2005, shortly after consolidation of the base.*

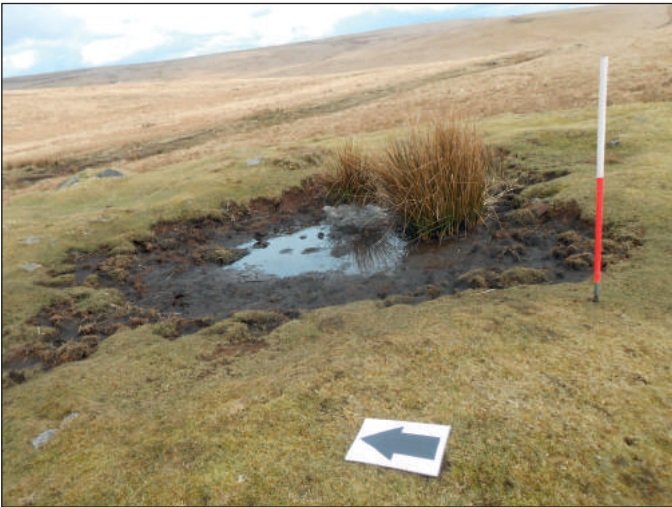
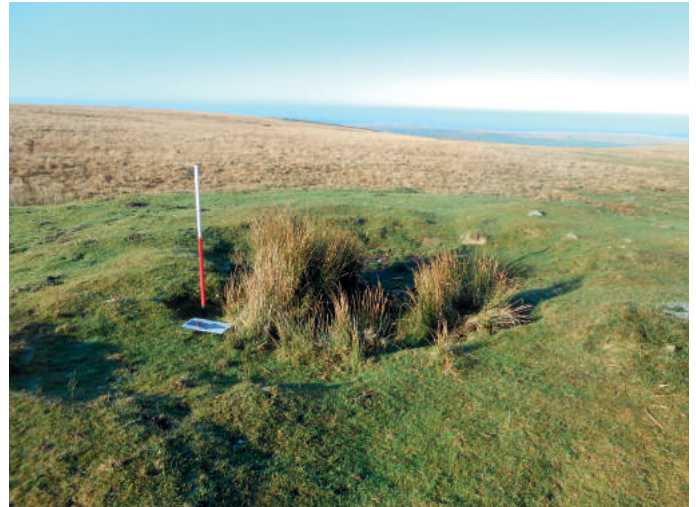
Fig 6. 439600 White Barrow: (left) the center of this important monument photographed in March 2018 showed the central hollow denuded and waterlogged, probably through livestock erosion; (right) the same area in January 2022 showing stabilisation and regrowth of turf.

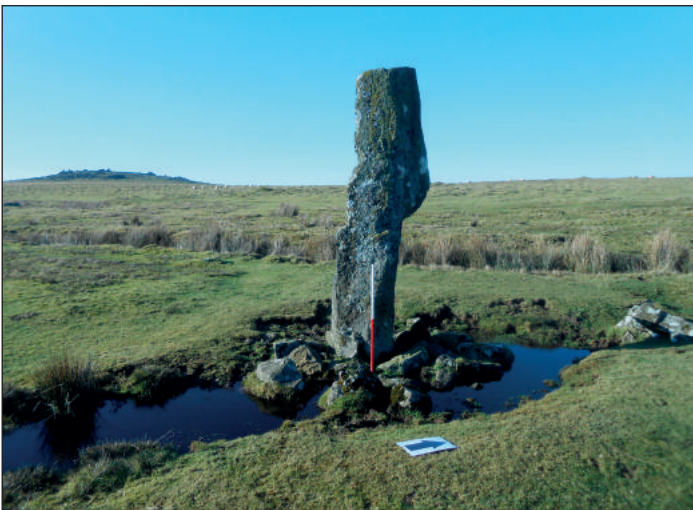
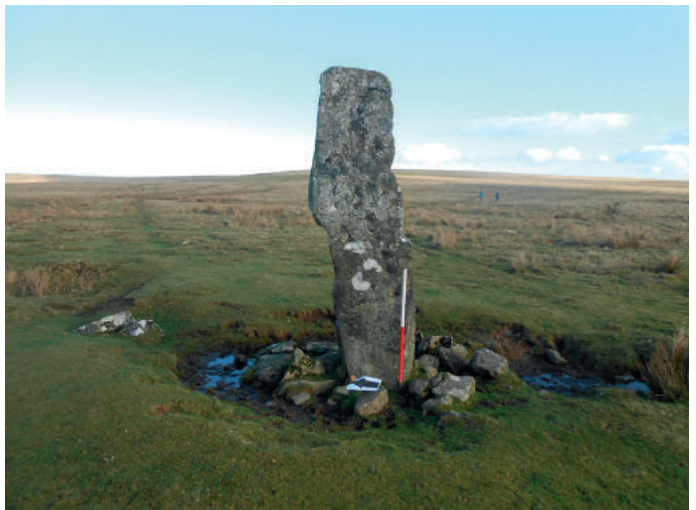
**439621 (SM No: 1007897)** Langstone Moor stone row (Fig. 7). The category of ‘improving’ can usually only be applied as a result of management interventions, however, at this site, a former vehicle tracks, which truncates the row, used by walkers and livestock (as reported in 2005 and 2010), appears to have seen less use than previously and the threat of erosion has lessened so in that respect there is an improvement. However, the terminal standing stone sits within a water-worn erosion hollow, where supporting stones around the base became further exposed between the 2010 and 2018 assessments as the hollow retained more water. This situation continues in 2022 and the risk of the stone toppling remains present.

Fig 7. 439621 Langstone Moor stone row: (left) the terminal standing stone (Longstone) viewed from the east in March 2018, seated in a denuded waterlogged hollow; (right) viewed from the west in January 2022 showing supporting stones around the base have become further exposed since the 2010 and 2018 assessments.

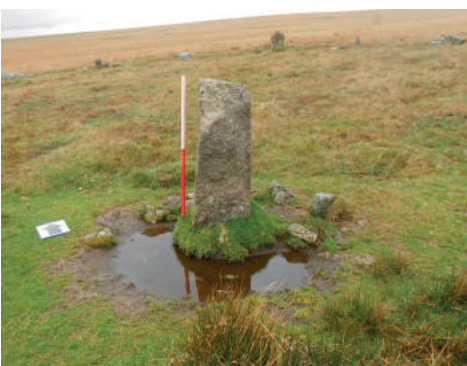
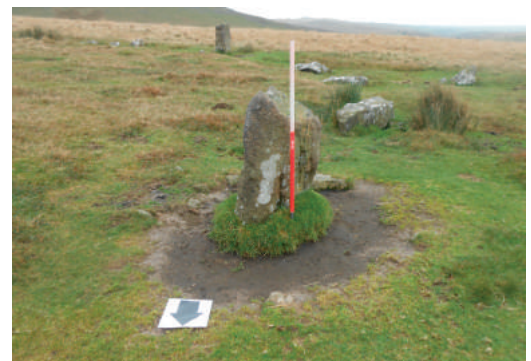
**439606 (SM No: 1007550)** Langstone Moor stone circle. Conservation work was carried out in 2003 to fill erosion hollows around the bases of the upright stones and prevent the stones from toppling (see Newman 2003). On two of the most vulnerable stones, this provision is beginning to fail. In 2018 this was not considered critical but watery hollows are again present around several of the stones and the erosion is back to its pre-2003 level. Remedial action should now be considered, whilst continued monitoring will be necessary to assess further decline in this situation. (see Figs 8 and 9).

Fig. 8: (left) 439606 Langstone Moor stone circle: (top left) the tallest in January 2022, showing denudation around the stone exacerbated by water erosion; (lower left) the same stone in August 2002 following consolidation work.

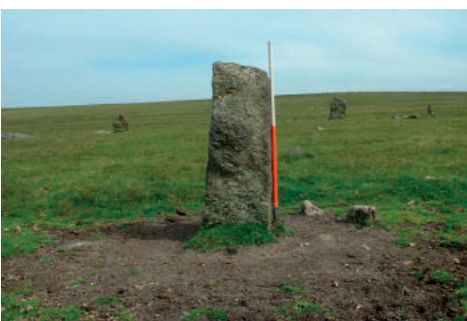
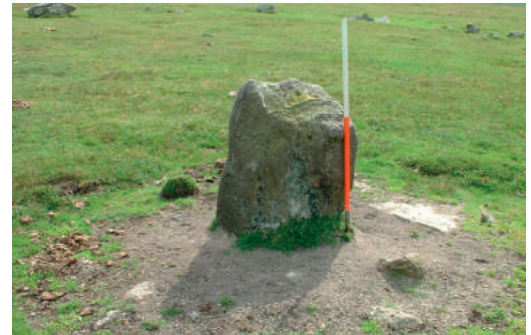
Fig. 9: (top right) another of the upright stones in January 2022 seated in an erosion hollow; (lower right) the same stone in August 2002 following consolidation work.
