AAIB Bulletin

2/2022

Published 10 February 2022

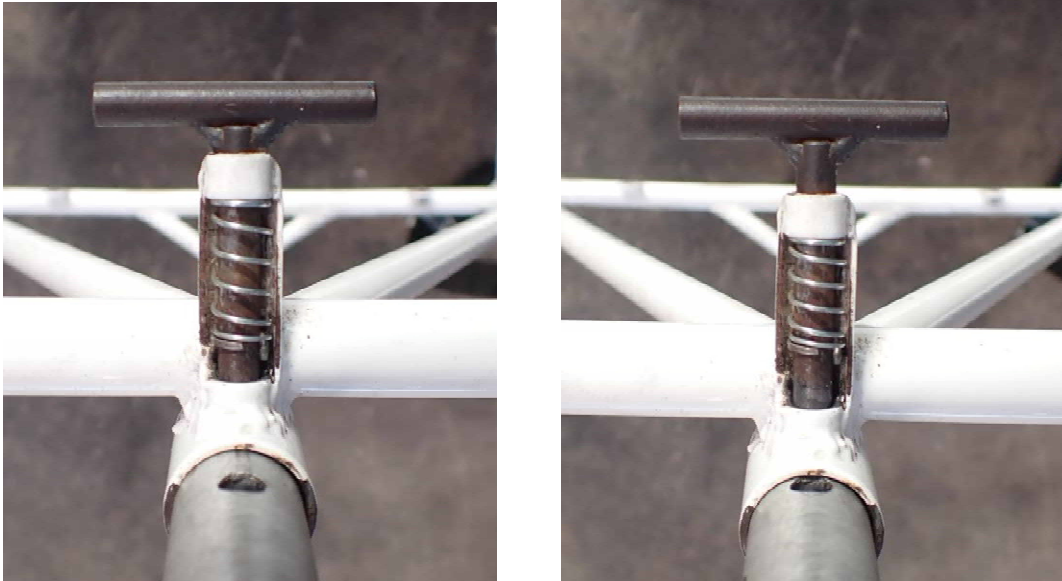
Figure 5

Seat adjustment pin correctly located in one of the holes in the adjustment rail (left) and incorrectly located sitting on top of the adjustment rail (right).
Note: seat cushion removed for clarity

Post-accident examination of the pilot's seat assembly showed that the seat pin was not correctly located in a hole in the adjustment rail. The damage and distortion to the adjustment rail was consistent with the seat being towards the rearmost extent of its travel when the aircraft struck the ground. Marks on the damaged adjustment rail showed that the seat adjustment pin and holes were slightly misaligned, with their centrelines offset (Figure 6), making it difficult for the pin to locate correctly.

The evidence indicates that the seat adjustment pin was not correctly located in one of the holes in the adjustment rail and therefore the seat was not locked in the fully forward position required by the pilot. Additionally, the seat adjuster backup strap, intended to prevent rearwards seat movement in case of pin failure, appears not to have been tightened.

Safety Recommendation 2021-049

It is recommended that the Light Aircraft Association remind owners of this aircraft type of the necessity, after every seat position adjustment, to:

Safety Recommendation 2021-050

It is recommended that the British Microlight Aircraft Association remind owners of this aircraft type of the necessity, after every seat position adjustment, to:

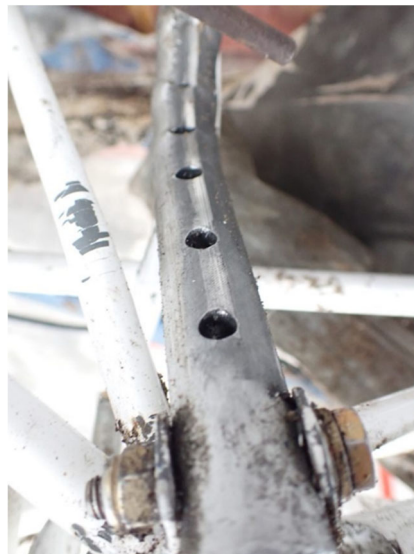
Figure 6

Marks created on the pilot's seat adjustment rail by the pin

The evidence indicates that the seat moved rearwards leading to the pilot losing control of the aircraft. The damage and distortion to the adjustment rail was consistent with the seat being towards the rearmost extent of its travel when the aircraft struck the ground.

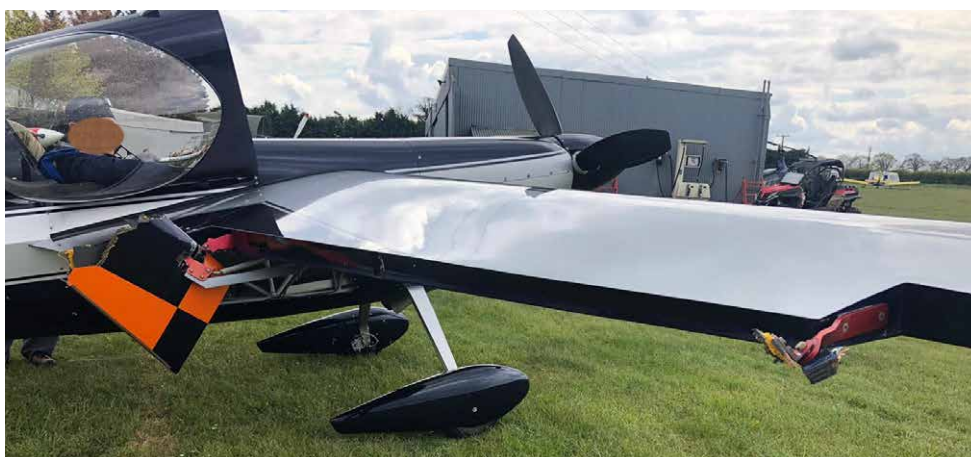
Figure 1

G-EDGY after landing, showing inboard hinge with section of aileron still attached and the distorted outboard hinge

aileron, had been bent upwards. The aileron had separated from the outboard hinge, but a small section of aileron remained attached to the inboard hinge along with the 'spade' (Figure 1). This part appeared to have been flailing in the slipstream and had caused some damage to the wing skin.

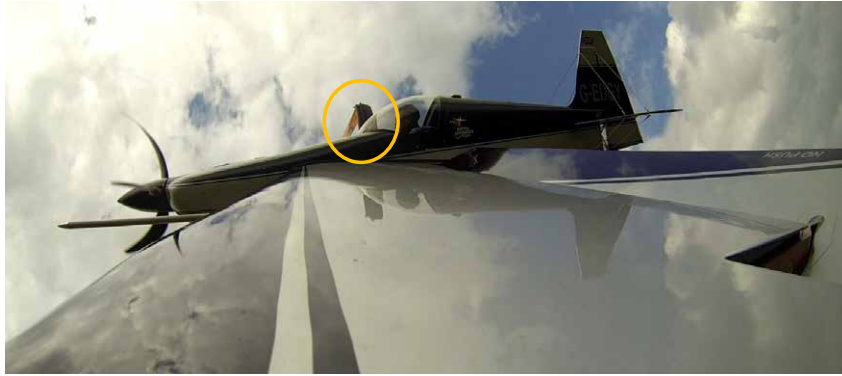
Figure 2

Aircraft entering the left roll showing the right aileron failing upwards (circled)

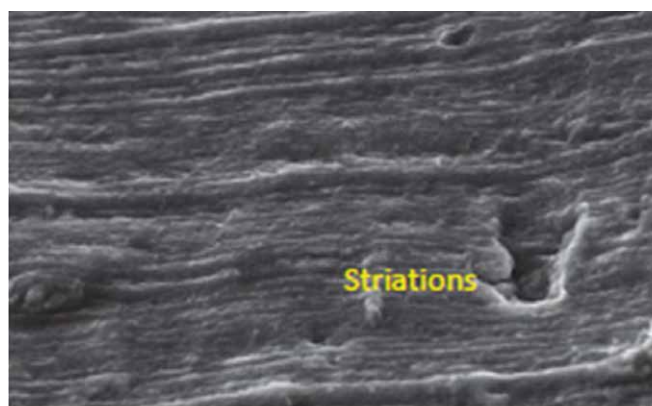
Figure 10

- Striation counting of the failure surfaces suggested that the estimated number of load cycles to failure was approximately 14,000 cycles (Figure 10).

From the striation marks, the metallurgy laboratory estimated that the hinge had been subjected to approximately 14,000 load cycles prior to failure. This is of the same order of magnitude as the owner's estimate of the number of full control deflections to roll quickly left which was 23,000.

High magnification, scanning electron microscope image of fatigue striations on a fracture surface of the failed right hinge (each striation is the result of a load cycle)

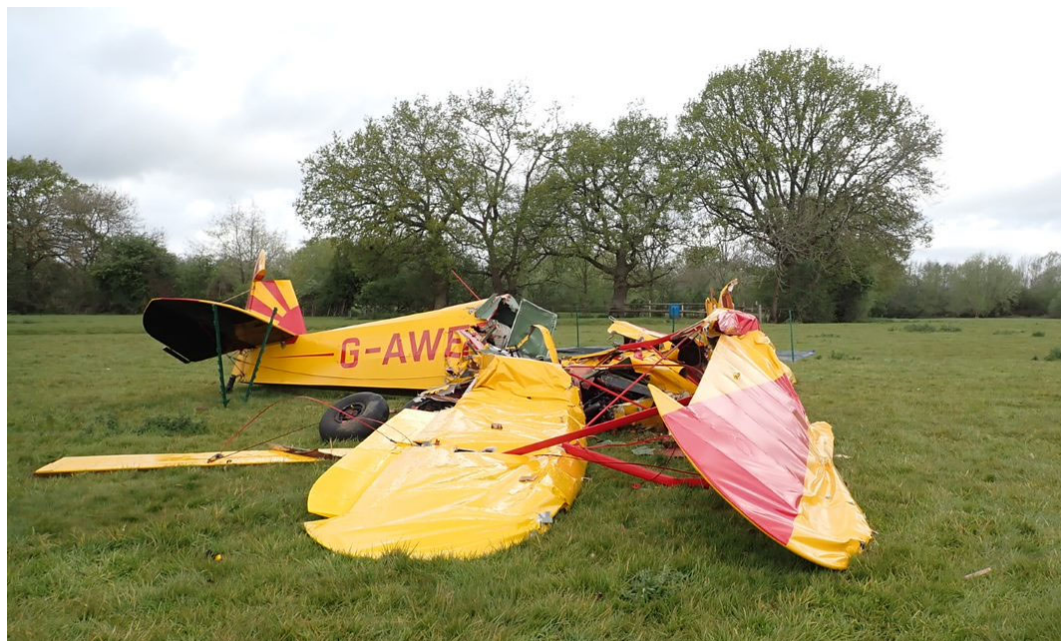
Figure 5

The aircraft hit the ground in a large open agricultural field and came to rest upright on a north-easterly heading. Initial examination of the wreckage indicated the aircraft was complete with no vital parts or control surfaces missing. The tail section, from the rear cockpit seat frame aft, was undamaged other than some distortion and splitting of the left tailplane tip structure. Both cockpit areas and the engine bay were extensively fragmented (Figure 5). The upper and lower wing leading edges had been compressed and distorted along the full length of both wings. The upper wing bracing struts and rods had been cut by the first responders and the wing had been moved forward to gain access to the pilot. After the aircraft was removed from the accident site, two distinct parallel marks had been left on the ground by the mainplane leading edges (Figure 6). Comparison of these ground marks with the aircraft's original structural dimensions suggest that the aircraft hit the ground with a 65° nose-down attitude.

Accident site showing tail and mainplane positions

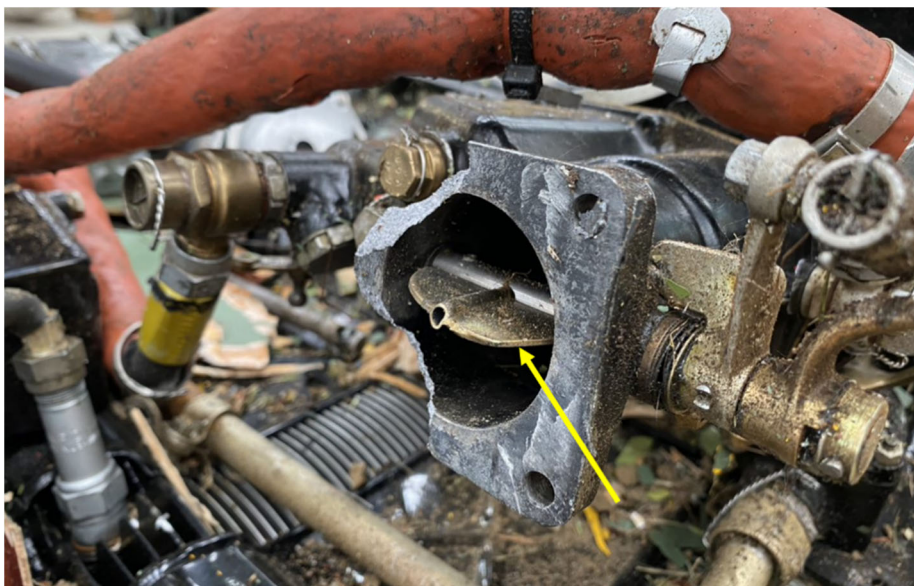
Figure 8

Examination of the carburettor indicated that it had detached from the intake manifold and had been pushed forward with considerable force. Two of the four mounting bolts had sheared and the rearmost section of the mounting flange, where the rear bolts were fitted, had broken away. The flange face had evidence of smearing showing how the carburettor had detached. The throttle butterfly valve was damaged by the lip of the carburettor attachment flange as it was pushed forwards (Figure 8).

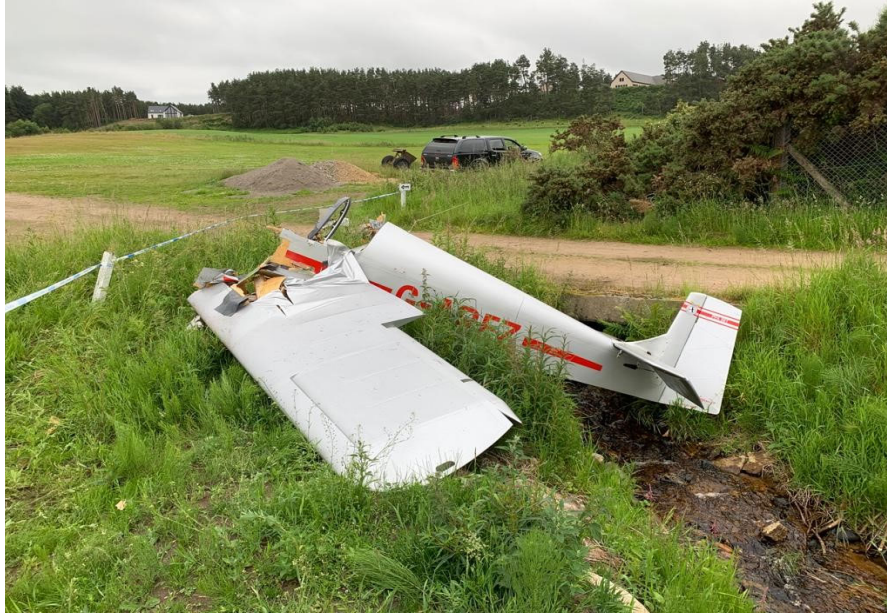
During the accident sequence the forward fuselage separated from the rest of the airframe just forward of the cockpit. There was extensive damage (Figure 3).

Figure 3
Aircraft at accident site

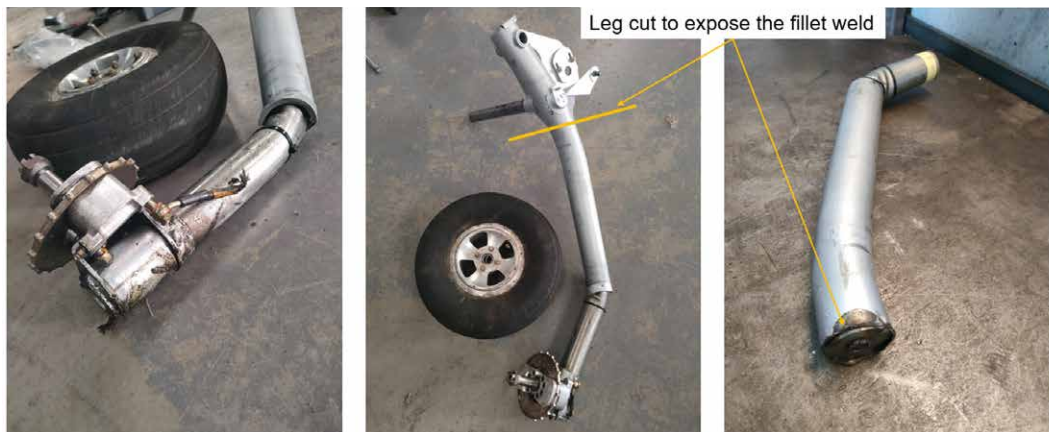
Figure 3

The left main gear leg removed and cut
