**ACCIDENT**

<b>Aircraft Type and Registration:</b>	Silent 2 Electro, G-CIRK	
<b>No &amp; Type of Engines:</b>	1 FES electric motor	
<b>Year of Manufacture:</b>	2013 (Serial no: 2054)	
<b>Date &amp; Time (UTC):</b>	23 April 2021 at 1305 hrs	
<b>Location:</b>	Wormingford Airfield, Colchester, Essex	
<b>Type of Flight:</b>	Private	
<b>Persons on Board:</b>	Crew - 1	Passengers - None
<b>Injuries:</b>	Crew - 1 (Serious)	Passengers - N/A
<b>Nature of Damage:</b>	Aircraft destroyed	
<b>Commander's Licence:</b>	Light Aircraft Pilot's Licence (Sailplanes)	
<b>Commander's Age:</b>	71 years	
<b>Commander's Flying Experience:</b>	295 hours (of which 55 were on type) Last 90 days - 13 hours Last 28 days - 13 hours	
<b>Information Source:</b>	AAIB Field Investigation

**Synopsis**

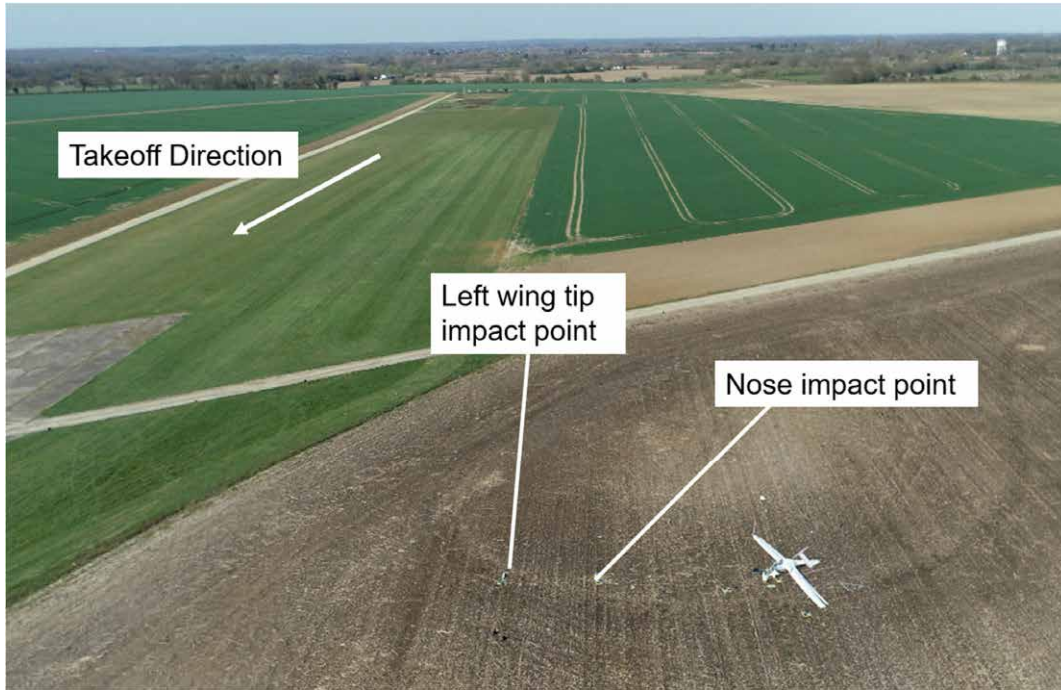
**Figure 1**  
Accident site

The accident site revealed that the aircraft had struck the ground in a steep nose-down attitude, after which the aircraft had yawed to the left and ended up pointing in the opposite direction of its final travel before coming to rest (Figure 1). The aircraft was about 230 m north-east of where it lifted off from the runway. The front of the cockpit was destroyed (Figure 2), the left wing had suffered significant damage and the tail had snapped in half. Both propeller blades had detached at their root and were close to the wreckage.

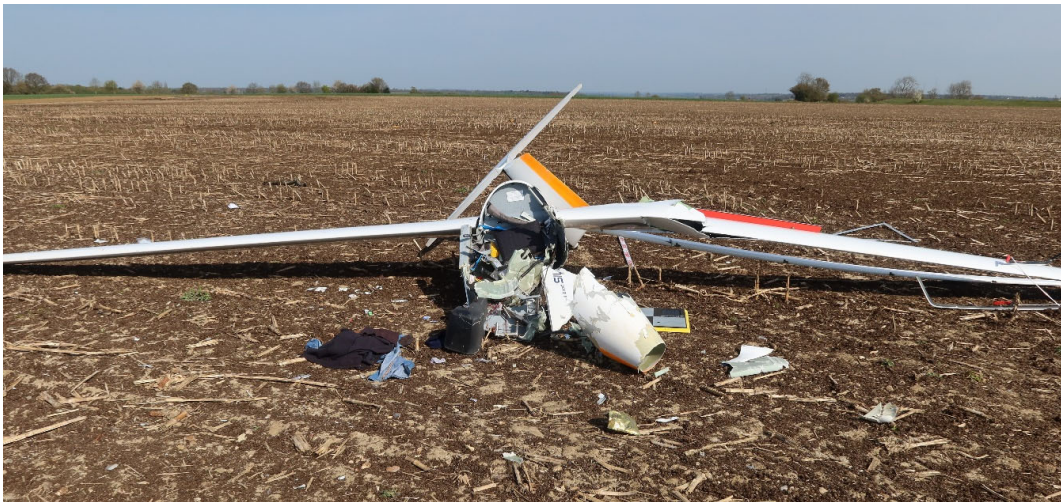
**Figure 2**  
Damage to the aircraft

The aircraft wreckage was recovered to the AAIB facility near Farnborough for a detailed examination. All the damage to the flying controls was consistent with impact damage. The tailplane actuation system operated normally but the broken tail boom had resulted in the actuating cable going slack, so it was not possible to determine the tailplane angle at impact. It was also not possible to determine the flap angle at impact due to damage to the flap control system. No mechanical fault was found that would cause an un-commanded pitch-up. There were no blockages in the pitot tube. The landing gear was in the DOWN position and the BPRS had not been operated. 4.5 kg of nose ballast was fitted.

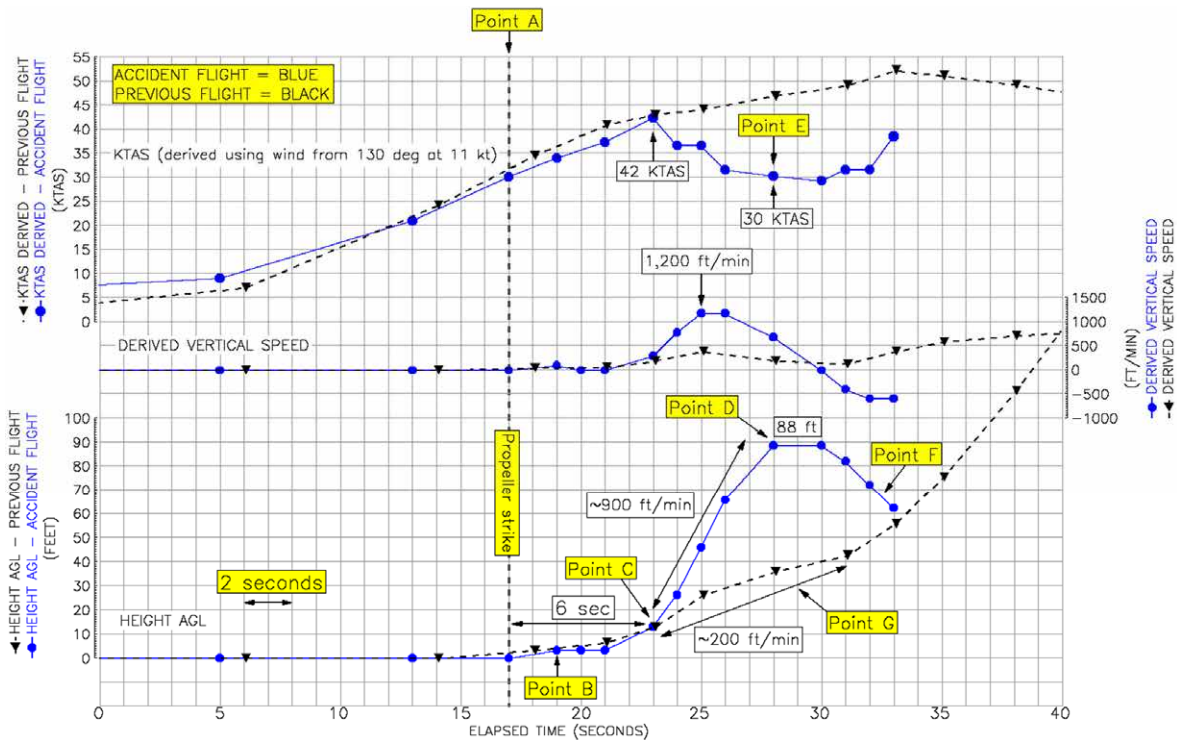
**Figure 3**

Comparison of the accident takeoff and the previous self-launch takeoff showed that the aircraft's acceleration during the takeoff roll, and its airspeed during the first few seconds of the climb, were similar. However, the climb profiles then diverged. During the previous takeoff, the initial rate of climb was maintained at about 200 ft/min (Figure 3 Point G) until the glider's airspeed had reached 50 KTAS, after which, the climb rate increased to about 430 ft/min.

GPS derived data for accident and previous self-launch takeoff

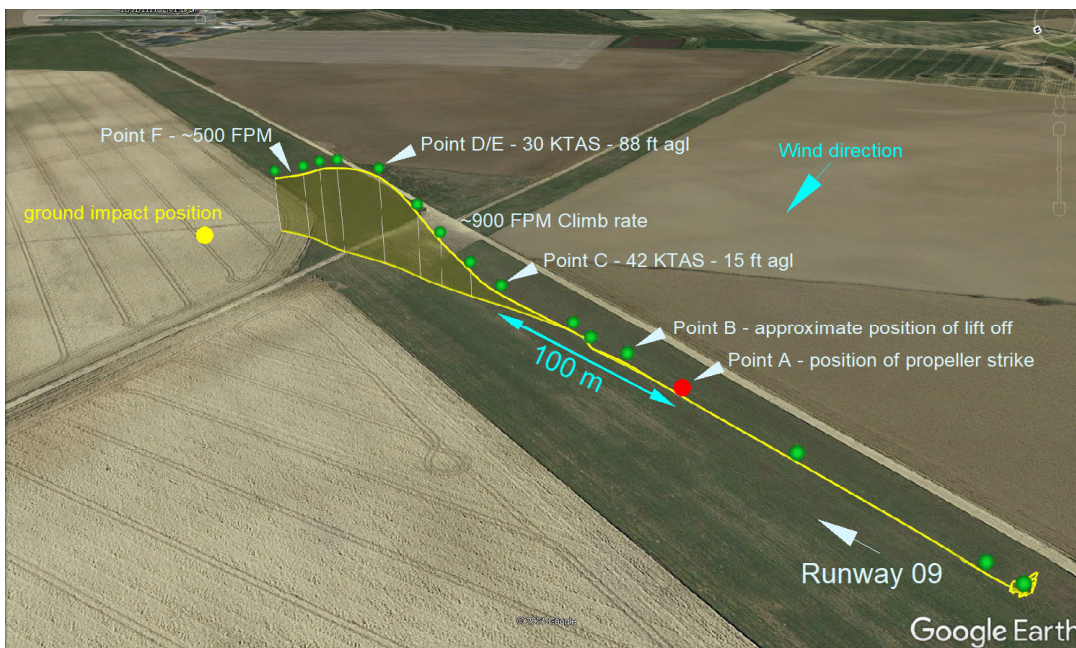
**Figure 4**  
GPS derived data for accident takeoff

A series of 11 propeller slash marks were found on the runway surface near the liftoff point (Figure 4) with an initial spacing of about 10 cm.

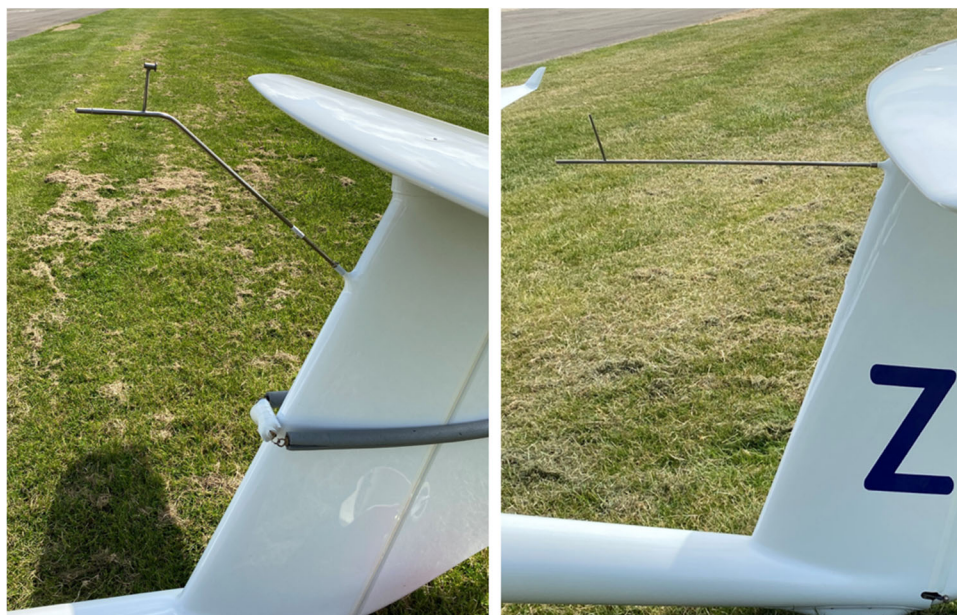
**Figure 8**

A pitot tube is used for measuring airspeed and G-CIRK was fitted with an angled version attached to the leading edge of the vertical tail (Figure 8, left). This same type of pitot tube was fitted to the Silent 2 Electro that was used for a flight evaluation as discussed later in the report. Later model Silent 2 Electro's have a straight pitot tube (Figure 8, right). It was reportedly changed to reduce aerodynamic drag.

The flight evaluation revealed that the ASI can overread during power-on stalls. This is probably caused by the propeller slipstream hitting the pitot tube on the vertical tail. If the ASI had overread during the takeoff climb this might have caused the pilot to increase the pitch attitude to reduce the speed back to his target. However, the ASI was only seen to overread close to stall, so if it was a factor in the accident, it would probably have occurred late when the pilot had already reached an excessively high pitch attitude for a different reason.

The flight evaluation revealed that during power-on stalls the propeller slipstream impinged on the pitot tube and caused erroneous overreadings on the ASI. The aircraft manufacturer was not aware of this issue and stated that they would investigate it if they resumed production. They believed that the pitot tube had been changed by the original aircraft manufacturer from an angled pitot tube to a straight pitot tube to reduce aerodynamic drag, but it is possible the change was also to address ASI overreadings.

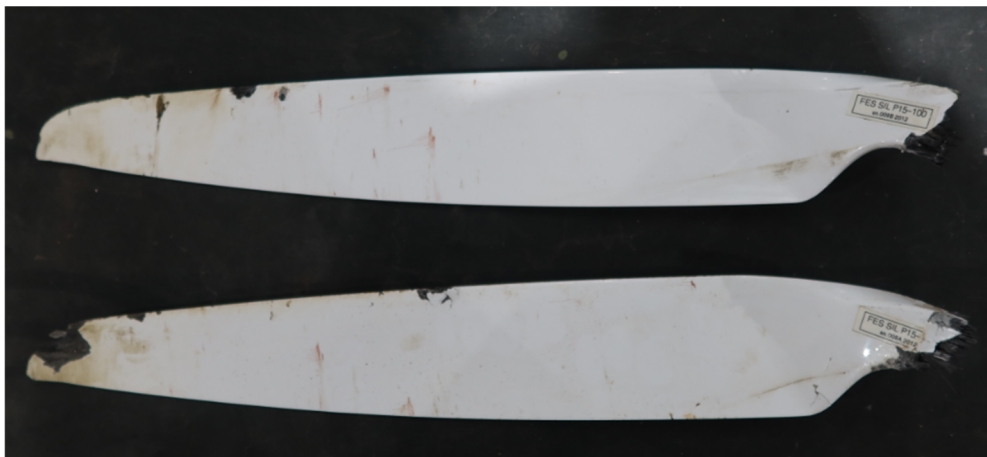
**Figure 9**  
Propeller blade damage

The electric motor was too severely damaged to test, but the separated propeller blades indicated that the motor was rotating at impact. As well as the root damage, the propeller blades had leading edge nicks and one blade had tip damage (Figure 9).

No mechanical fault or defect was found that would explain the aircraft pitching up excessively after takeoff. The 100 ft climb after takeoff indicates that power was applied and that the propeller had only suffered minor damage during the propeller strike. Although the batteries were not fully charged, the recorded data did not reveal a significant difference in the initial acceleration profile compared to the previous takeoff, so this did not appear to have been a factor in the accident.

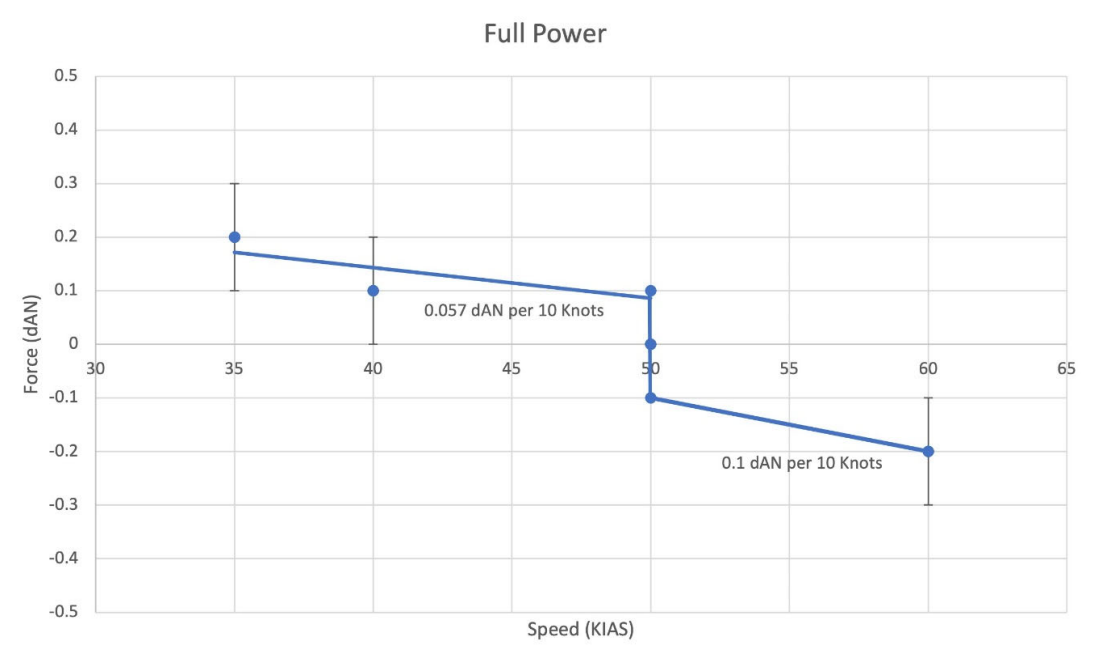
**Figure 13**

The test pilot reported that the flat stick force gradient and high break-out friction has two effects: it means that the pilot receives minimal feedback through the stick about how the aircraft is manoeuvring or its attitude, and it is difficult for the pilot to feel where the stick needs to be positioned to adopt a specific aircraft attitude or fly the aircraft smoothly and predictably.

The glider had weak positive longitudinal static stability at a CG that was 40 mm forward of the aft CG limit, so the stability would have been even less at the aft limit.

Stick force versus airspeed measurements

Regardless of the reason for the excessive aft stick input, the aircraft's very light longitudinal stick forces make an excessive aft input more likely. The flight evaluation revealed that a force of 0.3 dAN, relative to a break-out force of 0.1 dAN, was sufficient to cause an excessively high pitch attitude that would lead to a stall from an entry speed of 41 to 44 KIAS. 0.3 dAN is a pull force that can be generated with a 300 g weight. The stick force gradient is also very flat at 0.1 dAN per 10 kt nose-down and 0.06 dAN per 10 kt nose-up

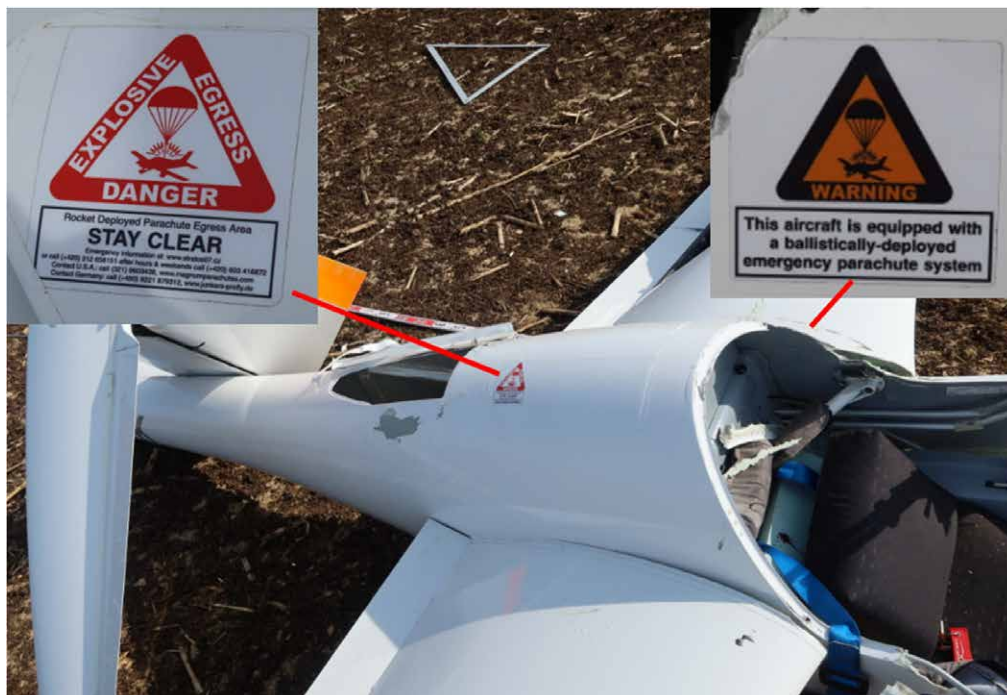
**Figure 14**  
BPRS placards on G-CIRK

The damage to the cockpit of G-CIRK had exposed the activation cable, and the pin was not inserted, so the rocket presented a hazard to the emergency services attending the

Two placards were affixed to the fuselage aft of the cockpit to warn people about the hazards from the rocket and parachute (Figure 14). These placards conformed to the requirements in ASTM F2316-12<sup>28</sup>. They did not conform to the placard requirements in BCAR Section S<sup>29</sup>, sub-section K on 'Microlight Parachute Recovery Systems', which require the 'DANGER' placard to be larger than that specified in ASTM F2316-12<sup>30</sup>, and which also require a double offset black and yellow chequered line to surround the parachute and rocket exit area (Figure 15). As an SSDR the Silent 2 Electro is not required to meet BCAR Section S; however, the CAA published Skywise article SW2021/91<sup>31</sup> on 29 April 2021 which stated that: 'The CAA strongly recommends that owners of SSDRs fitted with a BPRS comply with the requirements of BCAR Section S, Sub-Section K, to clearly identify the presence of the BPRS to emergency services and first responders in the event of an accident.'

The CAA are planning to contact the registered owners of SSSR aircraft, which are fitted with a BPRS device, to inform them about Sky Wise article SW2021/91 which strongly recommends that owners of these aircraft comply with the requirements of BCAR Section S, Sub-Section K, to clearly identify the presence of the BPRS.

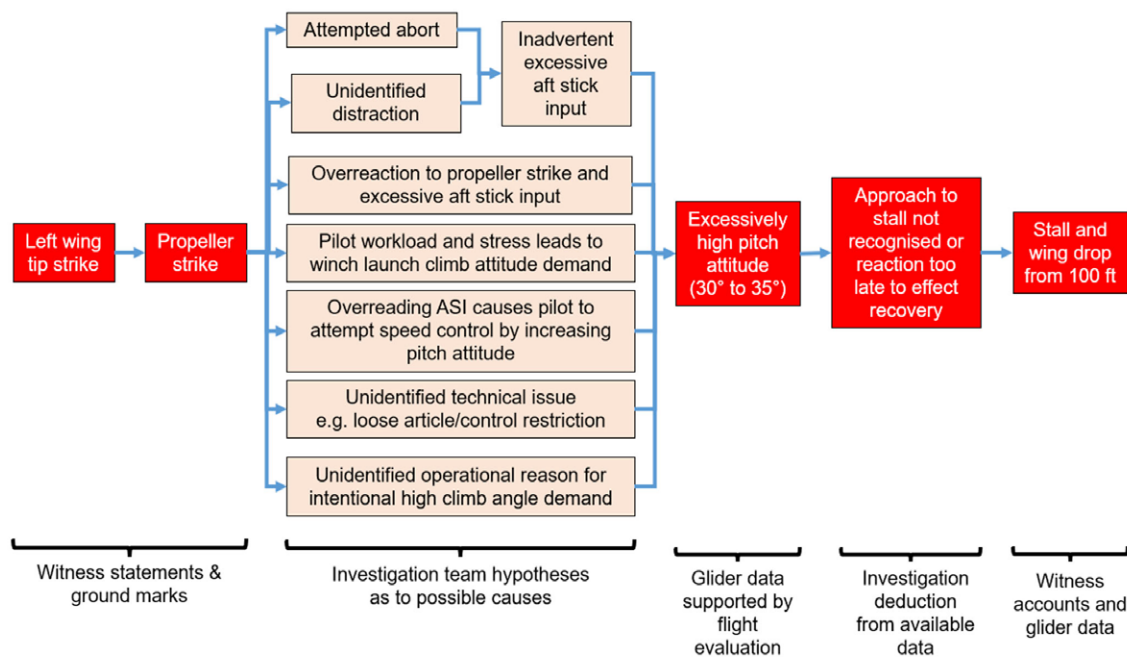
**Figure 16**

While the investigation could not determine the reason for the steep climb it considered that it most likely resulted from a single or combination of factors outlined in Figure 16 and explained below.

Sequence of events: actual (in red boxes) and possible (in pink boxes)
