**SERIOUS INCIDENT**

<b>Aircraft Type and Registration:</b>	Airbus A319-111, G-EZAJ	
<b>No &amp; Type of Engines:</b>	2 CFM CFM56-5B5/P turbofan engines	
<b>Year of Manufacture:</b>	2006 (Serial no: 2742)	
<b>Date &amp; Time (UTC):</b>	26 May 2021 at 0840 hrs	
<b>Location:</b>	Lasham Airfield, Hampshire	
<b>Type of Flight:</b>	Other	
<b>Persons on Board:</b>	Crew - 2	Passengers - None
<b>Injuries:</b>	Crew - None	Passengers - N/A
<b>Nature of Damage:</b>	None	
<b>Commander's Licence:</b>	Airline Transport Pilot's Licence	
<b>Commander's Age:</b>	35 years	
<b>Commander's Flying Experience:</b>	over 5,000 hours (of which 5,000 were on type) Last 90 days - 129 hours Last 28 days - 44 hours	
<b>Information Source:</b>	Aircraft Accident Report Form submitted by the pilot and MOR submitted by the aerodrome

**Synopsis**

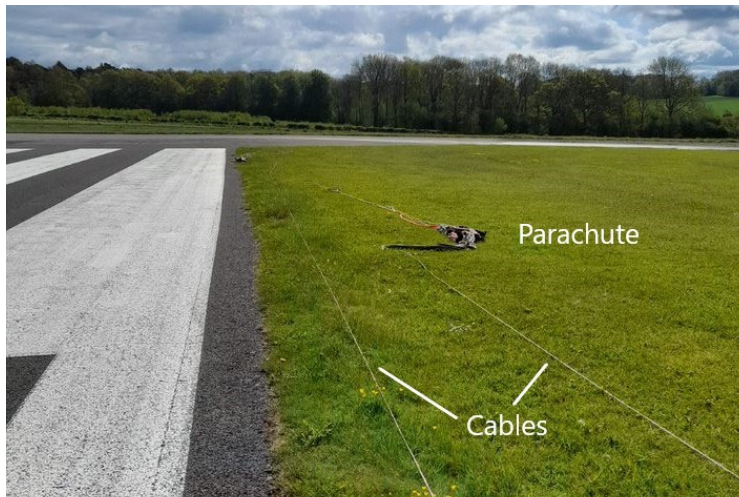
**Figure 1**

The cables were subject to a maintenance procedure known as a cable reversal, whereby the cables are reeled out to their full extent, the end of the cable attached to the winch is cut and the winch is then reattached with a splice to the opposite end of the cable. The procedure requires use of the longest part of the airfield, which is adjacent to Runway 09/27, and typically takes 10 minutes; however, it is recognised that the re-splicing of the cable back on to the winch should not be rushed due to its safety-critical nature (Figure1).

Winch cables with parachutes laid on grass along southern edge of Runway 27 abeam the landing threshold

The location of the winch cables along the southern edge of the runway posed a potential hazard to the landing aircraft because the parachute at the end of the cables lying abeam the landing threshold might become inflated by the jet wash of the landing aircraft. This risk was only likely to manifest itself if the landing aircraft had landed close to the threshold rather than in the touchdown zone. However, the commander commented that he considered this unlikely owing to the treeline in the undershoot, which deters landings in that location. In addition, the portable PAPIs would have provided appropriate glidepath guidance to the crew.

The Airbus A319 landed while winch-launch cables were present on the grass abeam the southern edge of the runway. This resulted from a lack of coordination between users of the airfield and insufficient guidance on what constituted a secure runway strip.

- Individuals are required to contact the DI for a brief on relevant airfield information and any aircraft movements if there is a need to enter the operational area prior to the daily briefing.
- Planned winch maintenance will be notified the day before it is due to take place.
- Any winch maintenance should be conducted as far away from the main runway as the circumstances allow.

- issued an information bulletin to provide guidance on the importance of securing the runway during heavy aircraft movements and what constitutes a secure runway strip. This will be incorporated into the AFS manual which is currently undergoing revision.
- briefed Fire Crew Commanders on the event and on the guidance about runway strips, the procedures to be used, and how to determine that a runway strip is secure. This will be incorporated into future Fire Crew Commander training.
- briefed all members of the AGCS on the incident and how the handover from FRC before the runway was available contributed to the incident.
