ACCIDENT

| Aircraft Type and Registration: | Cessna 402C, Businessliner, VQ-TIN | |
| Date & Time (UTC): | 17 July 2021 at 1923 hrs | |
| Location: | Ambergris Cay International Airport, Turks and Caicos Islands | |

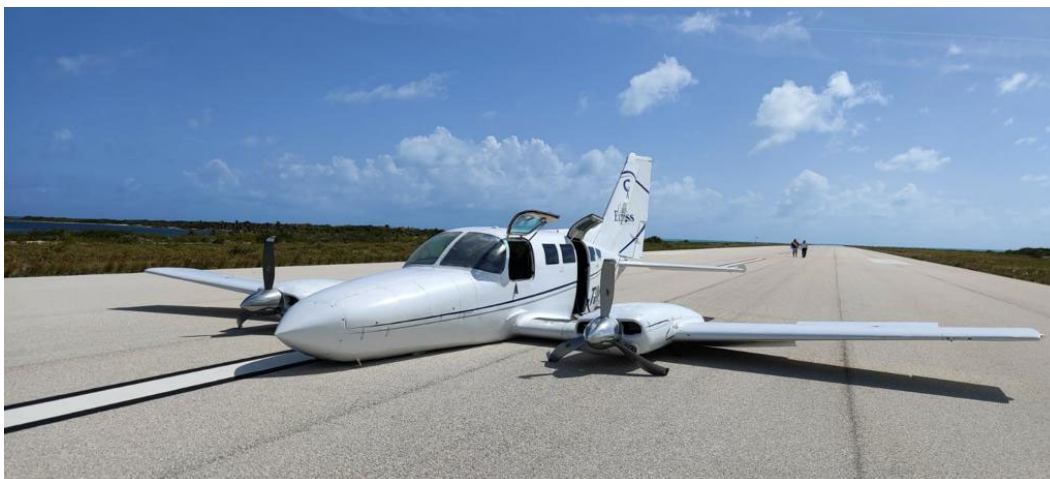
The aircraft sustained extensive damage to its flaps, propellers and underside, and both engines were shock-loaded.

Figure 1
VQ-TIN after landing

Given the physical evidence discovered by the maintenance organisation and the statements of a passenger it was concluded that the landing gear was not extended prior to the landing.
