## ACCIDENT

<b>Aircraft Type and Registration:</b>	DH82A Tiger Moth, G-ANMO	
<b>No &amp; Type of Engines:</b>	1 De Havilland Gipsy Major 1C piston engine	
<b>Year of Manufacture:</b>	1935 (Serial no: 3255)	
<b>Date &amp; Time (UTC):</b>	26 August 2021 at 0940 hrs	
<b>Location:</b>	Headcorn Aerodrome, Kent	
<b>Type of Flight:</b>	Training	
<b>Persons on Board:</b>	Crew - 2	Passengers - None
<b>Injuries:</b>	Crew - 2 (Minor)	Passengers - N/A
<b>Nature of Damage:</b>	Damage to landing gear, propeller, wings and fuselage	
<b>Commander's Licence:</b>	Private Pilot's Licence	
<b>Commander's Age:</b>	73 years	
<b>Commander's Flying Experience:</b>	21,154 hours (of which 770 were on type) Last 90 days - 29 hours Last 28 days - 5 hours	
<b>Information Source:</b>	Aircraft Accident Report Form submitted by the pilot and subsequent AAIB enquiries

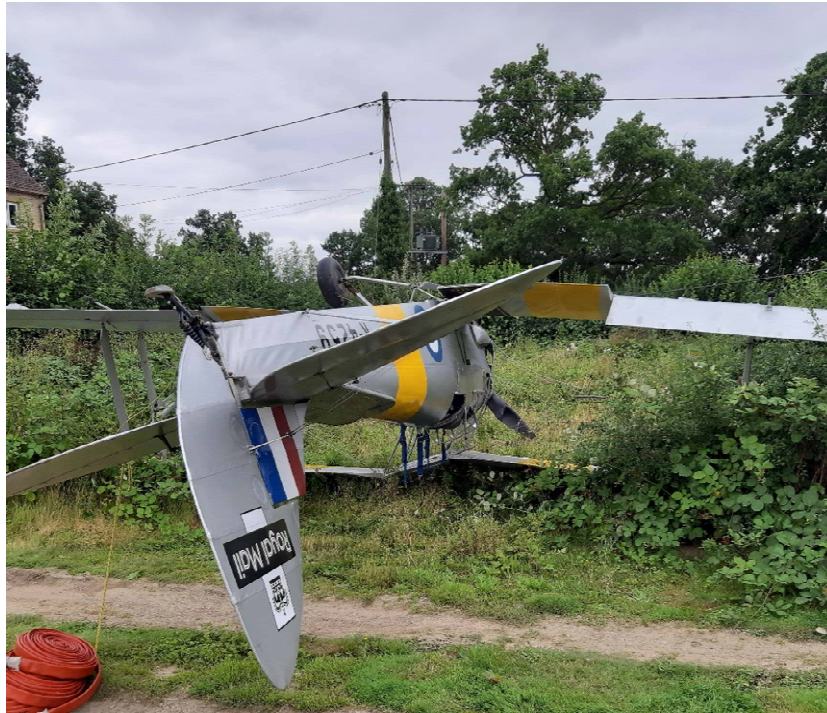
**Figure 2**

For the second approach the instructor again told the PF they were too high so the PF sideslipped the aircraft slightly to the right to lose some height. The PF, feeling the aircraft was getting low checked the altitude on his instruments, and noted they were descending through 300 ft aal at 50 kt. He then turned his attention to the touchdown point. By the time the aircraft neared the trees, the airspeed had decayed to near stalling speed. The PF felt the aircraft sinking and applied full power. In the meantime, the instructor hadn’t noticed that the aircraft was again low but also slow over the trees. The aircraft then started to buffet, which is an indication of an approaching stall, so the instructor took control just as the left wingtip hit a tree and the tailskid caught the power line. The aircraft pitched down and hit the ground, with very little forward speed, on the undercarriage and the nose, and finally onto its back (Figure 2).

The aircraft with the trees and power line on the approach to Runway 03

Both pilots failed to notice that they were too slow on the approach until the aircraft started to stall. By the time the aircraft was nearing the trees, the PF was focussed on looking out of the aircraft at the landing point, and no longer monitoring the airspeed on his cockpit ASI. He was, therefore, reliant on the instructor to say if the speed and position of the aircraft was wrong for the approach. The instructor was unaware of the reliance placed on him and given that his view of the approach and the strut-mounted ASI was compromised by his seating position, and with no serviceable altimeter or ASI in his cockpit, he was unable to monitor the progress of the approach and give effective instruction. The instrument unserviceabilities and compromised view would have been evident before the flight commenced and so this was an opportunity for the intended flight to have been rescheduled.
