ACCIDENT

Aircraft Type and Registration:	Eurofox 912(S), G-CGYG
No & Type of Engines:	1 Rotax 912 ULS piston engine
Year of Manufacture:	2011 (Serial no: LAA 376-15081)
Date & Time (UTC):	29 May 2021 at 1040 hrs
Location:	Highland Gliding Club, Easterton Airfield, Elgin
Type of Flight:	Private
Persons on Board:	Crew - 1 Passengers - None
Injuries:	Crew - 1 (Minor) Passengers - N/A
Nature of Damage:	Nose leg broken and damage to engine cowling, wing struts and airframe
Commander's Licence:	Commercial Pilot's Licence
Commander's Age:	31 years
Commander's Flying Experience:	499 hours (of which 132 were on type) Last 90 days - 22 hours Last 28 days - 6 hours
Information Source:	Aircraft Accident Report Form submitted by the pilot and further enquiries by the AAIB

Synopsis

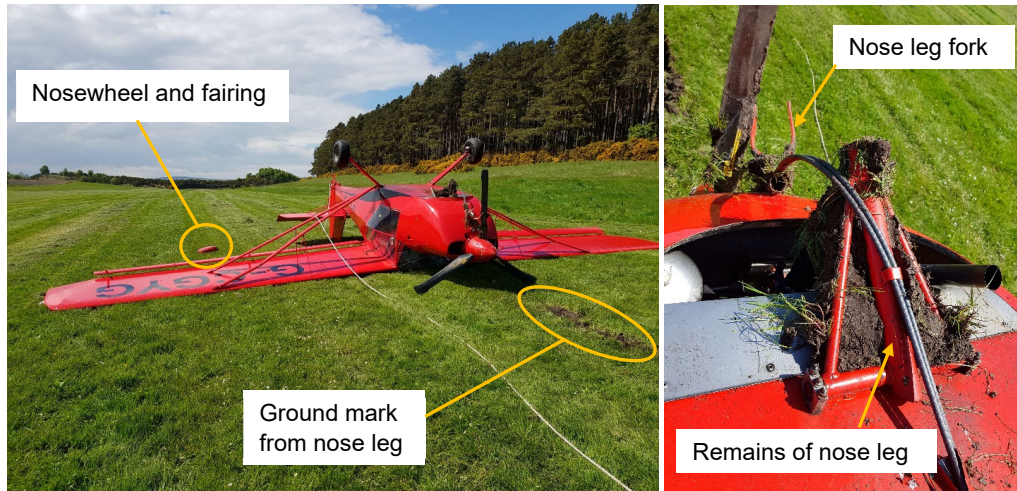
Figure 1

The aircraft was on its third landing following the replacement of the nosewheel tyre. Shortly after touching down the nosewheel and fairing detached from the nose leg fork which then dug into the ground and snapped. The remains of the leg, still attached to the aircraft, also dug into the ground flipping the aircraft onto its roof (Figure 1).

The aircraft pitched over onto its roof and, right, the snapped nose leg

The nose leg was bent downwards from its fitted orientation and had snapped at the point where the shock absorber bracket had been welded to the upper surface of the nose leg. Examination of the leg and the fracture surfaces showed that it failed in overload.

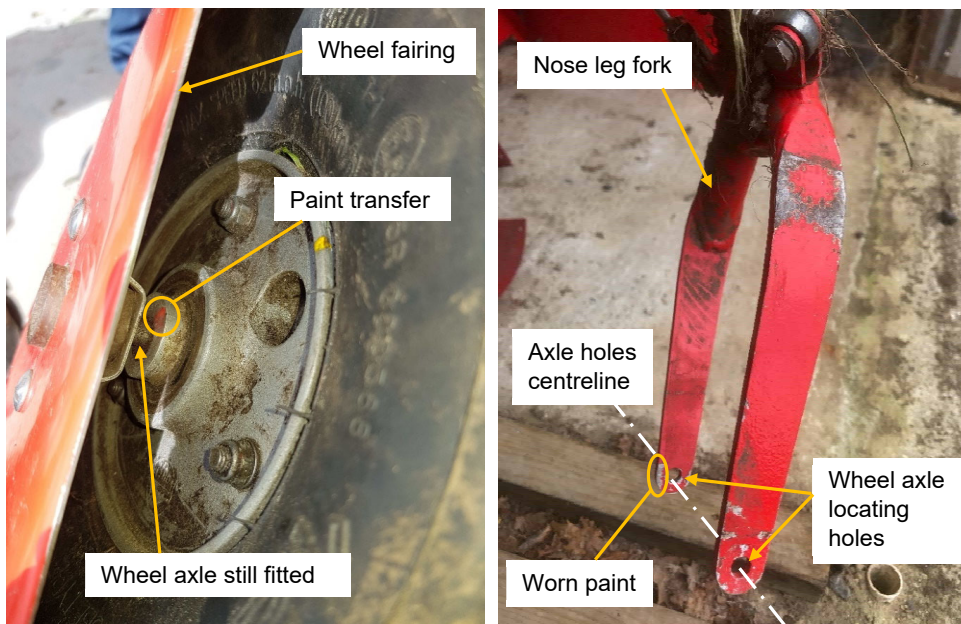
Figure 2

The nosewheel fairing was found a short distance from the aircraft with the nose wheel and axle still fitted. There was evidence of paint transfer between the wheel hub and fairing (Figure 2) and the nose leg fork had paint worn away around the axle holes. Both wheel axle locating holes in the nose leg fork were undamaged.

Nosewheel and fairing showing paint transfer and nose leg fork showing paint wear

Both wheel axle holes in the nose leg fork were still intact after the accident and showed that the axle could not have been routed through the fork. Paint transfer between the nose leg fork and wheel bearing indicated that the nose leg fork might have been clamped to the wheel assembly between the fairing and the wheel bearing.

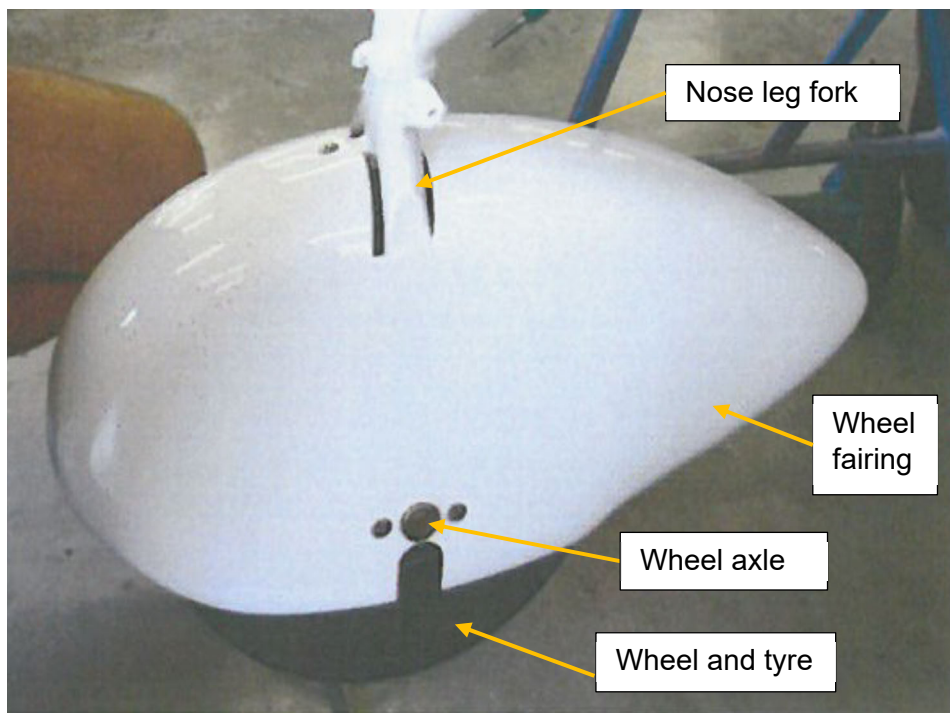
Figure 3

Example of an assembled nosewheel

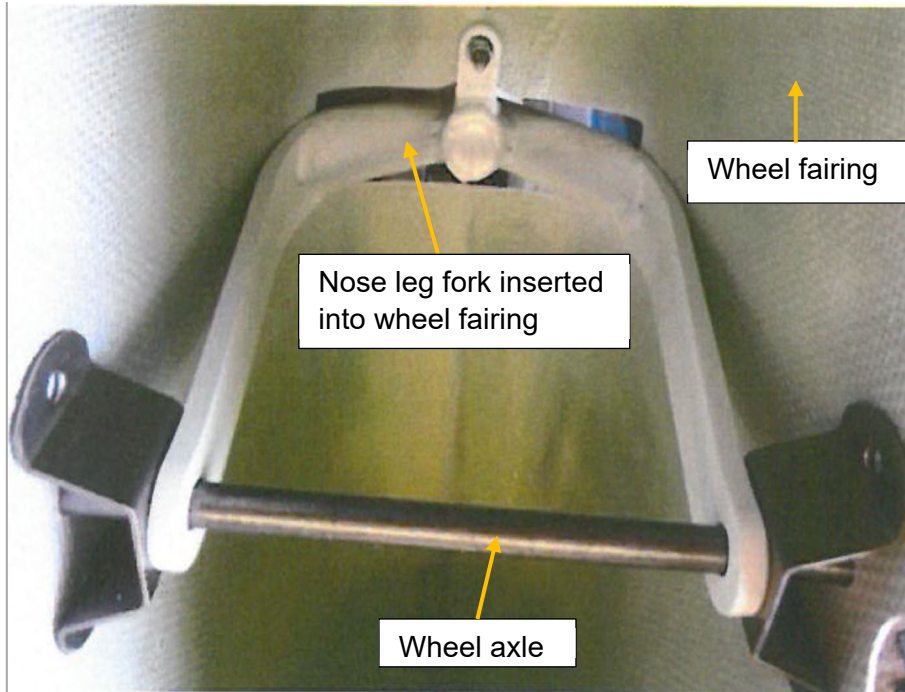
Figure 4

Nose leg fork and axle with the wheel removed

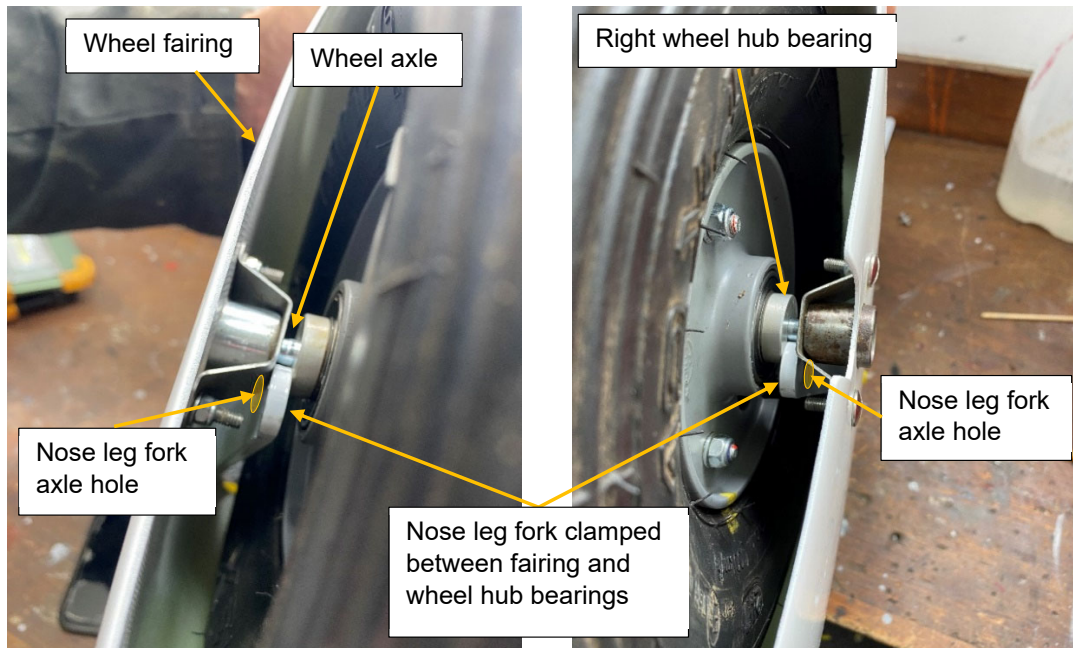
Figure 5 shows the axle not routed through the nose leg fork. Instead, the nose leg fork is clamped between the wheel hub bearings and the fairing.

Nose leg fork clamped between the fairing and left and right hub bearings but with the wheel axle not routed through the nose leg fork axle holes

When clamped in this position, the wheel feels like it is firmly attached to the nose leg when force is applied and the wheel spins freely.

The manufacturer will amend Section 5 of the AMM to include the procedure to refit the nosewheel and to highlight the potential for clamping the wheel onto the nose leg without correctly routing the wheel axle through the nose leg fork.

The LAA has produced an Engineering Matters article in their monthly Light Aviation magazine highlighting the potential to incorrectly fit the Eurofox 912(S) 3K nosewheel.

The LAA has updated the aircraft's Type Acceptance Data Sheet, TADS 376, to include reference to an incorrectly fitted nosewheel in paragraph 3.4 – '*Special Inspection Points.*'
