ACCIDENT

Aircraft Type and Registration:	Piper PA-28-161, G-BRBA	
No & Type of Engines:	1 Lycoming O-320-D3G piston engine	
Year of Manufacture:	1979 (Serial no: 28-7916109)	
Date & Time (UTC):	4 September 2021 at 1110 hrs	
Location:	Wycombe Air Park, Buckinghamshire	
Type of Flight:	Training	
Persons on Board:	Crew - 1	Passengers - 1
Injuries:	Crew - None	Passengers - None
Nature of Damage:	Damage to the right landing gear leg, right lower wing skin and right flap	
Commander's Licence:	Commercial Pilot's Licence	
Commander's Age:	56 years	
Commander's Flying Experience:	1,287 hours (of which 998 were on type) Last 90 days - 7 hours Last 28 days - 3 hours	
Information Source:	Information provided by the pilot and further enquiries made by the AAIB

Synopsis

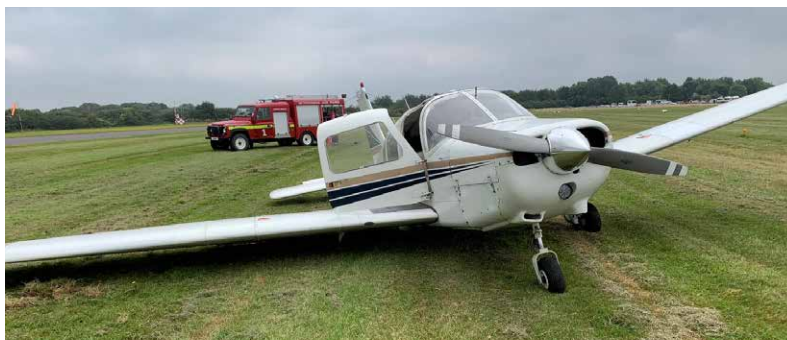
As the aircraft touched down on Runway 06L it was immediately obvious to the instructor that the right landing gear had failed. He described the landing as a “very gentle touchdown”. He applied left aileron and closed the mixture and, as the aircraft slowed and the right wing dropped, it turned though 180° and slid onto the grass (Figure 1). The instructor made the aircraft safe and helped the student exit the aircraft. Neither was injured.

Figure 1
G-BRBA after the accident

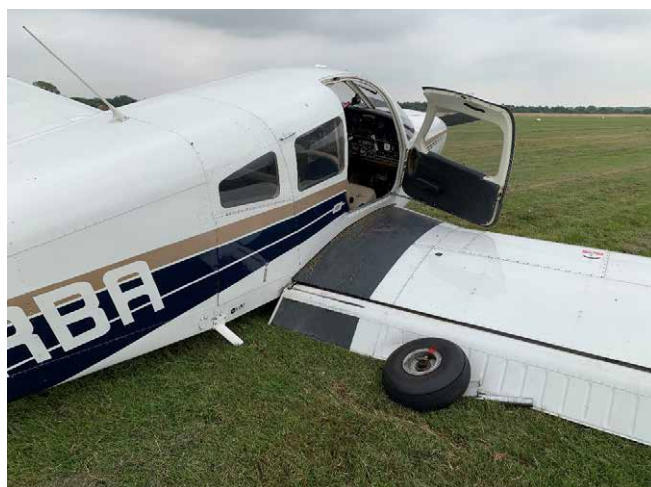
Inspection of the aircraft showed that the lower section of the right landing gear oleo had come out of the upper cylinder. The wheel assembly had remained attached to the aircraft by the flexible brake hose. The assembly had become wedged on the back of the right-wing flap (Figure 2 and 3). Abrasion on the brake calliper showed that as the aircraft landed and the right wing dropped, the aircraft slid on the underside of the wedged wheel assembly. The remaining upper portion of the landing gear oleo was undamaged and did not appear to have contacted the runway.

Figure 2
Right wheel assembly and lower portion of the oleo wedged on the flap

The right flap was damaged where the wheel assembly had become wedged on the flap. There were also puncher marks on the underside of the wing where the loose wheel assembly had been flailing below the wing.

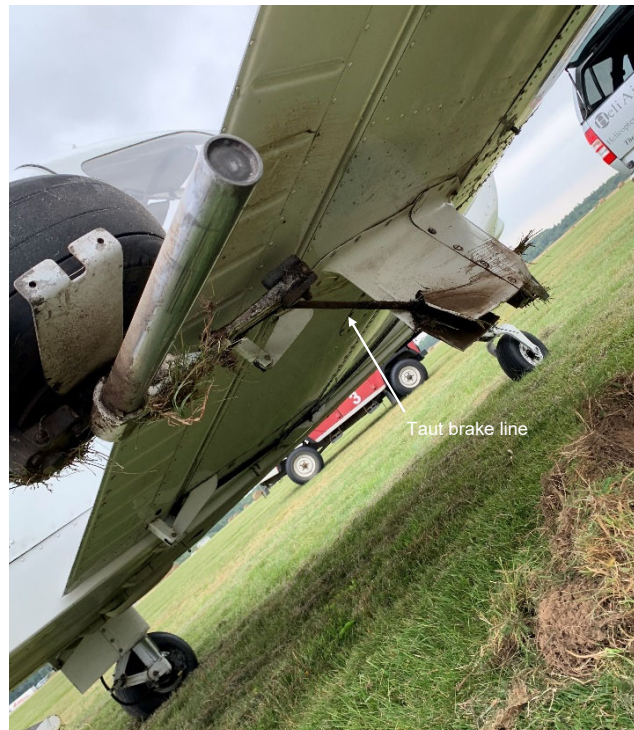
Figure 3

Right wheel assembly viewed when the wing was lifted after the accident, showing the taut brake line

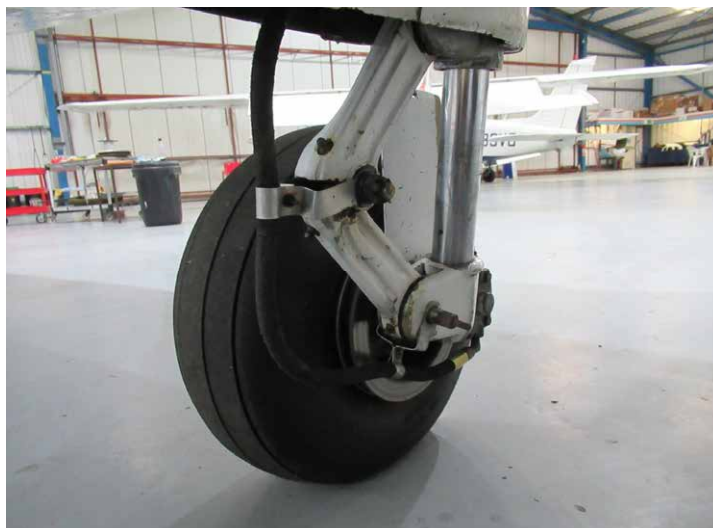
Figure 4

PA-28 left main landing gear

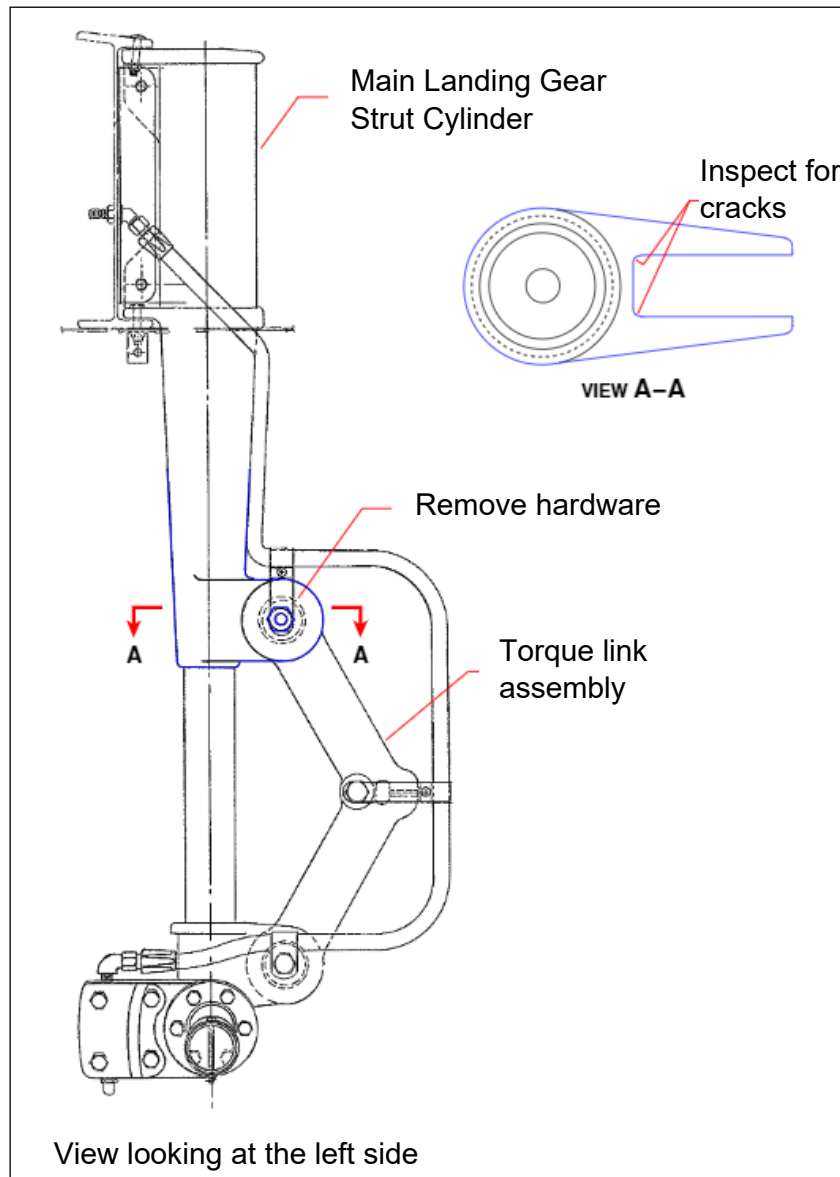
On 18 August 2003 the aircraft manufacturer issued Service Bulletin (SB) 1131 providing instruction for the inspection of the oleo lugs at 100-hour intervals. The inspection required the torque link to be removed and the lugs to be inspected visually using a 10x magnifying glass. If no cracks were found the SB required the area to be inspected using liquid dye penetrant. On 18 August 2016, an updated SB (SB 1131A) was issued which added illustrations and further instructions to clarify the inspection procedure. Figure 5 is extracted from the SB and shows the area which required inspection.

Extract from SB 1131A showing the area requiring inspection

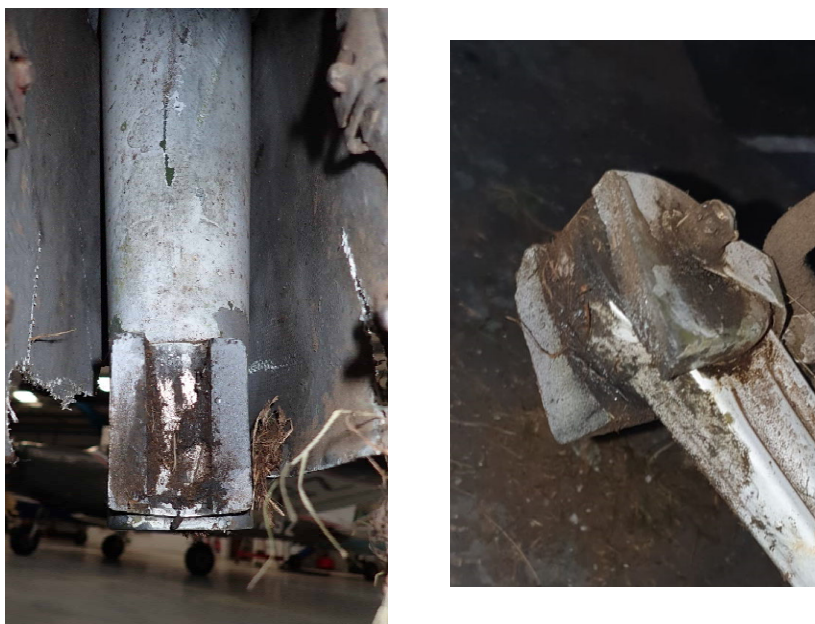
Figure 6

Examination of the landing gear oleo on G-BRBA showed that the torque link upper attachment lugs had broken away from the upper cylinder (Figure 6) disconnecting the torque link.

Right landing gear assembly showed the failed upper torque link attachment lugs

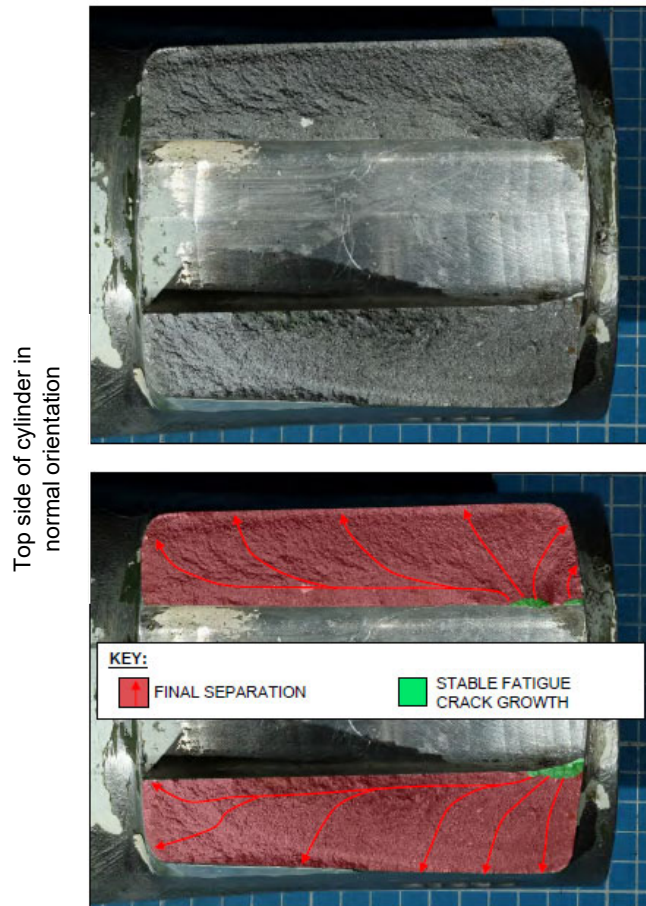
**Figure 7**

The fracture surfaces were examined using a scanning electron microscope. Macroscopic radial markings on the fracture surface indicated that, on each lug, the fracture had initiated at the lower end of the inner radius (Figure 7 and 8). At the locations of fracture initiation, faint crack progression markings indicated the presence of fatigue cracks. The fatigue crack fronts extended inwards from the surface to a maximum depth of 2 mm. The appearance of the remainder of the fracture surface area was consistent with final separation, when the remaining uncracked cross-section became overloaded, due to the advancing fatigue cracks. There was no evidence of pre-existing material or mechanical defects associated with the fatigue crack initiation.

Fracture surface on the landing gear upper cylinder

Analysis of the failed attachment lugs showed that fatigue cracks had formed in the lower inner corner of both lugs and these had grown until they failed in overload. The fatigue crack had grown to a maximum depth of 2 mm prior to the failure. It was not possible to determine how long the fatigue crack had been growing.

This accident shows that fatigue cracking of the torque link attachment lugs continues to occur, and that this can lead to an accident. It highlights the importance that operators of the affected aircraft continue to inspect their aircraft in accordance with the SB. It also suggests that it may be prudent for operators whose aircraft accumulate a significant number of landings to inspect their aircraft more frequently than required by the SB.

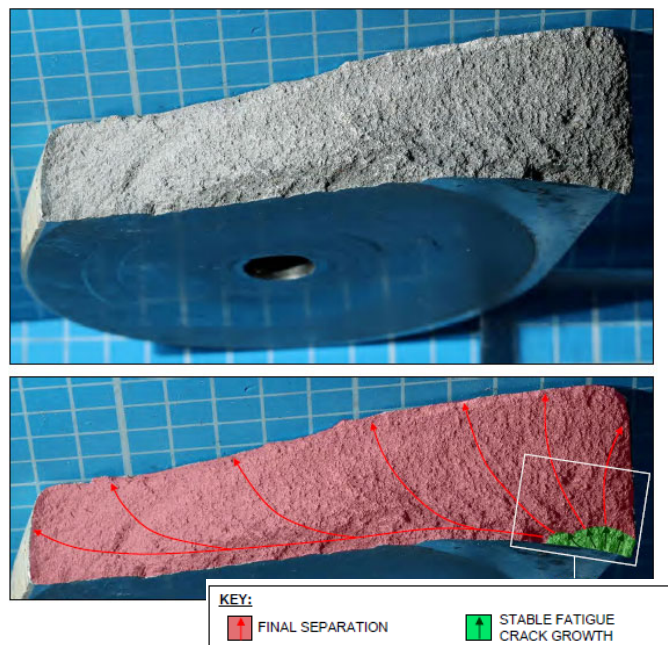
**Figure 8**

View of the left lug (similar cracks were found on the right lug)
