ACCIDENT

Aircraft Type and Registration:	P84 Jet Provost Mk 5, G-VIVM	
No & Type of Engines:	1 Rolls-Royce Viper 20201 turbojet engine	
Year of Manufacture:	1967 (Serial no: PAC/W/23907)	
Date & Time (UTC):	16 June 2021 at 1300 hrs	
Location:	North Weald Airport, Essex	
Type of Flight:	Private	
Persons on Board:	Crew - 1	Passengers - 1
Injuries:	Crew - None	Passengers - None
Nature of Damage:	Damage to aircraft nose structure and main landing gear. Nose landing gear collapsed	
Commander's Licence:	Private Pilot's Licence	
Commander's Age:	69 years	
Commander's Flying Experience:	15,000 hours (of which 350 were on type) Last 90 days - 42 hours Last 28 days - 16 hours	
Information Source:	Aircraft Accident Report Form submitted by the pilot and further AAIB enquiries

Synopsis

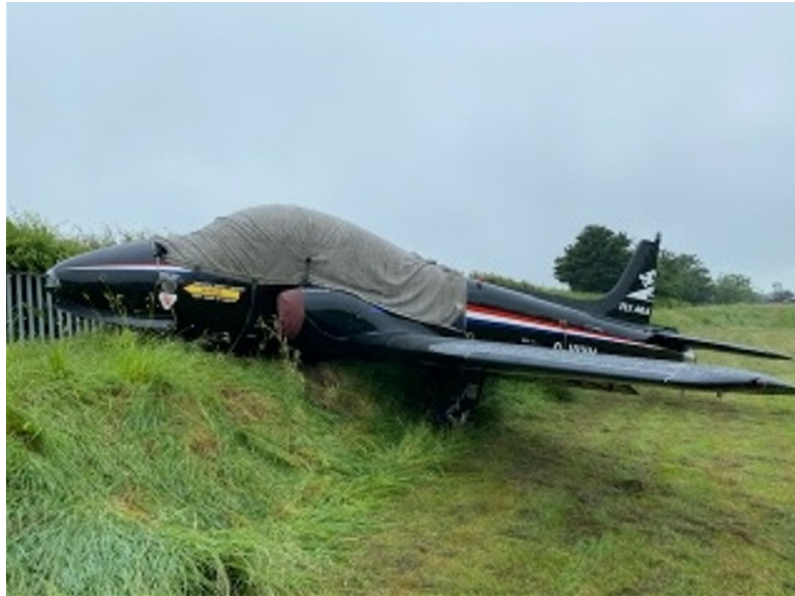
Figure 1
G-VIVM final position

The aircraft departed the end of the runway at a speed of approximately 10 – 15 kt, into a grass area and came to rest after striking a shallow earth bank and the airport perimeter fence (Figure 1). Both occupants were unhurt and exited the aircraft without assistance. A small grass fire initiated next to each wheel as a result of the hot brakes. These were extinguished by the ARFFS.

The nose light was damaged when the aircraft struck the airport perimeter fence. The nose landing gear had collapsed and the stabilising/retraction arm was broken. The pitot probe was bent upwards and cracked and the surrounding support structure deformed. The left main landing gear support strut had failed. Damage to both main landing gear wheels is described in the 'Aircraft Examination' section of this report.

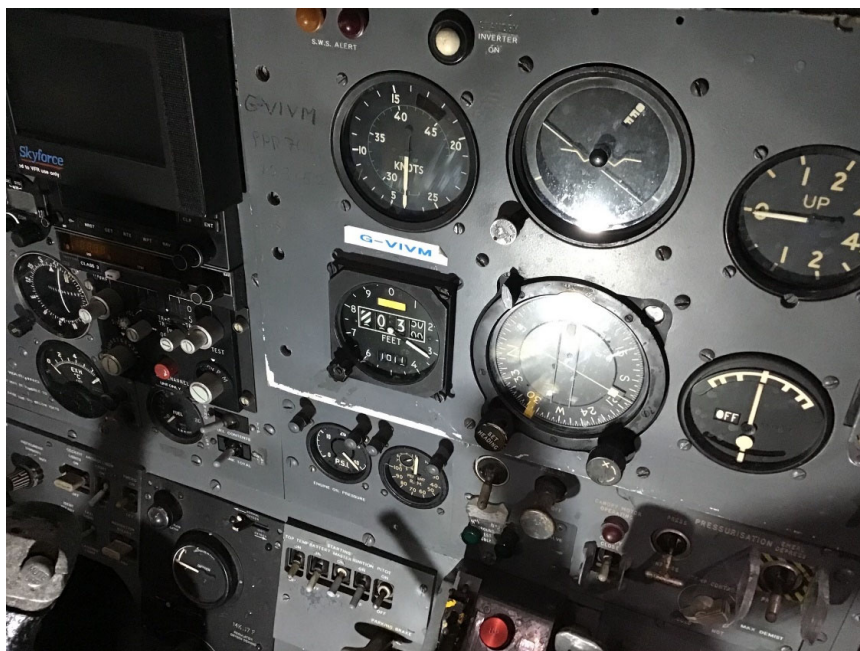
Figure 2

The Jet Provost Mk 5 is two seat ex-military jet trainer, with a side-by-side seating arrangement. On G-VIVM, the ASI occupied the top left position in a cluster of six instruments centrally grouped on the instrument panel (Figure 2). The ASI speed scale indicates from 50 to 500 kt.

G-VIVM central instrument cluster showing position of ASI

Examination and testing of the pitot/static system by the maintenance organisation and independent testing of the ASI, did not identify any defects which could explain the lack of airspeed indication reported by the commander. The reason for the absence of airspeed indication was not determined.

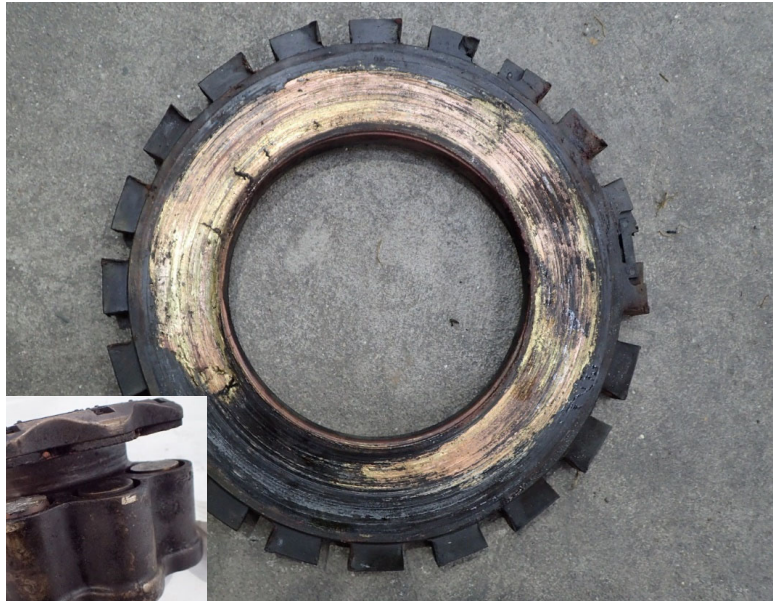
Figure 4

Both wheels showed signs of heat exposure, including blistering of the surface coating on the wheels and brake callipers. The outboard sidewalls of each tyre exhibited areas of charred and cracked rubber. Both brake discs displayed heat damage and heavy scoring and gouging with the surface plating removed. On each calliper the inboard fixed friction pads had remained in place and were heavily worn, while all the floating friction pads had become dislodged from the pistons. The pistons had travelled all the way through the piston housing and one piston on each calliper had over-travelled, such that there was metal-to-metal contact between the piston crown and disc (Figures 3 and 4).

On the right wheel, two of the floating friction pads had fused to the disc and one was absent. Two pads found in the grass close to the left landing gear exhibited heavy wear; the third was absent. The recovered floating friction pads were not evenly worn across the entire surface area, but measured thickness ranged from 3.71 mm – 5.80 mm. This compared to a thickness of 16.05 mm for a new floating friction pad.

Left main landing gear brake disc.
Inset shows brake calliper and pistons

Displacement of the brake pistons was consistent with hydraulic pressure being applied at the callipers and the extent of piston travel suggests heavy braking. Mechanical and heat damage to the wheels and brakes was consistent with the application of heavy braking, such as might occur during a high energy (high speed) RTO.

All six floating friction pads were displaced from the pistons, and four of them were found on or close to their respective wheels. Two were not retrieved and it is not known at what point these were liberated. The loss of one or more floating friction pads would substantially reduce braking efficiency and increase the temperature and wear rate experienced by the remaining friction pads. Disruption to the friction surface of the disc from direct contact with a piston would also have exacerbated this. It is therefore likely that this would have had an adverse effect on braking efficiency, which would have reduced throughout the ground run of the RTO.
