ACCIDENT

Aircraft Type and Registration:	Cessna 208B, Caravan (Cargomaster), G-OJMP
No & Type of Engines:	1 Honeywell TPE331-12JR-704TT turboprop engine
Year of Manufacture:	2002 (Serial no: 208B0917)
Date & Time (UTC):	17 July 2021 at 1338 hrs
Location:	Old Sarum Airfield, Wiltshire
Type of Flight:	Commercial
Persons on Board:	Crew - 1 Passengers - None
Injuries:	Crew - 1 (Minor) Passengers - N/A
Nature of Damage:	Damaged beyond economical repair
Commander's Licence:	Commercial Pilot's Licence
Commander's Age:	47 years
Commander's Flying Experience:	5,390 hours (of which 3,746 were on type) Last 90 days - 171 hours Last 28 days - 76 hours
Information Source:	Aircraft Accident Report Form submitted by the pilot and further enquiries by the AAIB

Synopsis

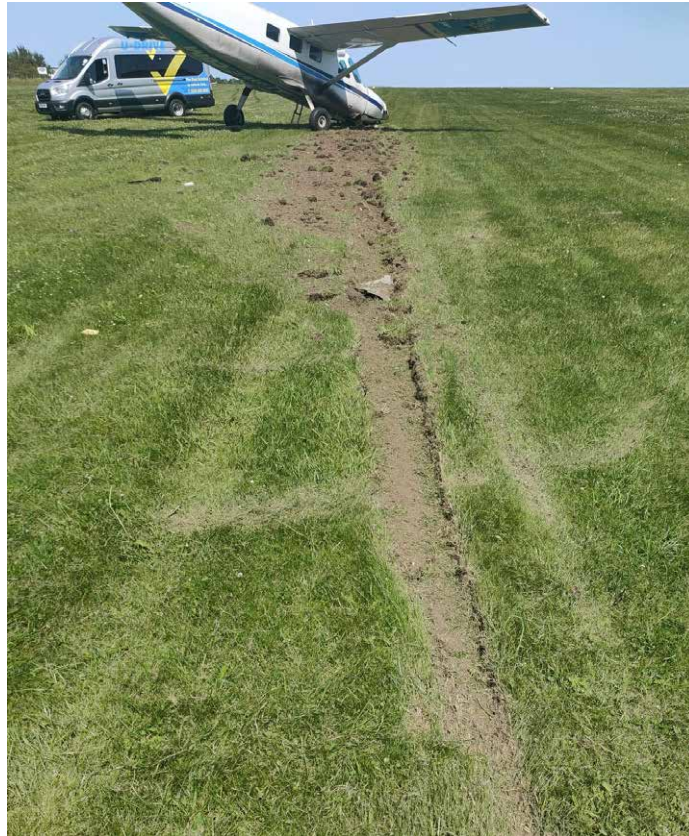
Figure 1

Upon looking up, after retrieving the kneeboard, the aircraft was a lot lower than expected. As a result, the pilot abruptly pitched the aircraft up in a bid to arrest the rate of descent (ROD). He described this as a “lifesaving manoeuvre”. The aircraft touched down very hard in a field about 2 m short of the airfield boundary. It then crossed a berm that borders the airfield, at which point the nosewheel began to oscillate before collapsing. The aircraft came to rest soon thereafter within the lateral confines of the runway (Figure 1).

The aircraft was damaged beyond economical repair.

G-OJMP after the accident

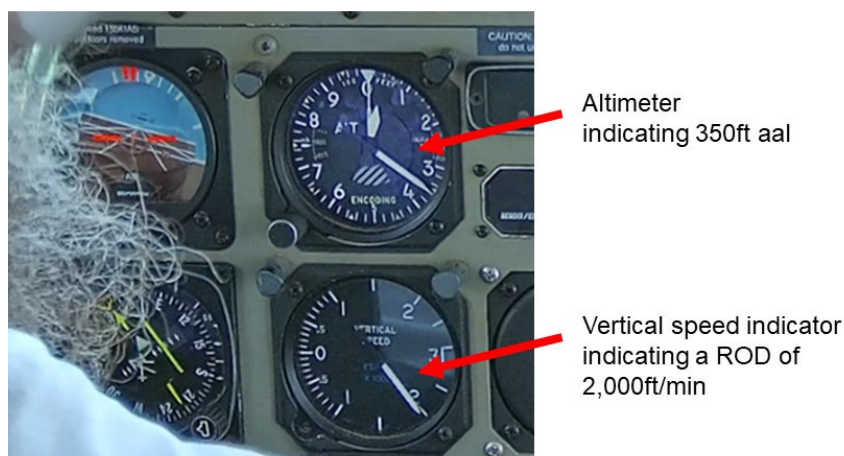
Figure 2

The final visible rate of descent was about 2,000 ft/min at 350 ft aal (Figure 2). This was just before the aircraft rolled out onto the final approach.

A still from the image recorder showing the ROD at 350 ft aal

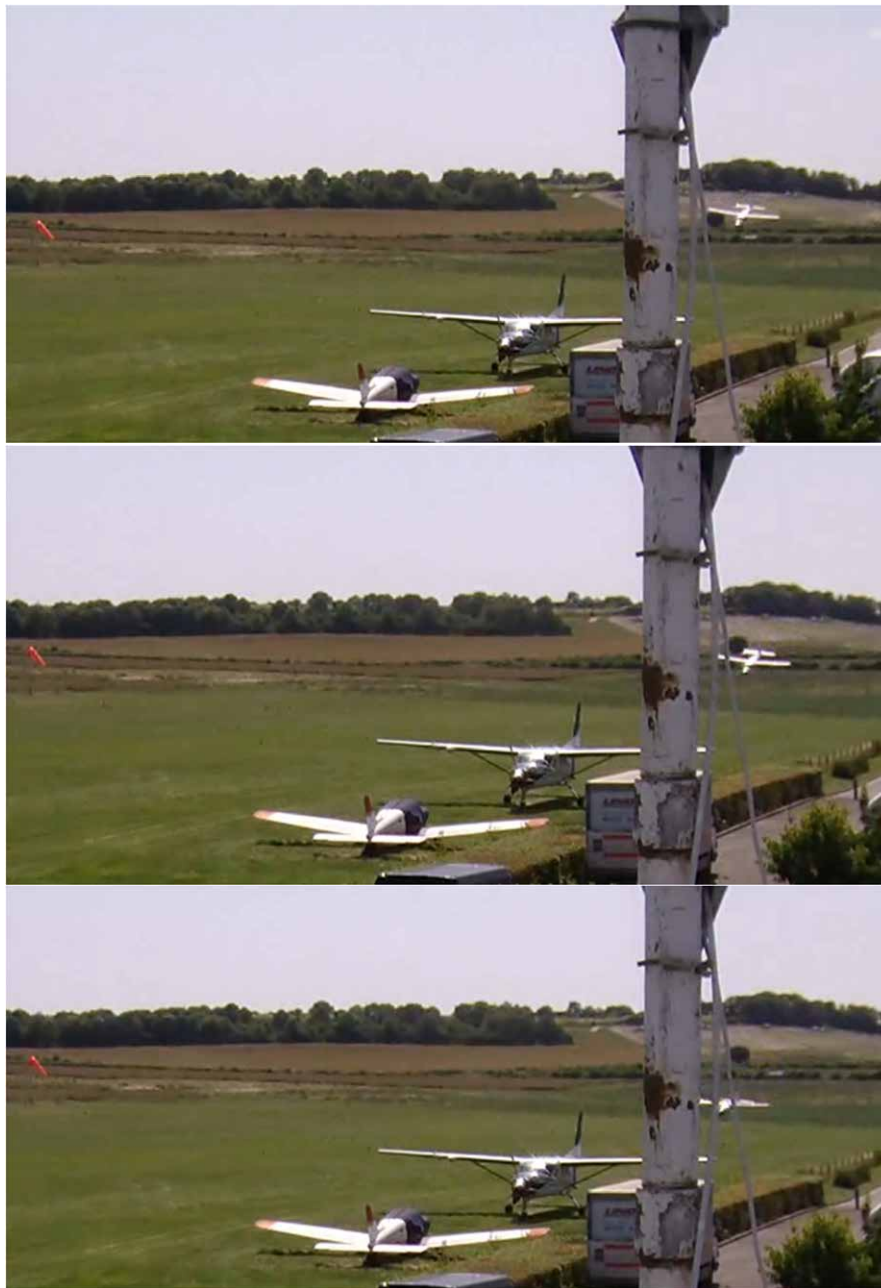
Figure 3

The accident was recorded on the airfield's CCTV camera that was pointing towards the threshold of Runway 06. It initially captured the aircraft on the final approach with a steep nose down attitude and a high ROD. The aircraft continued in this attitude until it was very close to the ground, at which point its nose was seen to pitch up abruptly (Figure 3). The aircraft then struck the ground, close to the airfield boundary.

It could not be positively determined from the CCTV if the aircraft had its flaps down during the landing.

A series of stills from the CCTV showing the last moments of the approach
