SERIOUS INCIDENT

Aircraft Type and Registration:	Leonardo AW189, G-MCGU
No & Type of Engines:	2 General Electric Co CT7-2E1 turboshaft engines
Year of Manufacture:	2014 (Serial no: 92007)
Date & Time (UTC):	4 March 2021 at 1036 hrs
Location:	3 nm south-east of Porthcawl, Wales
Type of Flight:	Emergency Services Operations
Persons on Board:	Crew - 4 Passengers - None
Injuries:	Crew - None Passengers - N/A
Nature of Damage:	Collapsed heating duct, cabin air vent motors and auto transformer rectifier units ingested debris
Commander's Licence:	Airline Transport Pilot's Licence
Commander's Age:	45 years
Commander's Flying Experience:	4,507 hours (of which 595 were on type) Last 90 days - 77 hours Last 28 days - 24 hours
Information Source:	Aircraft Accident Report Form submitted by the pilot and additional enquiries by the AAIB

Synopsis

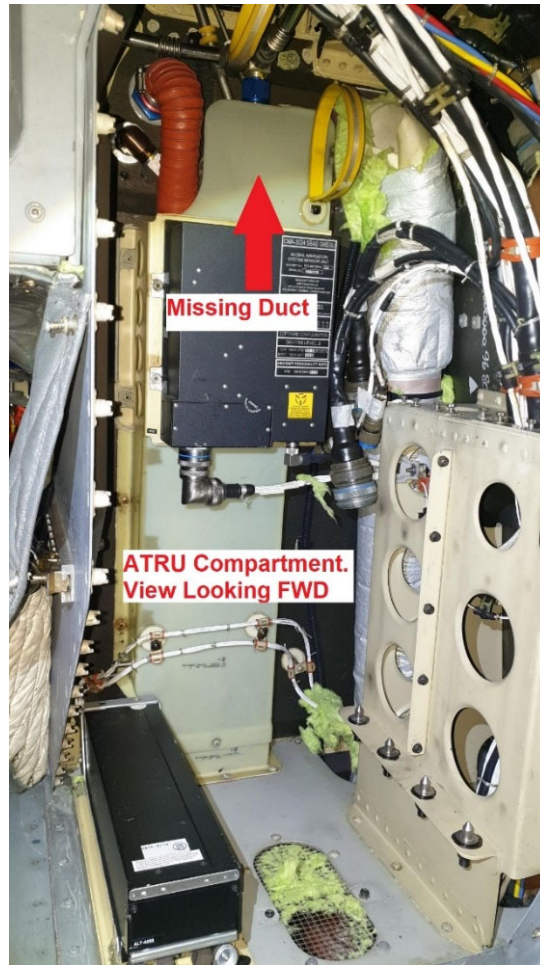
Figure 1

Subsequent inspection by the operator’s engineers showed that a heating duct in the right-hand rear area of the fuselage had collapsed and the external insulation was missing from a large section (Figure 1). The cockpit fans and two Auto-Transformer Rectifier Units (ATRUs) which have integral cooling fans and are mounted close to the failed duct, were found to have ingested duct insulation material. The duct failure occurred at 1,399 flight hours since new.

Collapsed heating duct on G-MCGU

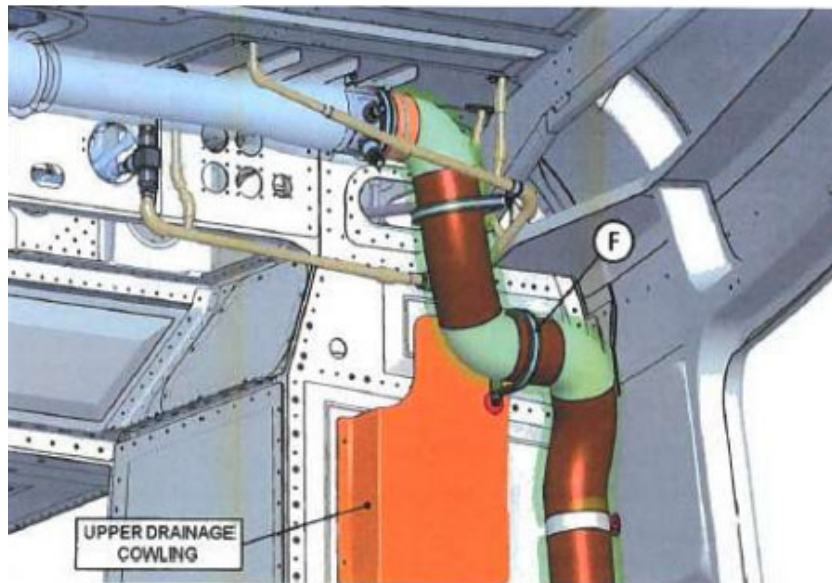
Figure 2

Heating duct on AW189 showing flexible sections in brown and rigid sections in green (Circle 'F' indicates a securing 'P-clamp')

The SB requires operators to perform a one-off inspection of the heating duct and to improve installation of the duct by repositioning an existing 'P-clamp' at one of the bonded joints (shown as item F in Figure 2) and introducing an additional fixing at another joint. The compliance instructions require that the SB is embodied within 400 flight hours or 12 months from date of publication, whichever occurs first.

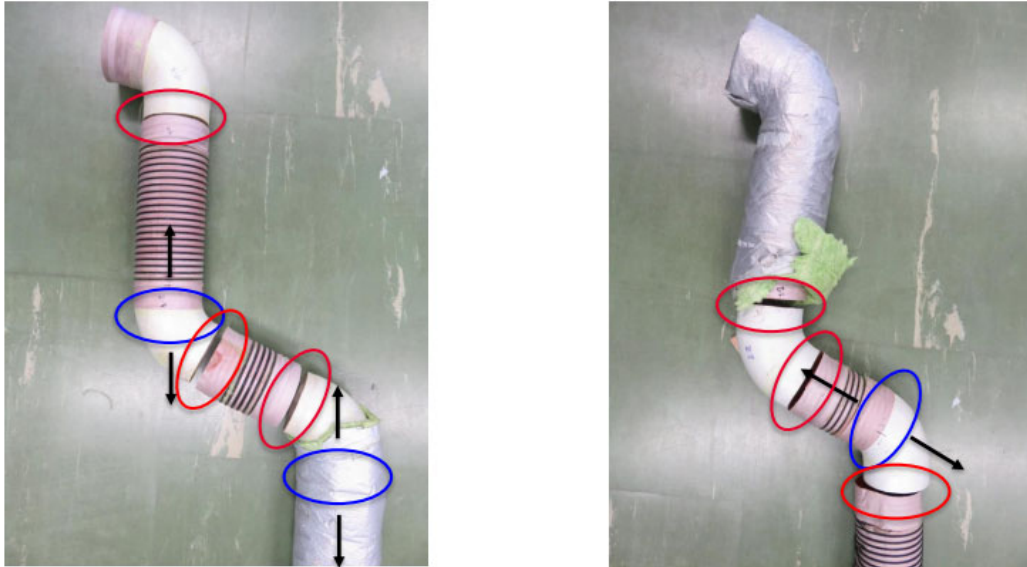
**Figure 3**

The failed ducts from G-MCGU and G-MCGT were sent to the aircraft manufacturer's laboratory for examination. The manufacturer analysed the morphology of the bonding surfaces and compared those from the failed joints (highlighted by red ellipses in Figure 3) to those on the intact joints (blue ellipses). To facilitate the examination, the intact joints were manually separated by pulling the mating sections in opposite directions (denoted by black arrows).

Failed heating ducts from G-MCGU (left) and G-MCGT (right)

On failed joints and those manually separated, adhesive was generally only present on the internal surfaces of the flexible sections. The only traces of adhesive present on the outer surfaces of the rigid bend sections appeared to be where adhesive had squeezed out from the joints during the assembly process.

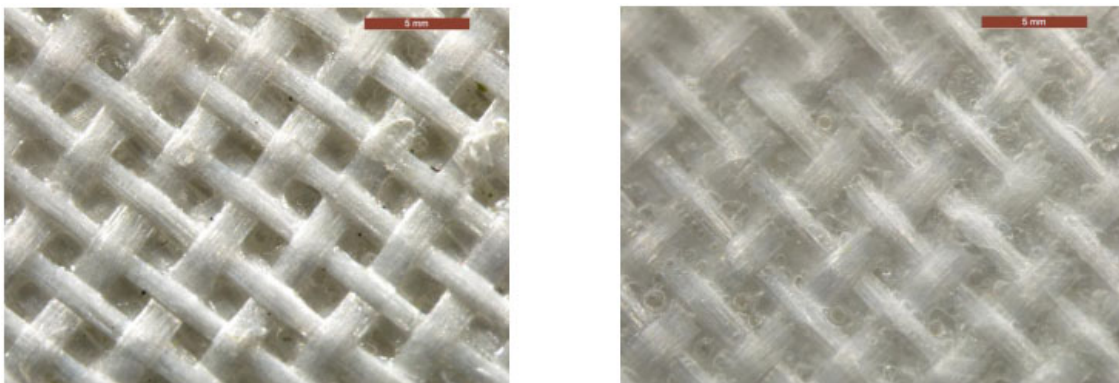
**Figure 4**

In this design, the rigid bends are fabricated from composite fibre bundles arranged in a criss-cross pattern, impregnated with resin. It was noted that the rigid sections did not exhibit uniform smoothness across their entire surface; in some areas, voids were evident between the fibre bundles, while in others, resin had filled the voids (Figure 4).

Surface of rigid bend sections, showing voids between fibre bundles

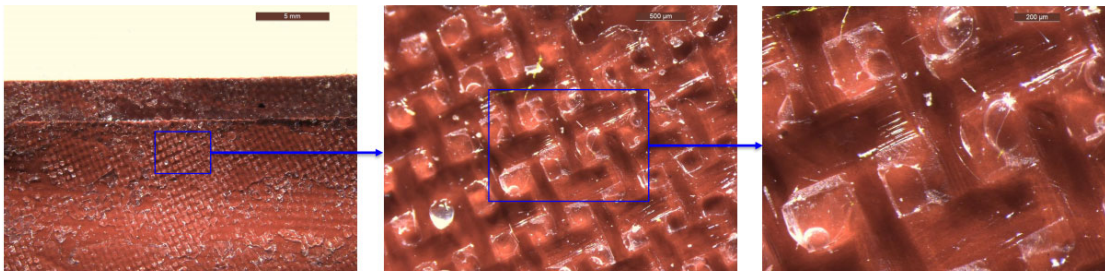
Figure 5

Cubic-shaped reliefs in adhesive, corresponding to cross-fibre bundles on rigid sections of duct

The presence of cubic-shaped reliefs within the adhesive has a positive effect on the adhesion, as it indicates mechanical interlocking to the surface of the rigid bend sections. However, as the surface of the rigid bend sections was not uniform in respect of the presence of voids between the fibre bundles, this morphology could not be achieved across the entire bonding surface.

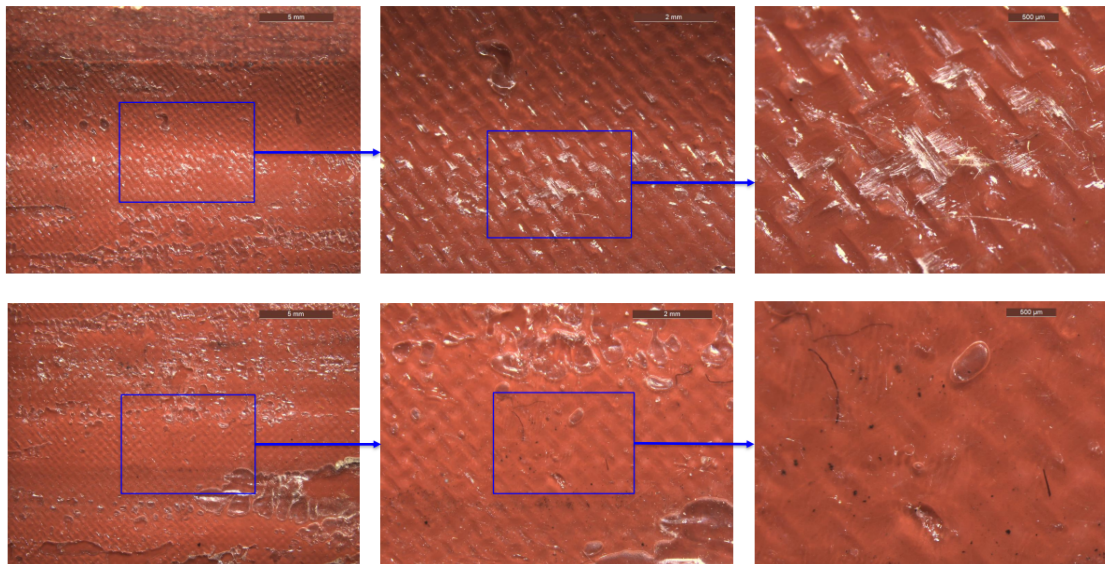
Figure 6

Areas of adhesive showing well-defined imprints from cross-fibre bundles (top row) and less well-defined imprints (bottom row)

The manufacturer considered that the definition of imprints from the fibre bundles in the adhesive varied according to the local mating pressure between the sections. In some areas with well-defined imprints, a few fibre bundles from the rigid bend section had detached with the adhesive, when the joints separated. This suggested that the adhesion may have been effective in those areas and, in the areas with less well-defined imprints, the adhesion was likely to be weak.

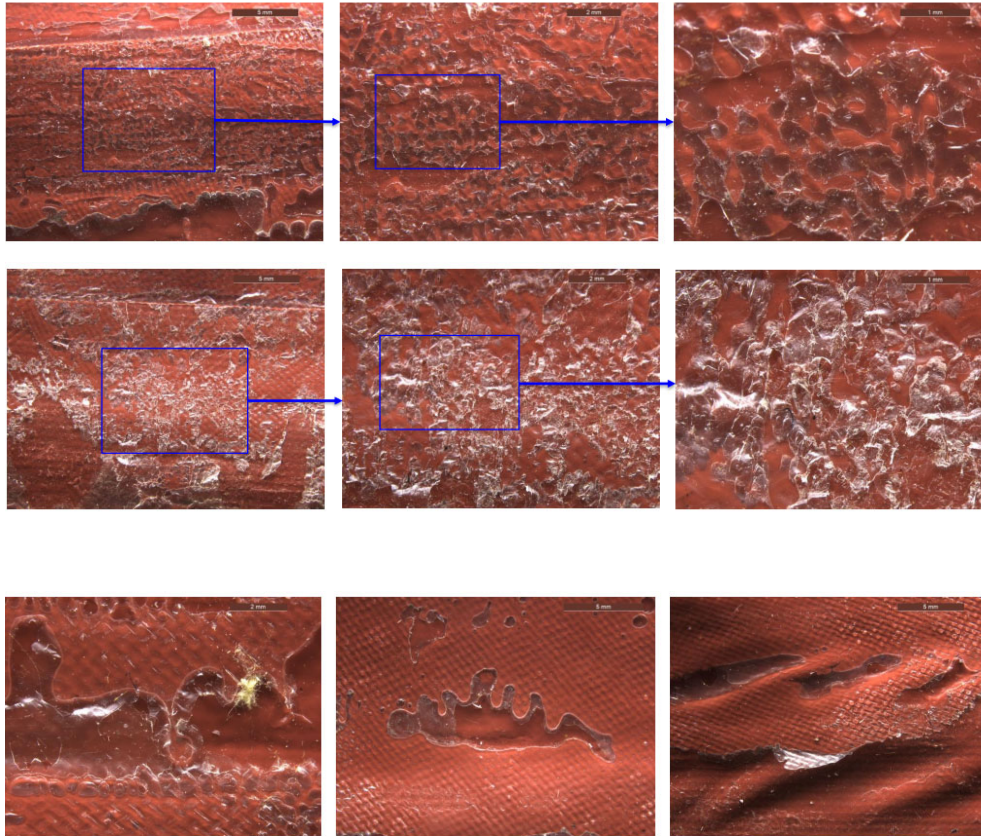
Figure 7

Areas of adhesive showing small intact bubbles (top row), small bubbles with broken film (middle row) and large bubbles (bottom row)

The manufacturer considered that the presence of bubbles in the adhesive may have been caused by relative movement between the mating surfaces during the bonding operation prior to solidification of the sealant, due to a loss of the applied mating pressure. The bubbles were characterised by weak films of adhesive, which would originally have been in contact with the surface of the rigid bend sections. When the joints separated, these films either remained intact or broke, forming some dimples in the latter case.

The fact that only a thin film of adhesive would have been in contact with the surface of the rigid bend sections, in combination with the presence of bubbles, which represent discontinuities in the adhesive layer, would have reduced the effectiveness of the bond.
