**SERIOUS INCIDENT**

| <b>Aircraft Type and Registration:</b> | Beechcraft 95-B55 Baron, 2-NOVA | |
| <b>Date &amp; Time (UTC):</b> | 13 August 2021 at 1232 hrs | |
| <b>Location:</b> | Gloucestershire Airport | |

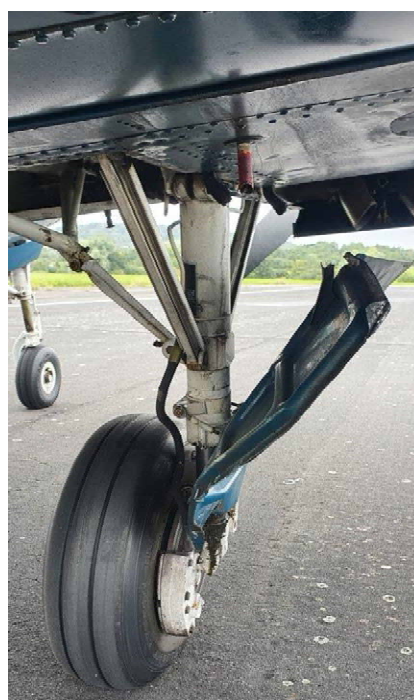
**Figure 1**

Both hinges on the right main landing gear door were found to be broken (Figure 1). There was no other damage to the aircraft.

Right main landing gear door retained by the two lower links

The landing gear is electrically actuated but there is also a manual emergency extension system. A cautionary note in the Pilot's Operating Handbook (POH) states that the emergency system should not be used to retract the landing gear. The aircraft manufacturer advised that there is very little clearance between the landing gear doors and the adjacent wing skins, and manually retracting the landing gear can pull it up too far, stressing the hinges.

The pilot used the emergency landing gear manual extension system twice, which was contrary to the POH. The aircraft manufacturer said that the landing gear can over-travel if it is retracted using the manual system, thereby adversely loading the hinges. Both hinges were found to be broken after the aircraft landed and it is possible that retracting the gear manually could have caused or contributed to this.

This event is a reminder of the importance of referring to the POH in unfamiliar situations and the need to consider the implications of unexpected events on fuel status.
