## ACCIDENT

| <b>Aircraft Type and Registration:</b> | Jodel D120A, G-AVLY |
| <b>Date &amp; Time (UTC):</b> | 27 August 2021 at 0950 hrs |
| <b>Location:</b> | Halwell Airfield, Devon |

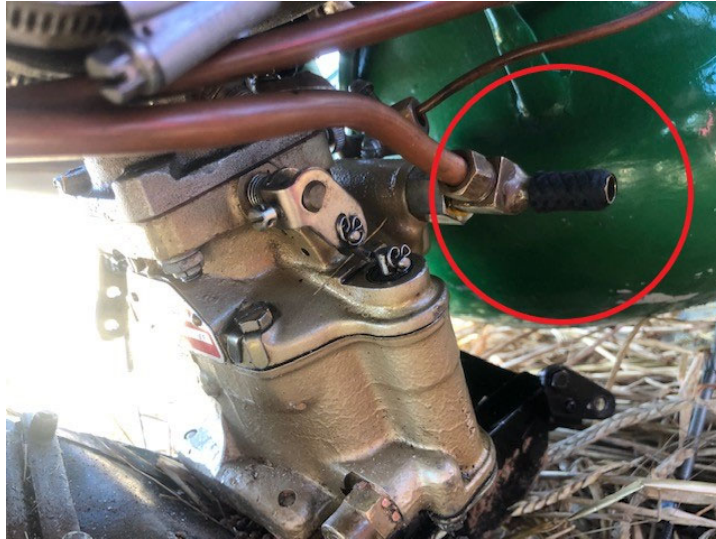
**Figure 1**

During the subsequent recovery of the aircraft, the pilot reported that when he removed the fuel delivery hose to the carburettor, the inner section of the fuel hose had remained attached to the carburettor's inlet union (Figure 1).

The inner section of the fuel hose that remained attached to the carburettor's inlet union (Image used with permission)

The pilot reported that, as he detached the rest of the hose from the inlet union, he found that some of the fibre mesh material had bunched up against the face of the carburettor's fuel inlet, having potentially migrated through an internal split in the hose where it joined the inlet union. He considered that this may have caused a restriction in the engine's fuel flow and the subsequent loss of power. However, because the fuel hose was clamped to the inlet union, it would be difficult for a circumferential gap in the inner, fuel carrying section, to have opened wide enough to allow sufficient mesh material to migrate into the fuel flow.

The AAIB inspected the fuel hose and noted that the hose had a 6 mm internal diameter compared to the inlet union's outer diameter of 7.75 mm. This potentially explains why, after the accident, a section of the fuel hose remained attached to the inlet union when the hose was removed. The hose appeared to be quite brittle with age and examination of the aircraft's maintenance records indicated that it had probably been installed on the aircraft for several years<sup>1</sup>. It was also confirmed that the part, although designed for automotive use, was suitable for use with Avgas and Mogas, both of which G-AVLY routinely used.

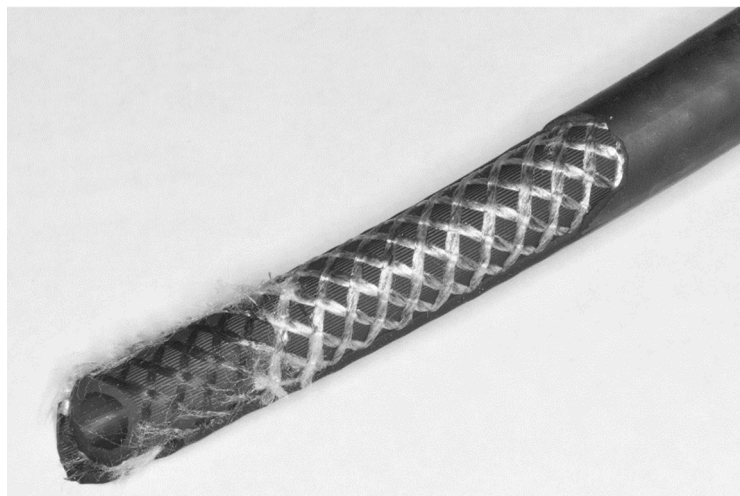
**Figure 2**

The fuel hose (Figure 2) is comprised of three concentric parts; an inner, fuel carrying section made of Nitrile rubber, a synthetic fibre mesh to give the whole assembly additional rigidity, and an outer Nitrile rubber sheath designed to protect the hose from external wear.

Sectioned fuel hose showing construction
