Frigg Field Cessation Plan

Close Out Report

Stavanger 12 May 2011

TOTAL E&P NORGE AS

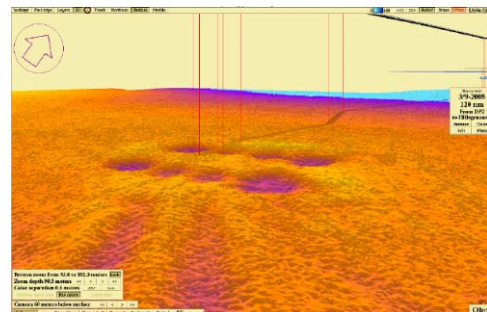
The Environmental Impact Assessment in the Frigg Field Cessation Plan [1] defined the need to cover the remaining jacket piles in the dredged areas and as they could represent a potential obstruction to future bottom trawl fishing. Consequently, gravel has been placed where the seabed have been dredged to facilitate the cutting of the jacket piles, see illustration on Figure 13. The seabed profiles after the removal of the two 26" pipelines from DP2 to TCP2 are also clearly visible on the lower part on Figure 14.

Figure 14. Foot prints of DP2 Jacket and pipelines after removal

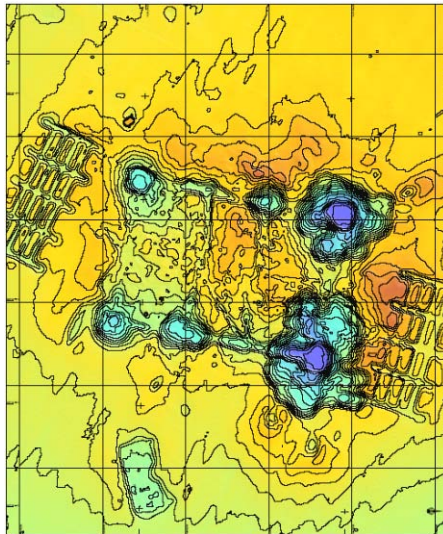
Figure 18 shows the foot prints of the DP1 jacket after the jacket had been removed but before the removal of the debris. These footprints have been filled with gravel in line with the recommendation given in the EIA [1].

Figure 18. Foot print of DP1 Jacket after removal showing the debris which have been removed

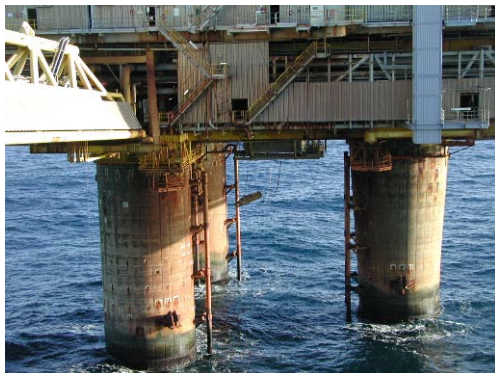
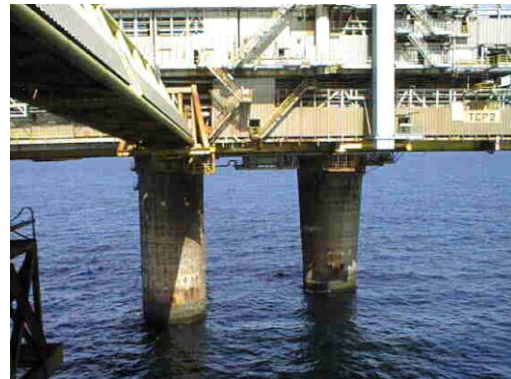
All the identified steelwork above and below water has been removed except for three items. The 5.8 tonne pull-in sheave located on concrete base slab next to the seabed turned out to be impossible to remove despite applying a force of 50 tonnes after all the bolts were cut. As this item would not represent any obstructions to fishing, MPE has agreed to TOTAL Norge's recommendation to leave it in place.

Figure 25. Before and after the removal of utility risers and ladders on one of the TCP2 concrete columns.

It can be concluded the target set to remove all external steelwork attached to the TCP2 concrete substructure, as far as reasonably practicable, has been achieved.

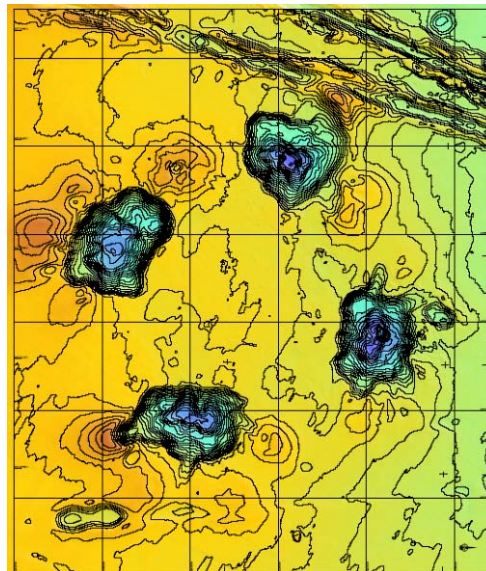
The Environmental Impact Assessment in the Frigg Field Cessation Plan [1] defined the need to cover the remaining sections of the QP jacket piles in the dredged areas as they could represent a potential obstruction to future bottom trawl fishing. Consequently, gravel has been placed where the seabed have been dredged to allow the cutting of the jacket piles.

Figure 32. Foot print of QP Jacket after removal

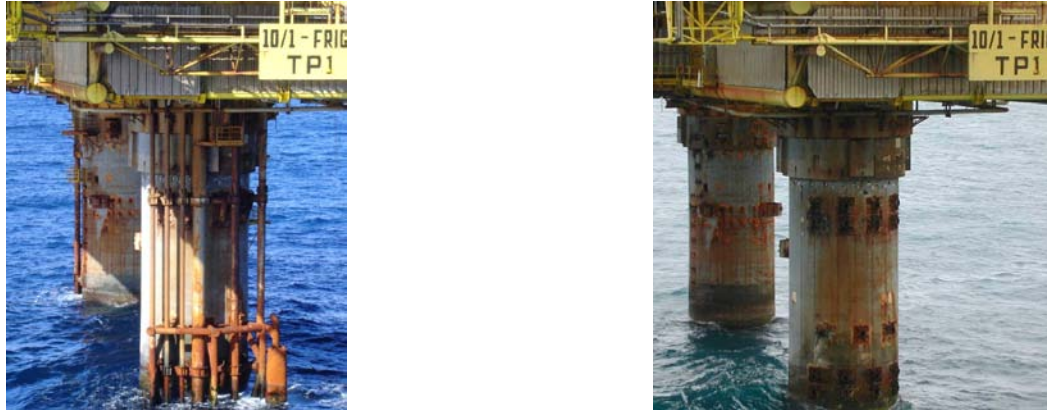
Two utility riser support frames on each concrete column at -6m and -17m each weighing about five tonnes have not been removed. A detailed survey showed that the frames were closer to the concrete wall than shown on the installation drawings. After an overall evaluation considering the limited space, risks involved in working in the splash zone and that they would not represent any obstructions to fishing as they would fall on top of the caisson, DECC has agreed to TOTAL Norge's recommendation not to remove these frames.

Figure 38. Before and after the removal of utility risers and ladders on one of the TP1 concrete columns.

It can be concluded the target set to remove all external steelwork attached to the TP1 concrete substructure as far as reasonably practicable has been achieved.

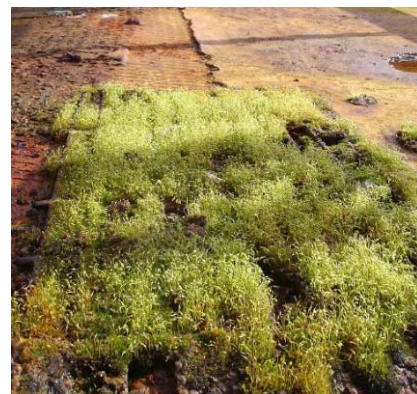
No general maintenance was carried out during the following years. As a result, the removal of the topside facilities was very challenging with specific access concerns in many areas. More than one month was spent in making the platform safe before commencing actively the preparation work required before removal of modules could commence. Safety nets were put in place under the deck which enhanced the safety precautions by providing a second barrier to prevent personnel falling into the sea within the moonpool (inside the outer concrete wall). This was particularly important as the offshore work was undertaken during the winter period when rough weather prevented effective rescue from the moonpool.

Figure 40. Grass found growing on the steel deck

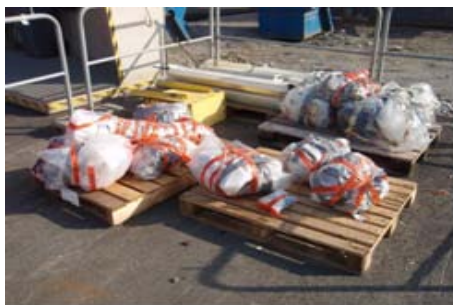
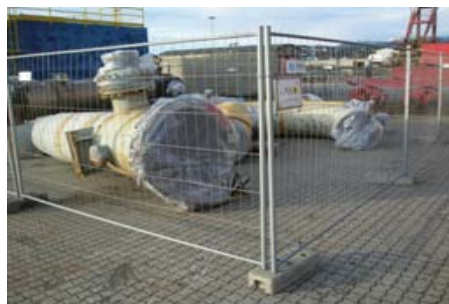
Figure 51. Material containing Asbestos which have been isolated before transport to final disposal site
