Report on the investigation of two catastrophic engine failures, one resulting in a fire, on board the ro-ro passenger ferry

***Wight Sky***

at the entrance to Lymington River and before berthing at Lymington Pier on 26 August and 14 December 2018

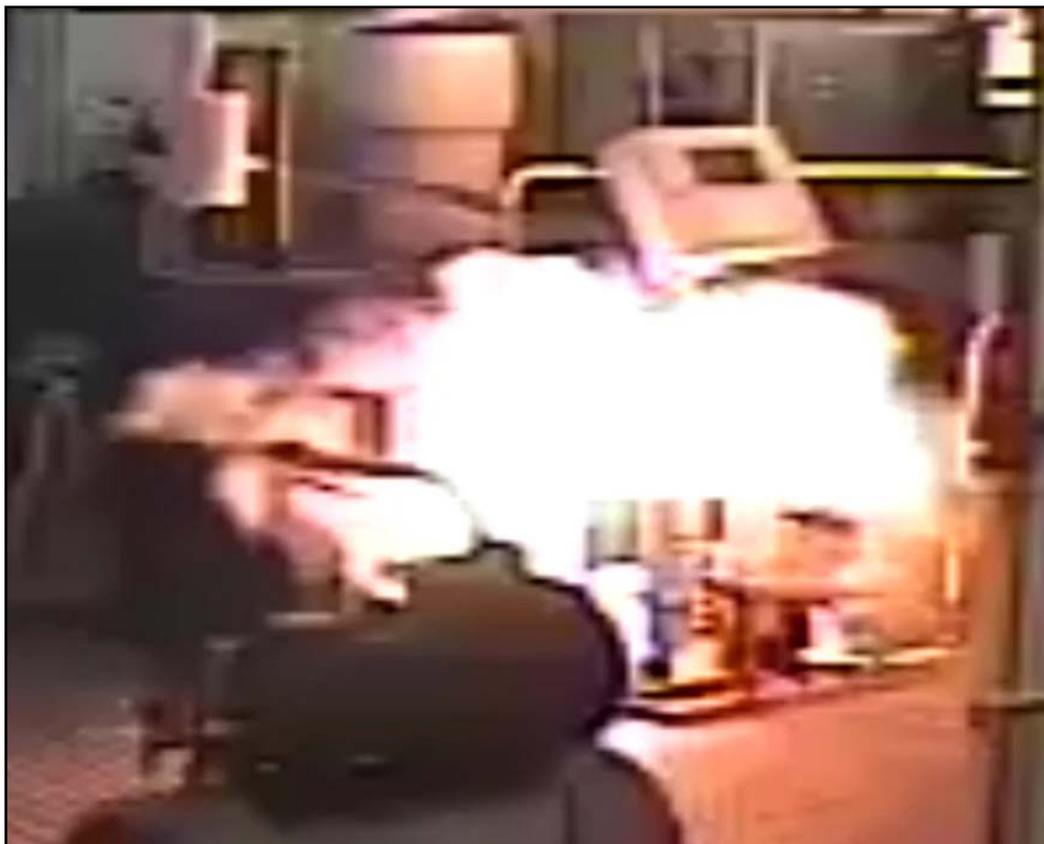
**Figure 3:** Engine room CCTV of ME2 engine fire

At 1840:52, *Wight Sky*'s machinery monitoring system identified a loss of ME2 lubricating oil pressure and initiated an engine shutdown. Within 2 seconds, ME2's low piston cooling oil pressure and shutdown common alarms activated. At 1841:55, the engine failed catastrophically, causing internal engine components to be thrown through the engine crankcase into the engine room. The oil and vapours released from the crankcase into the engine room ignited and created a fireball around the engine (**Figure 3**) that activated the fire detection system alarm on the bridge. The master looked at the engine room's closed-circuit television (CCTV) monitor, saw the smoke and fire, took immediate action to ensure the engine had declutched and stopped, and activated the engine room's water mist fire suppression system, which extinguished the fire.

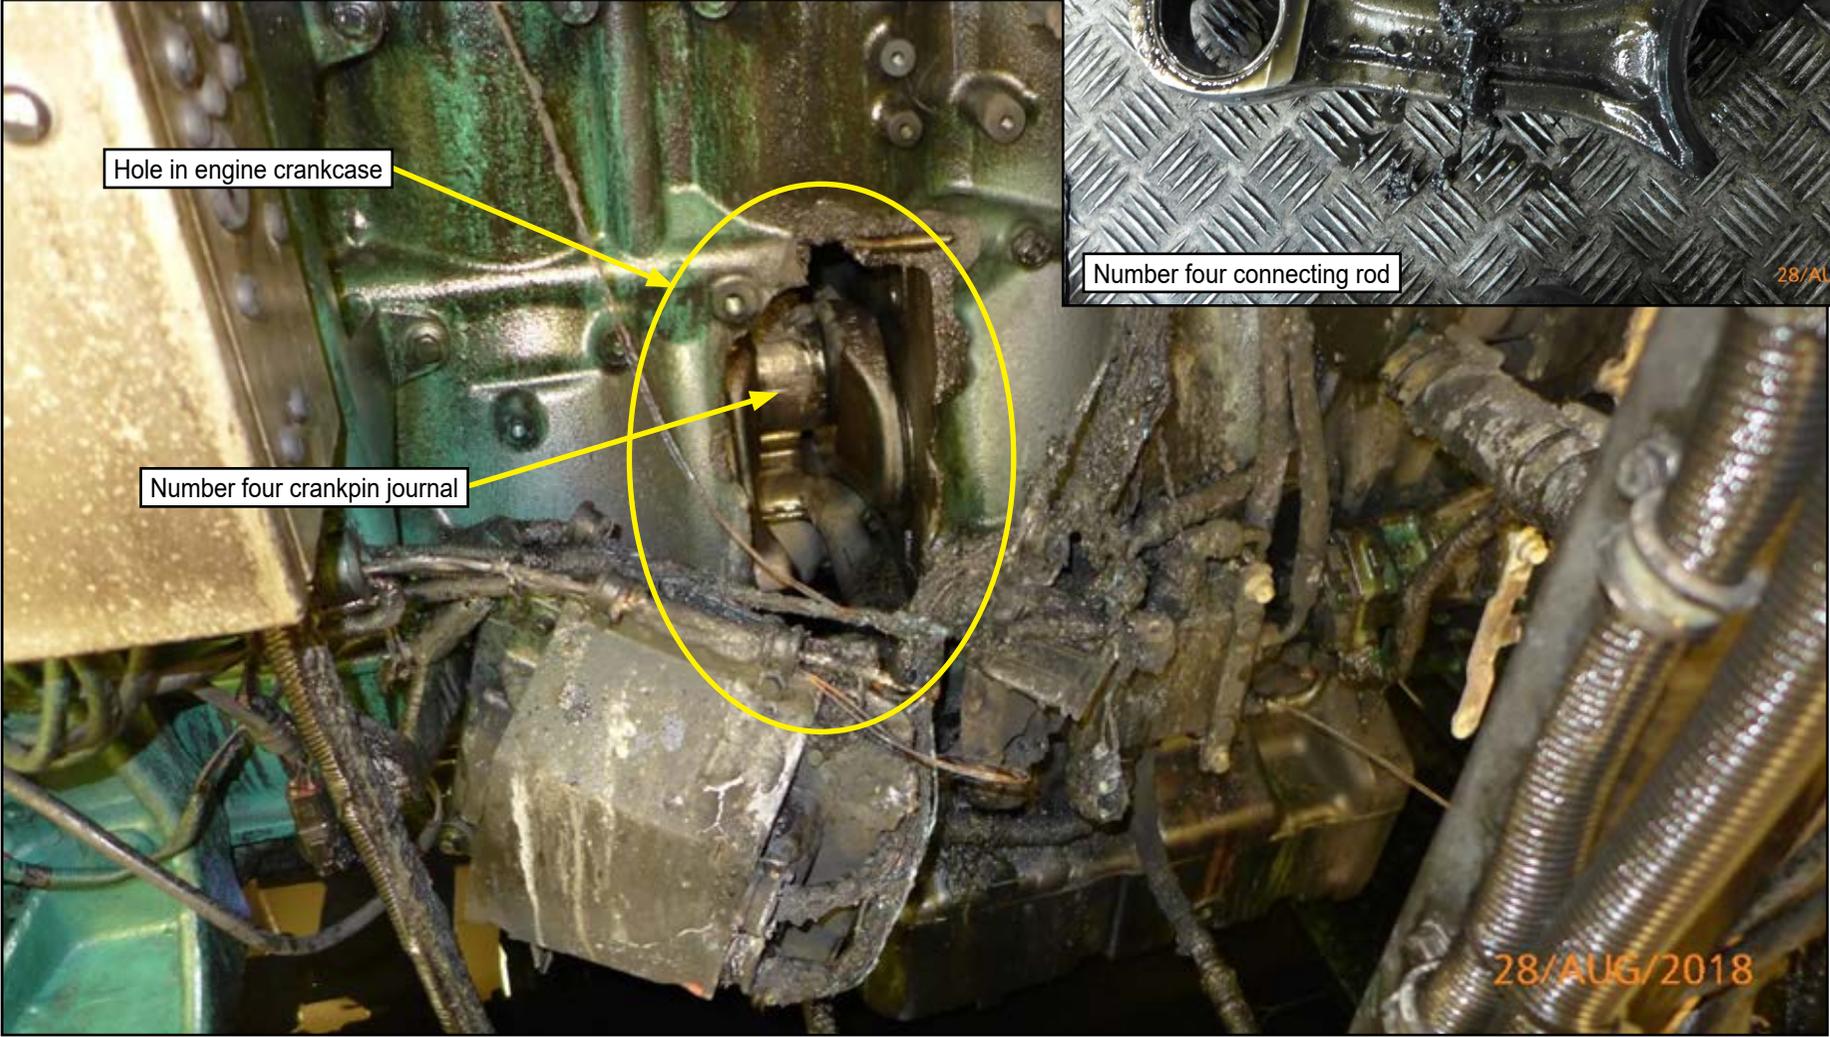
**Figure 4:** Hole in ME2 crankcase, showing number four crankpin journal, and inset, showing number four connecting rod on the engine room deck plate

The initial ME2 inspection identified that the engine's number four cylinder connecting rod had failed and been ejected through the side of the engine crankcase (**Figure 4**), and that a localised fire had ensued. The engine had accumulated 2241 running hours since its installation and, as the failure mode appeared identical to the previous ME2 failure, the MAIB began a new investigation.

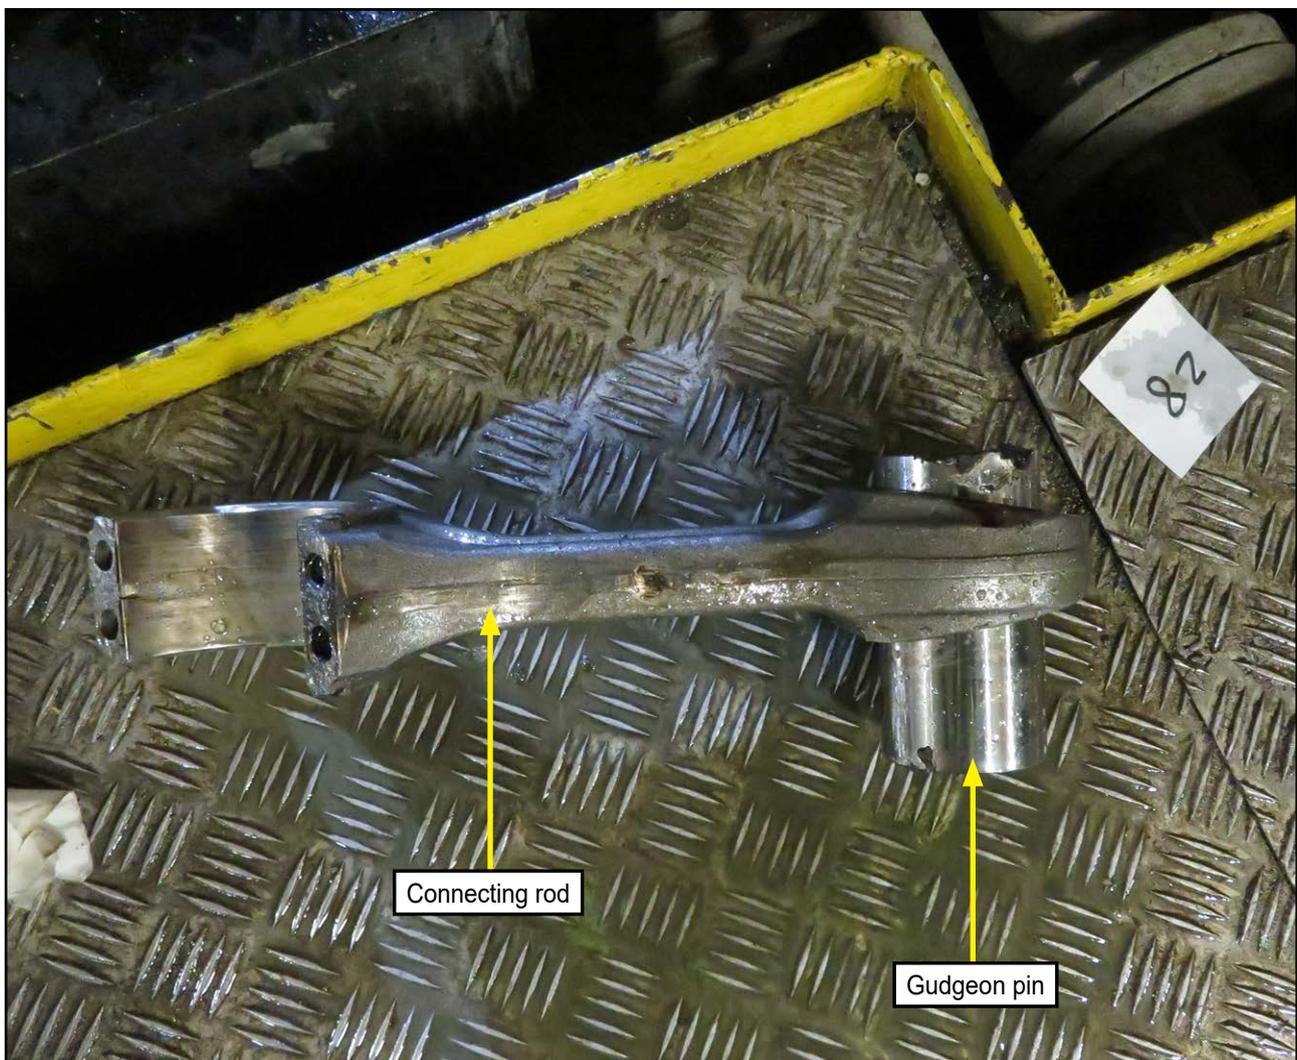
**Figure 5:** ME4 number four connecting rod and gudgeon pin

The initial inspection of the engine room identified that ME4 had failed catastrophically and that its number four connecting rod and gudgeon pin (**Figure 5**) had been ejected through the side of the engine crankcase (**Figure 6**) into the engine room. The engine room was unoccupied at the time and there was no evidence of a fire.

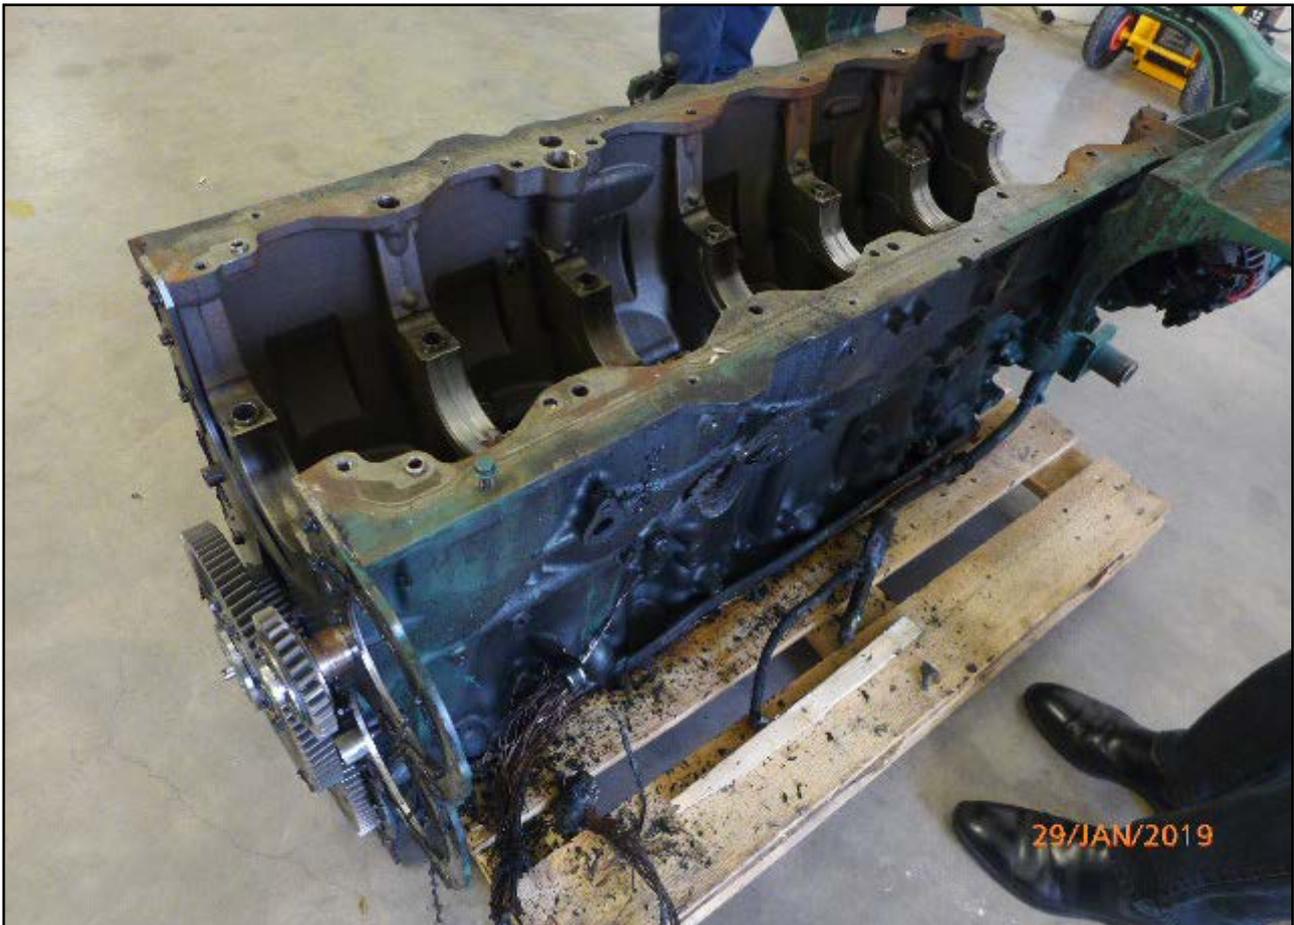
**Figure 21:** Event 1 – engine block re-examination

The re-examination of the engine in Sweden focused on the condition of the liners, pistons, engine block, various oilways and reciprocating components (**Figure 21**). The examination identified piston and liner scuffing on all units, scoring within the oil pump, and scoring to main bearings. It was also noted that a Belzona repair had been made to the block in way of the liner landing face.

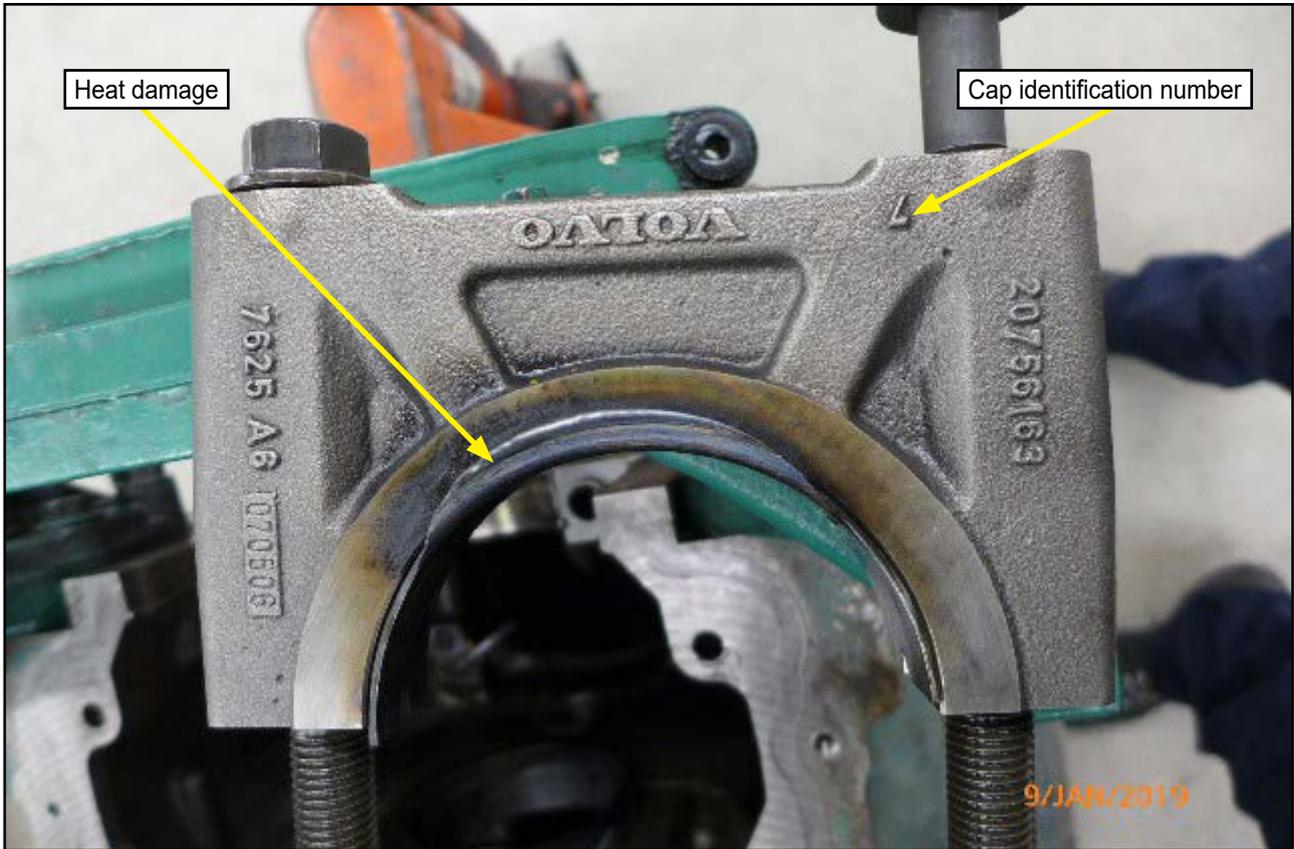
**Figure 22:** Event 2 – main journal bearing cap number seven

- The ECU was not original to the engine, having been transferred from the replacement engine.
- Number seven crankshaft main journal bearing was more worn than the others, probably caused by seizure on number six piston.
- The upper piston rings showed discolouration in the contact surface towards the liner.
- There were high levels of carbon build-up above the second piston ring.

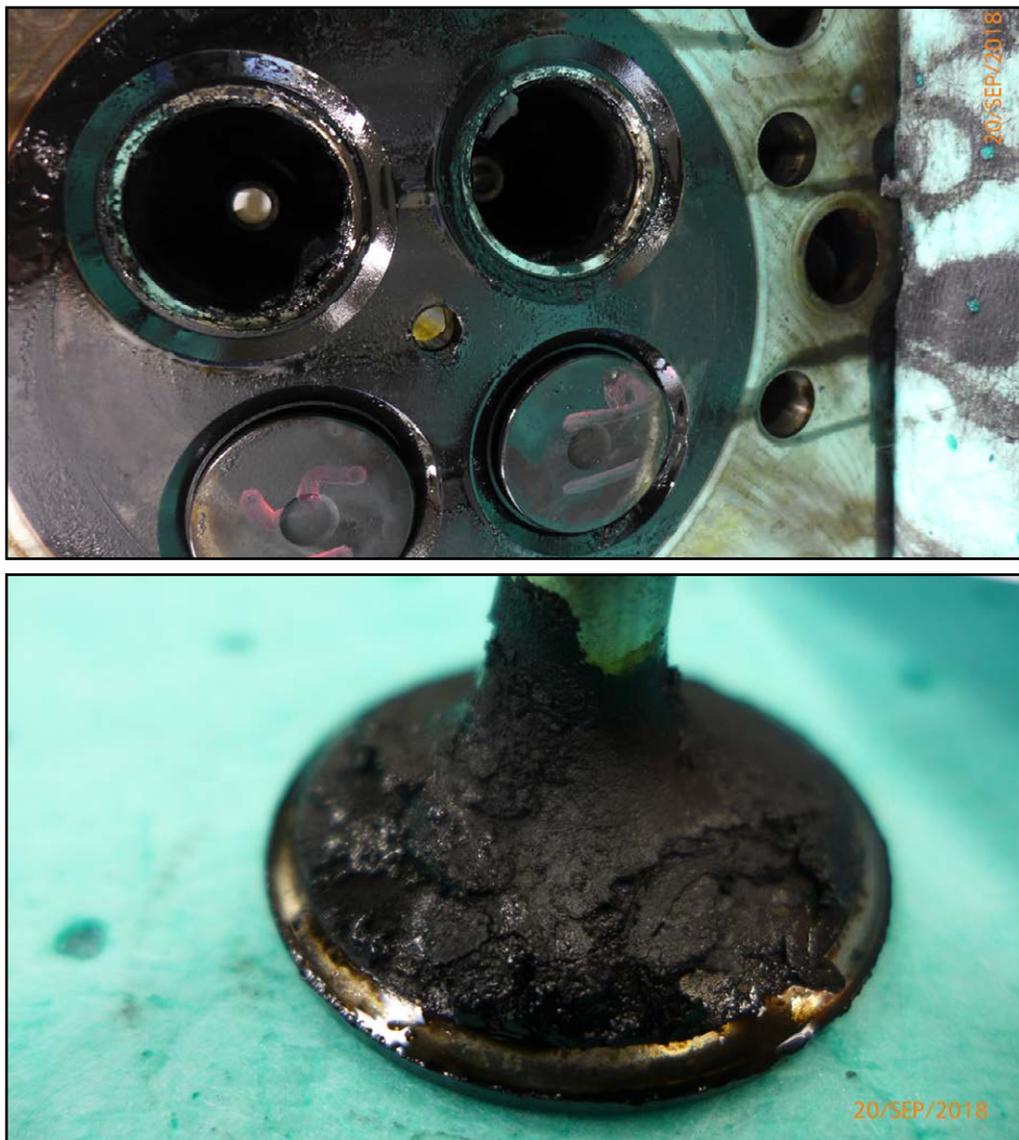
**Figure 24:** Event 4 – carbon deposits on cylinder head valves

- Carbonaceous deposits were identified on the inlet valves indicating poor combustion.
- Fractured cylinder liner No.4 showed graphitisation on the bore surface. Graphitisation is a corrosion mechanism in cast irons and occurs when the cast iron surface is exposed to medium acids or soft water. This graphitisation indicates an ingress of water into cylinder No.4 (**Figure 27**).
- The SEM<sup>26</sup> examination identified the brittle nature of the fracture surface and suggests that the crankcase, cylinder liner and piston failed due to a sudden, impact type loading.
- The microstructural examination of the cap end shell bearings did identify regions of scoring.

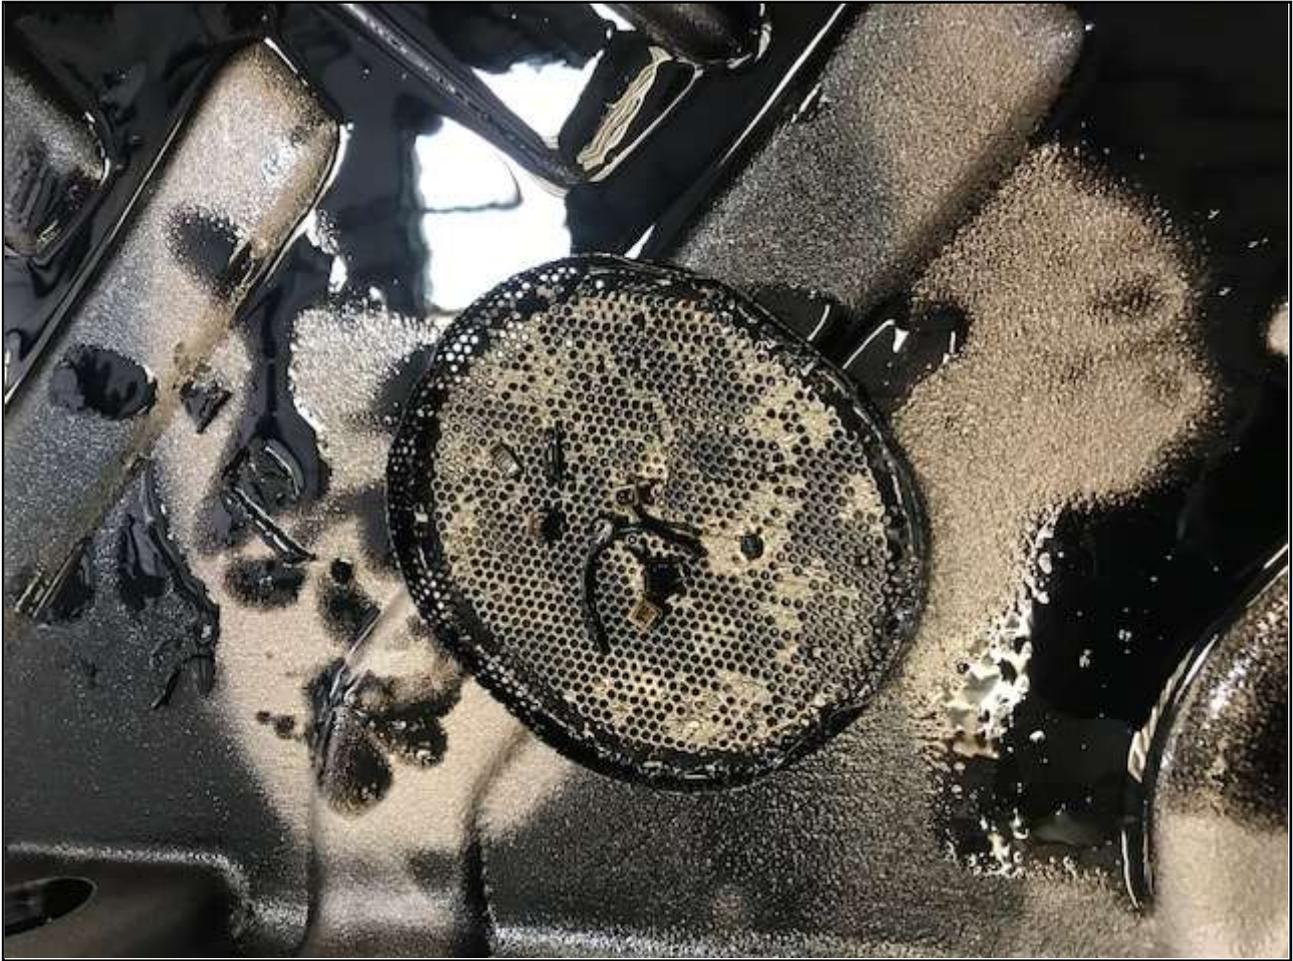
**Figure 29:** Debris found in engine sump pan and lubricating oil strainer

- Two engines with debris in the sump pan and one with debris in the lubricating oil pump strainer. The debris included old cable ties (**Figure 29**).

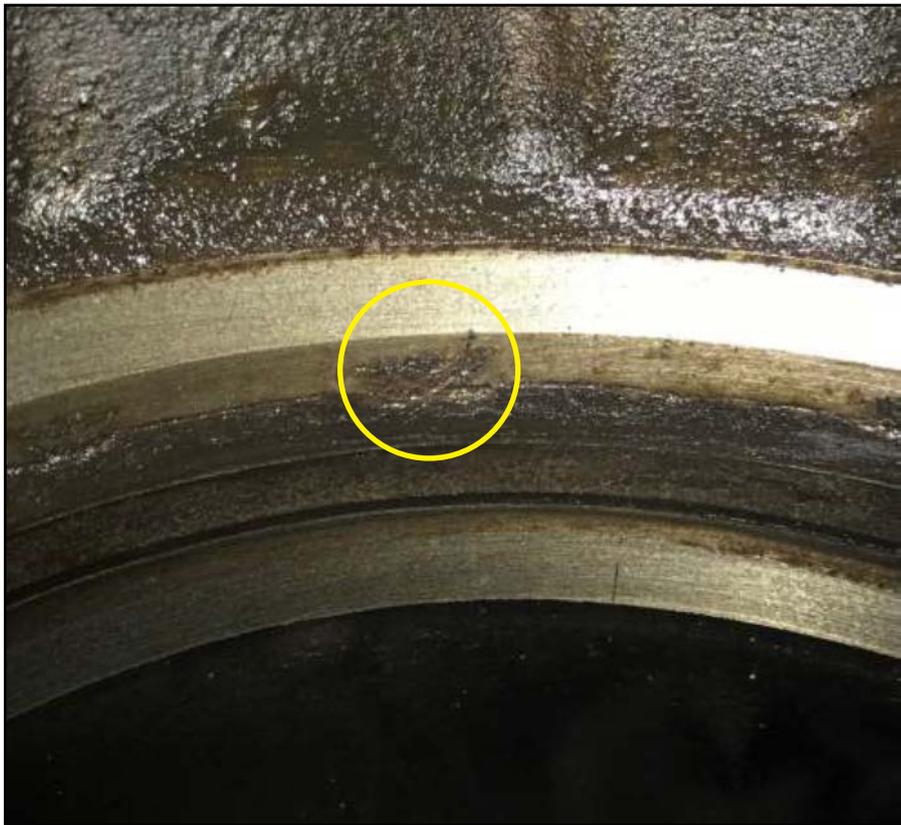
**Figure 30:** Erosion to engine block in line with and below the upper of the two lower cylinder liner seals

- Liner sealing ring hardening, resulting in the seal not making contact for the full circumference of the liner; block erosion/corrosion in an area that should be dry (**Figure 30**) and pitting/erosion of the liner at the liner seal groove.
- Two engines with cavitation erosion to the HT coolant circulation pump, considered to be because of low system pressure and/or incorrect coolant concentrations (**Figure 31**).
- Two engines with pockets of corrosion in cylinder heads (**Figure 32**) thought to indicate airlocks and a failure of deaeration system pipework.
