Interim report on the investigation into two catastrophic engine failures on board the ro-ro passenger ferry *Wight Sky* on 26 August 2018 and 14 December 2018

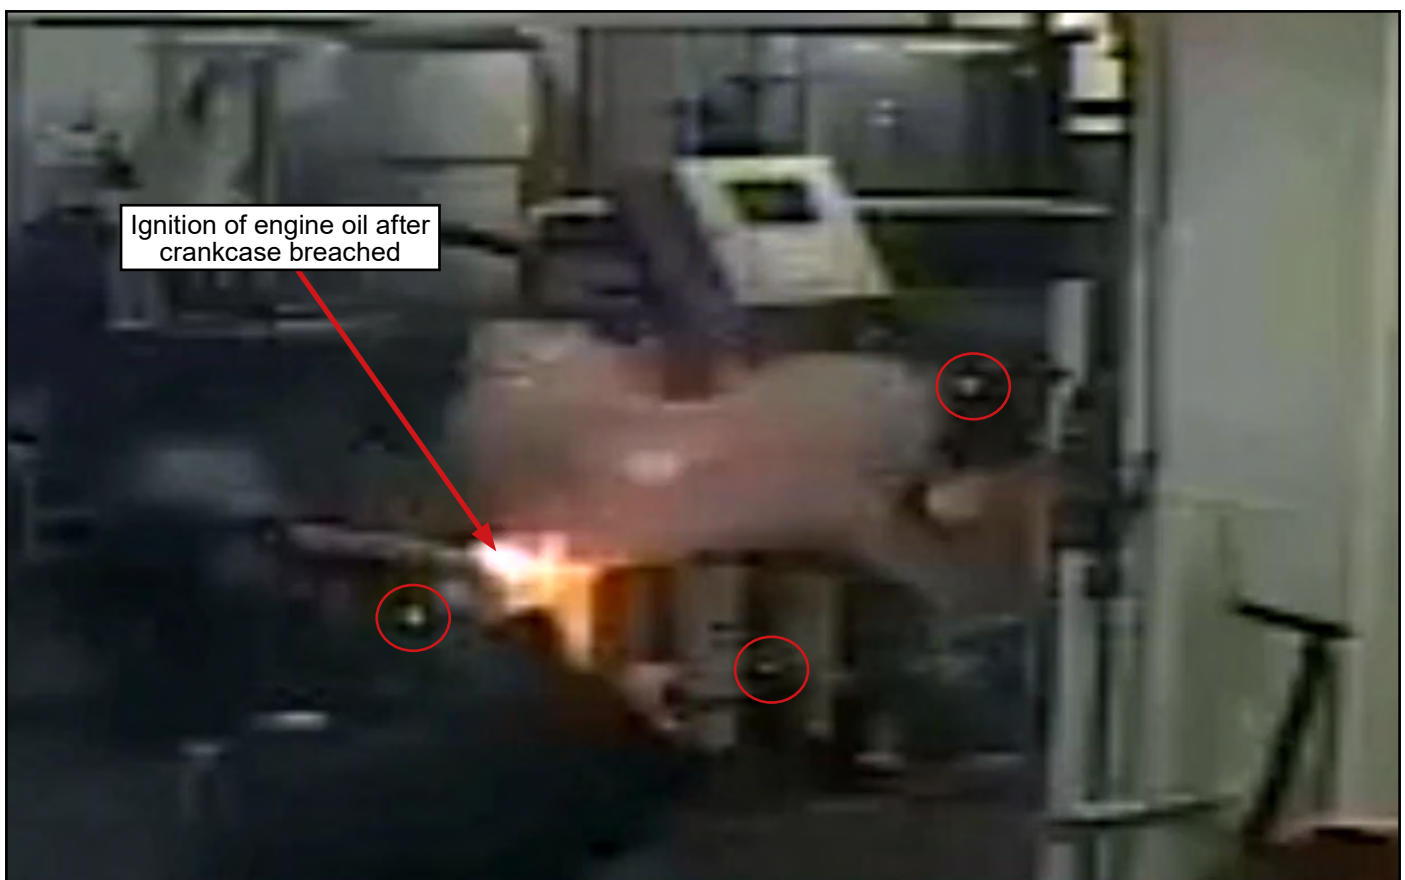
On 26 August 2018, *Wight Sky's* replacement ME2 catastrophically failed (**Figure 2**) as the vessel was preparing to enter the Lymington river. One of the engine's connecting rods (**Figure 3**) and various other internal engine components were ejected through the engine block. The engine lubricating oil ignited, causing a fireball to engulf the engine (**Figure 4**). The engine room was unmanned at the time.

The engine that failed had accumulated 2241 running hours since its installation. It was a new build engine that had been delivered from Volvo Penta's factory in Sweden and installed by the local Volvo Penta dealer. Initially, the failure appeared to be identical to the previous one and the MAIB began a new investigation.

Figure 2: Catastrophic failure of *Wight Sky's* replacement ME2 on 26 August 2018 (various pieces of engine debris circled)

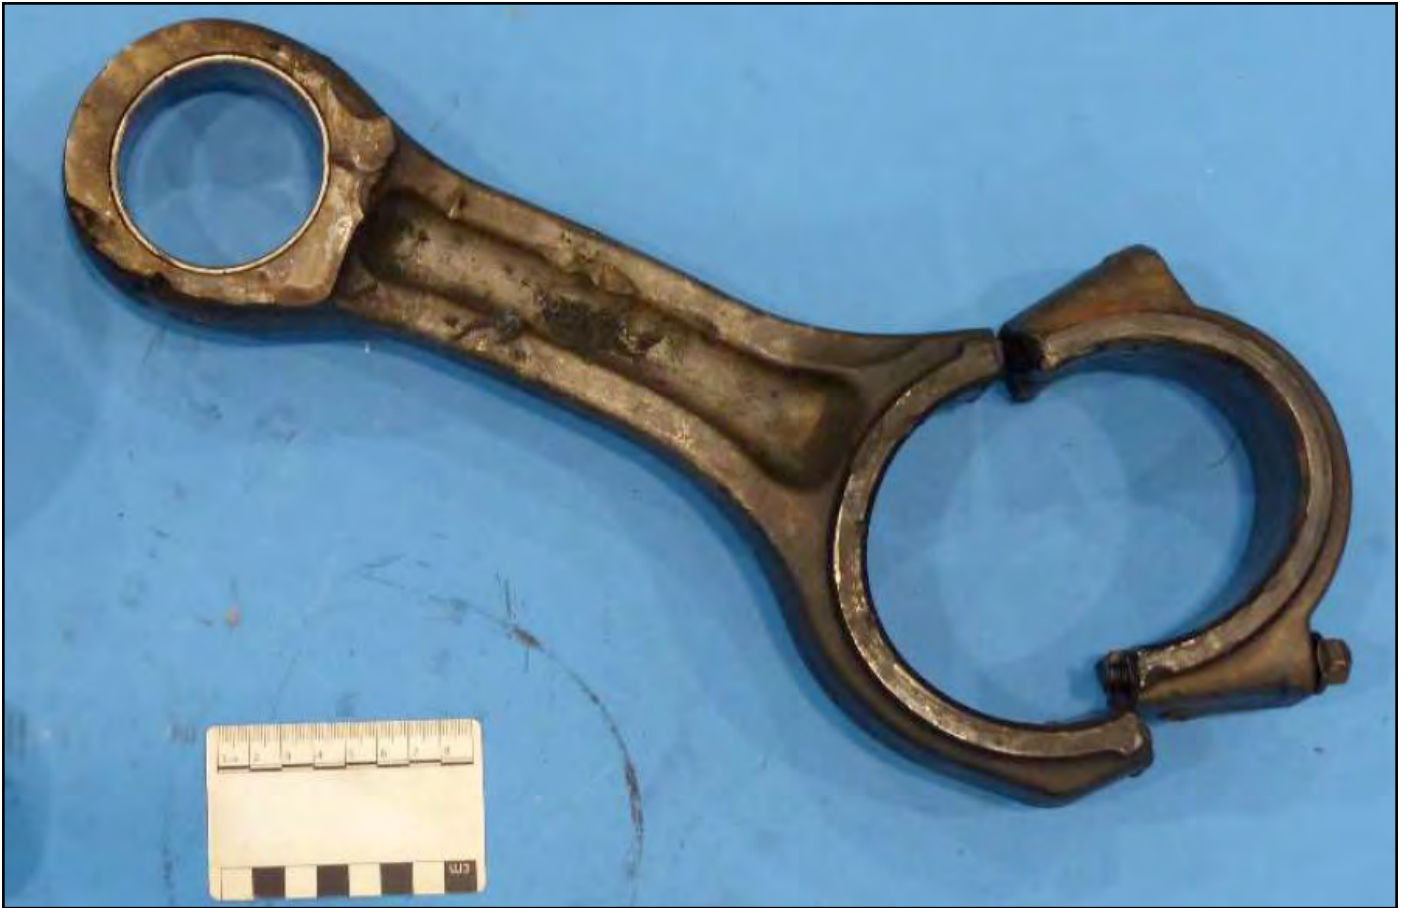
Figure 3: Failed connecting rod

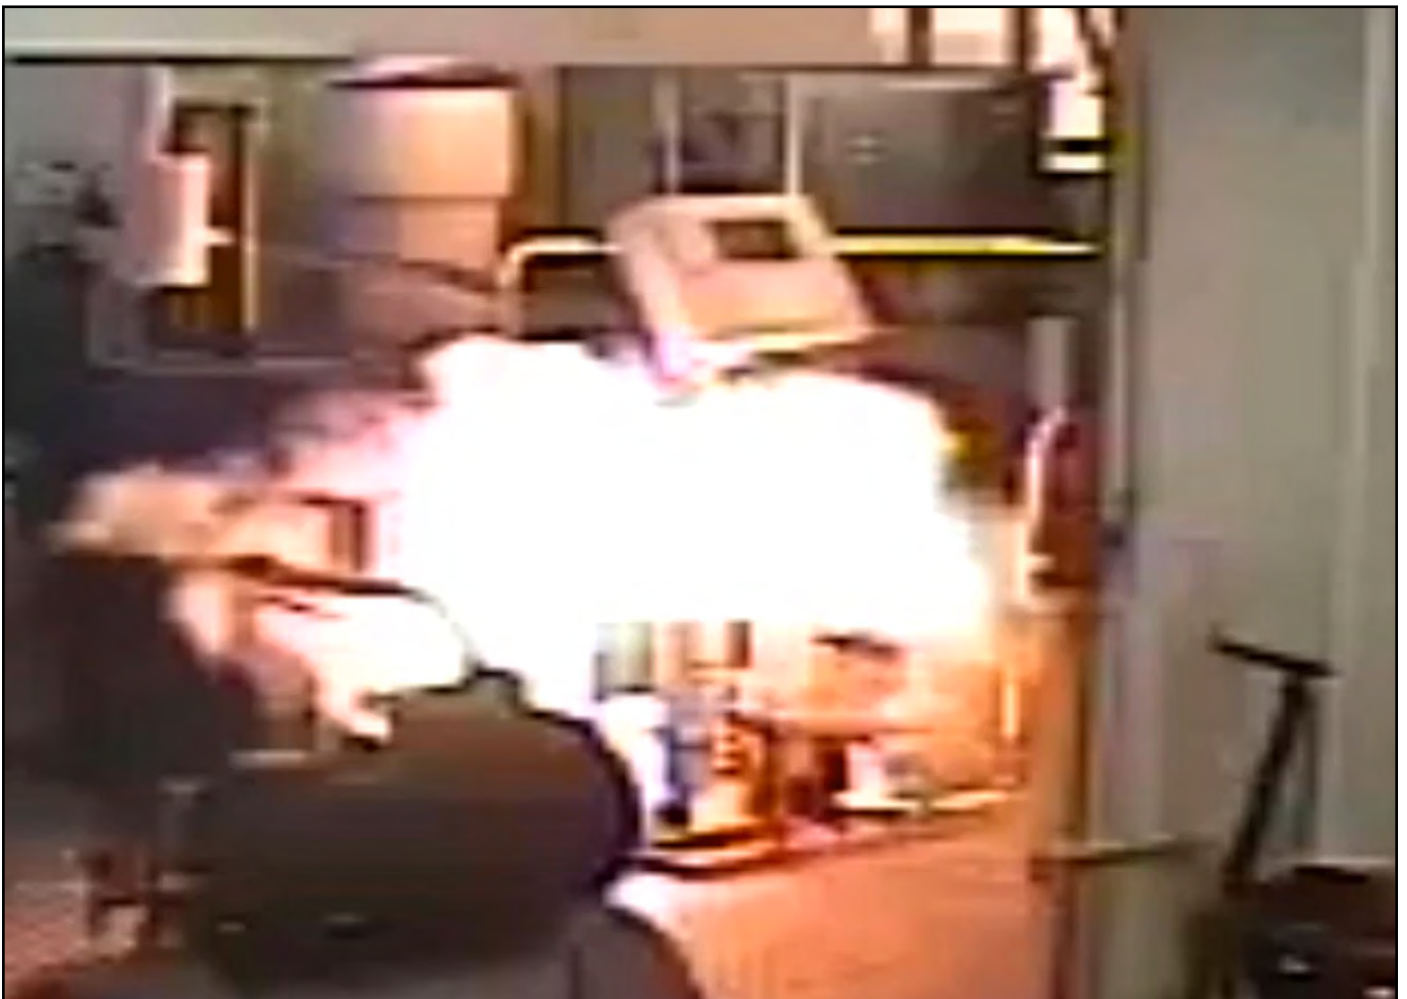
Figure 4: Engine engulfed by flame from ignition of hot engine oil

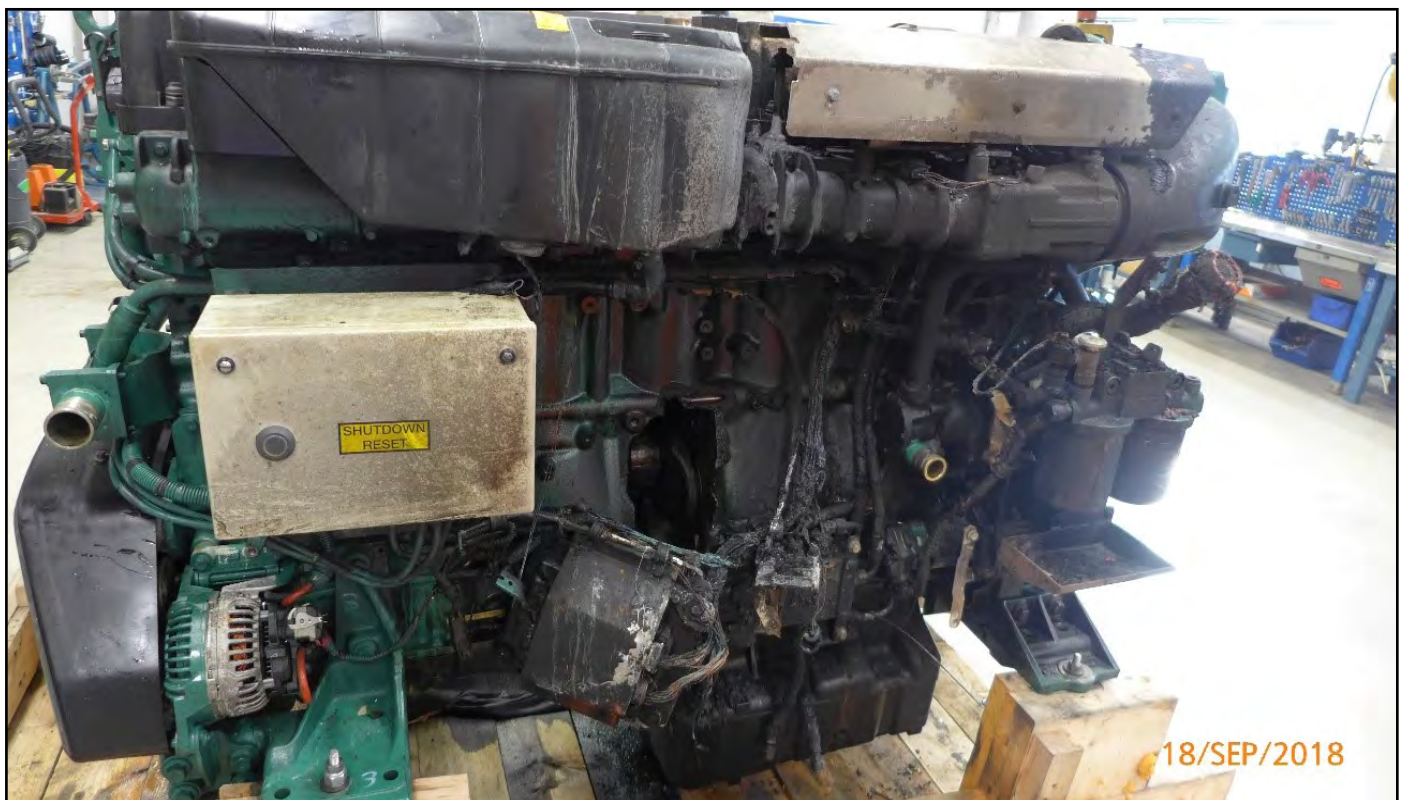
The engines were sent to Volvo Penta's facility in Gothenburg for dismantling and examination (**Figure 5**) to determine the cause of failure. The initial examination of *Wight Sky's* ME2 that failed on 26 August 2018 did not identify any obvious cause of failure, and it was brought back to the UK for metallurgical examination.

Figure 5: Removed engine after delivery to Volvo Penta's factory in Gothenburg
