Report on the investigation of  
the fatal person overboard from the motor cruiser  
***Diamond Emblem 1***  
at Great Yarmouth Yacht Station, River Bure, England  
on 19 August 2020

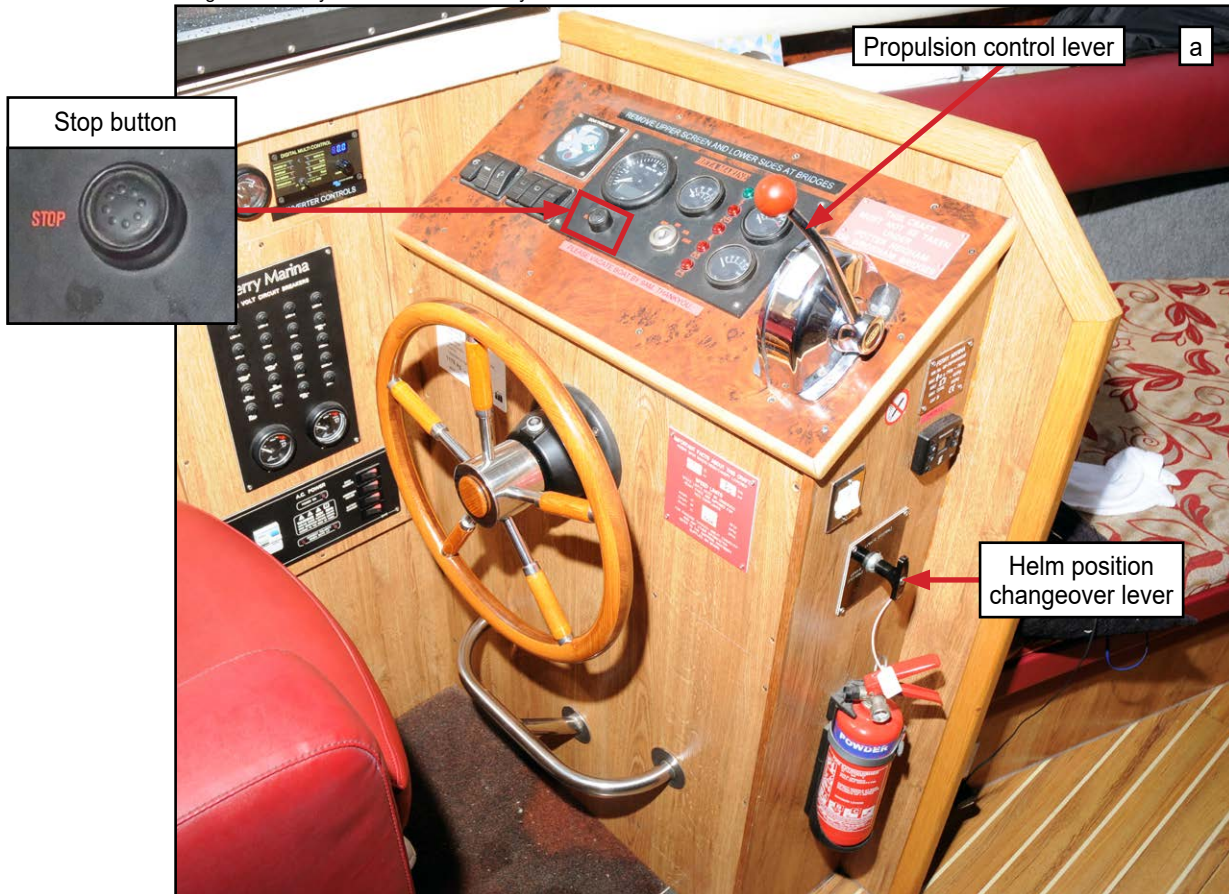
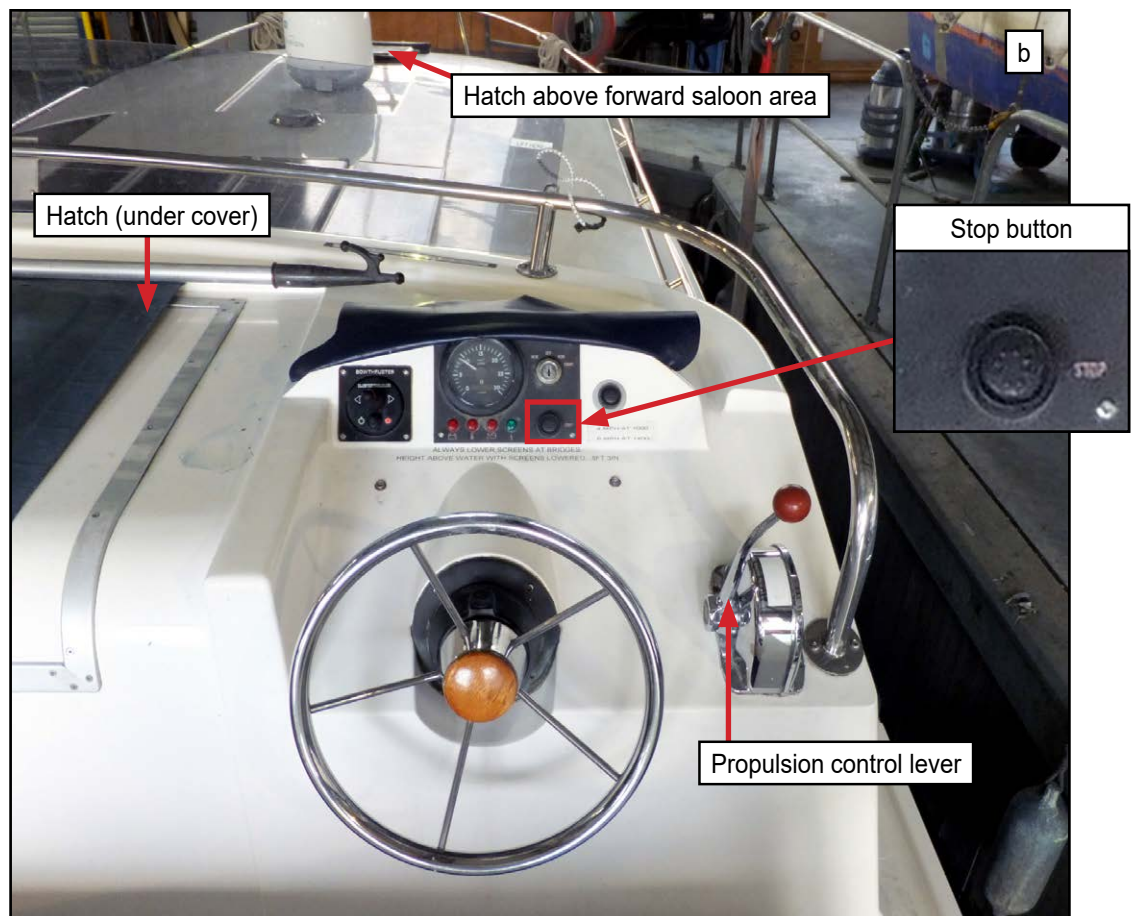
Figure 3: Lower helm control position (a) and upper helm control position (b)

Each helm control console had a steering wheel, dual-function<sup>1</sup> propulsion control lever, key operated engine start switch, engine stop button, and bow thruster control. A helm position changeover lever was located on the inboard side of the lower helm console (**Figures 3a and 4**); there was no similar changeover lever at the upper helm console.

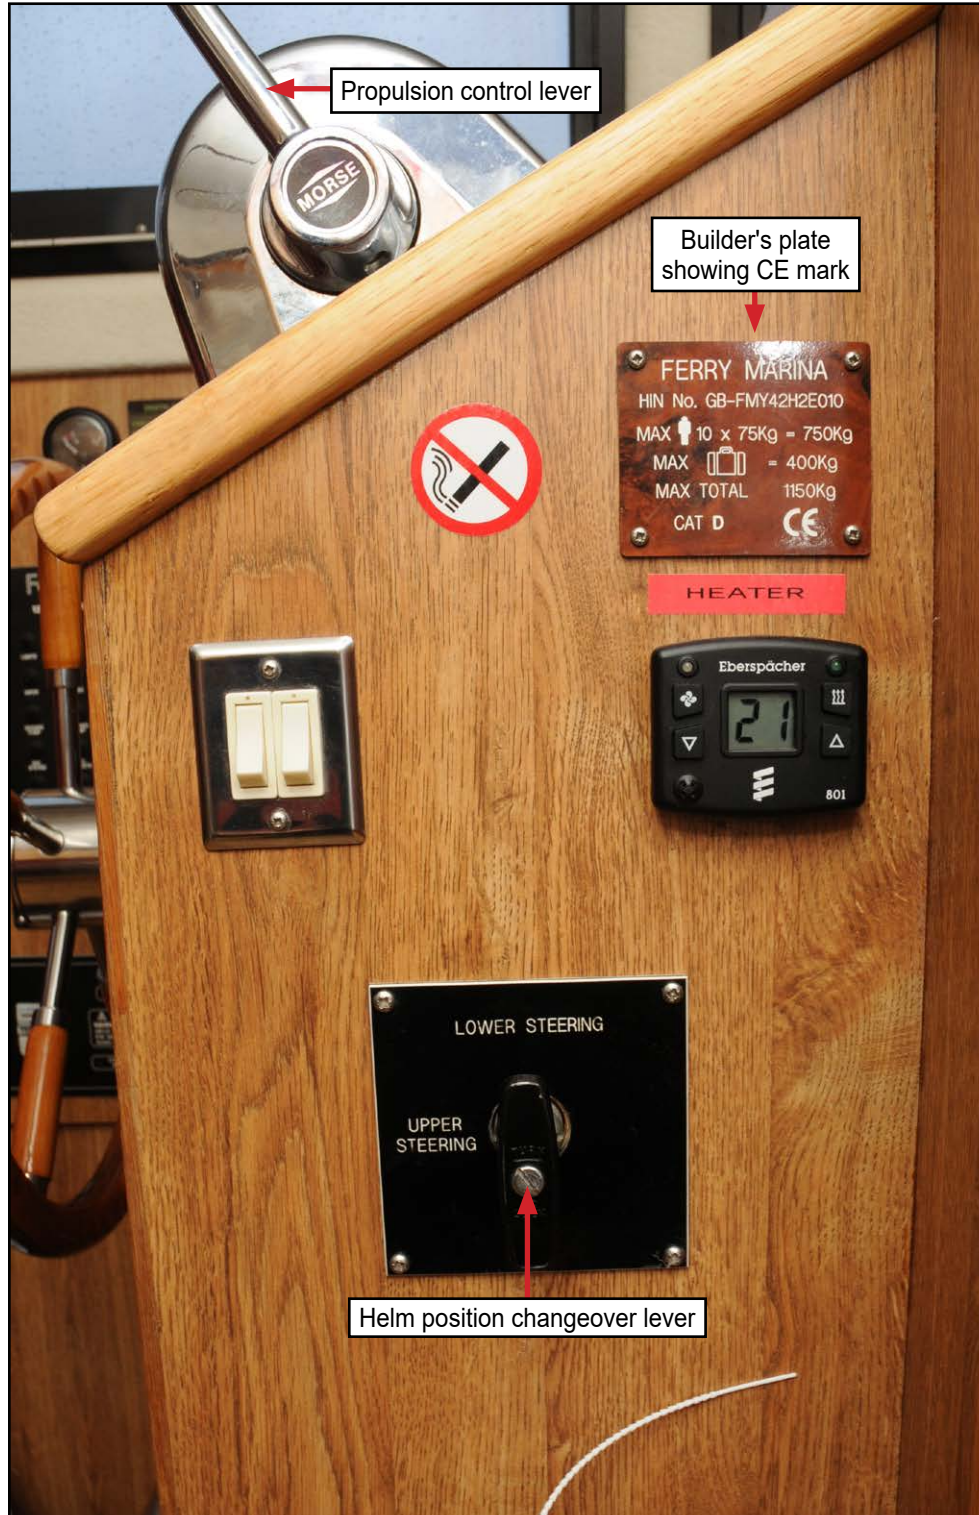
**Figure 4:** Helm position changeover lever at lower helm control position

- Counterintuitive helm position changeover lever positions.
- Signage at the helm position changeover lever implied that the steering position was being changed instead of the propulsion control. As the vessel could be steered irrespective of which helm control position was in use, this had the potential to cause confusion.

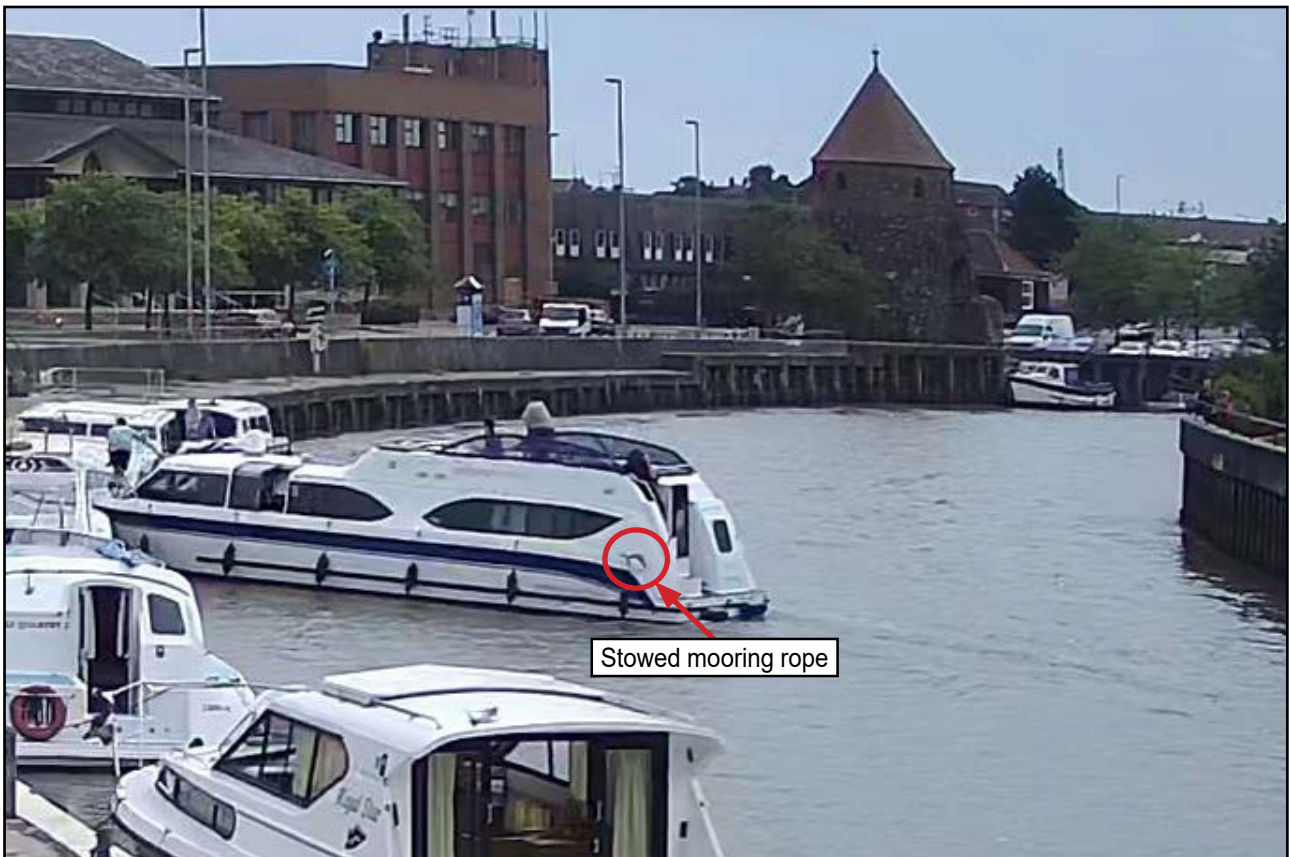
At 1317:44, *Diamond Emblem 1* collided with the stern of the moored motor cruiser *Challenger* (**Figure 7**). The force of the impact caused a wine glass to fall onto the cabin space floor and shatter and the youngest child cried out.

**Figure 7:** *Diamond Emblem 1* making contact with the moored boat *Challenger* at 1317:44

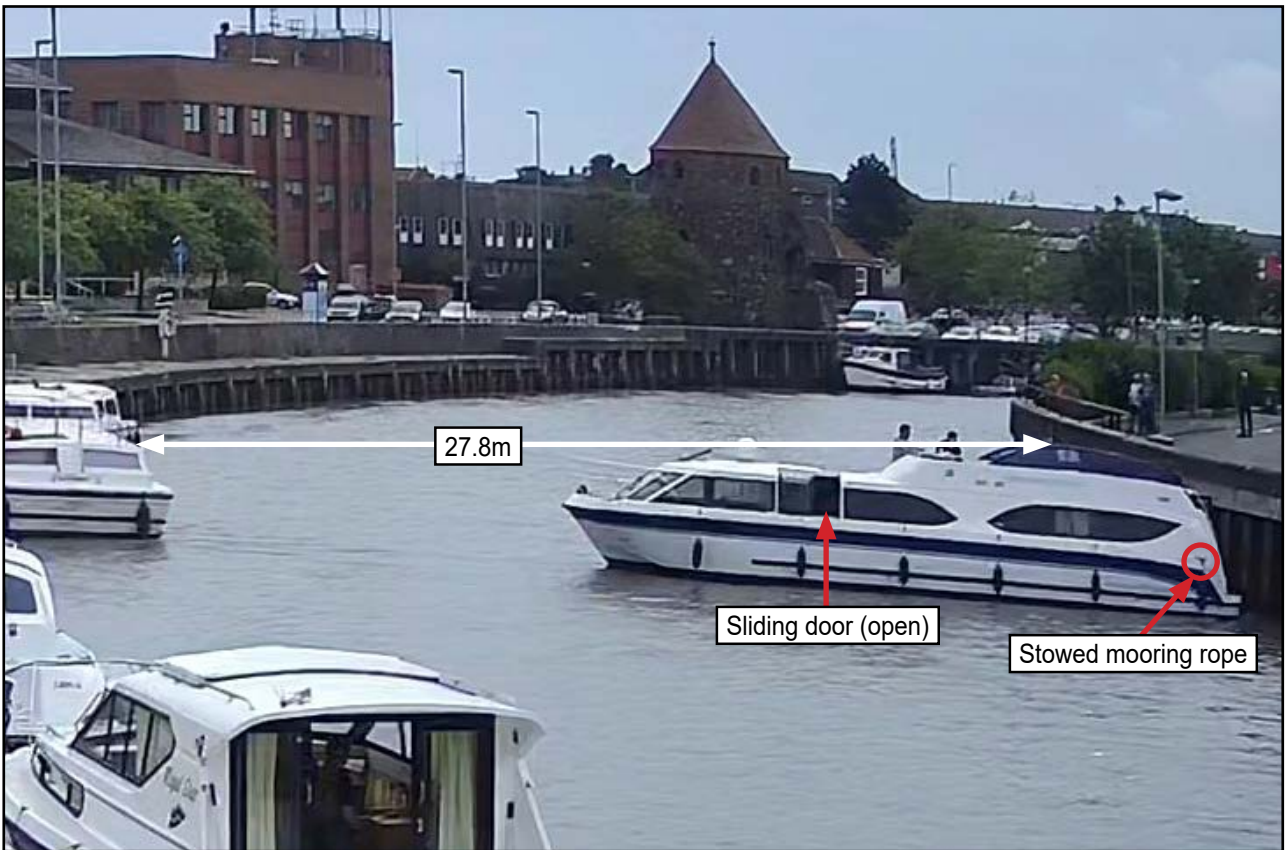
At 1318:01, as Laura opened the aft deck door to the cabin space, *Diamond Emblem 1* made heavy contact with the embankment wall (**Figure 8a**). At the same time, Laura was thrown violently backwards into the water, while holding a large piece of material that appeared to be the curtain that was hanging inside the doorway, and did not resurface. The impact with the wall also caused a length of mooring rope that had been loosely stowed on the boat's port aft side deck to fall aft into the water (**Figure 8b**).

**Figure 8a:** *Diamond Emblem 1* making contact with the river embankment wall at 1318:01

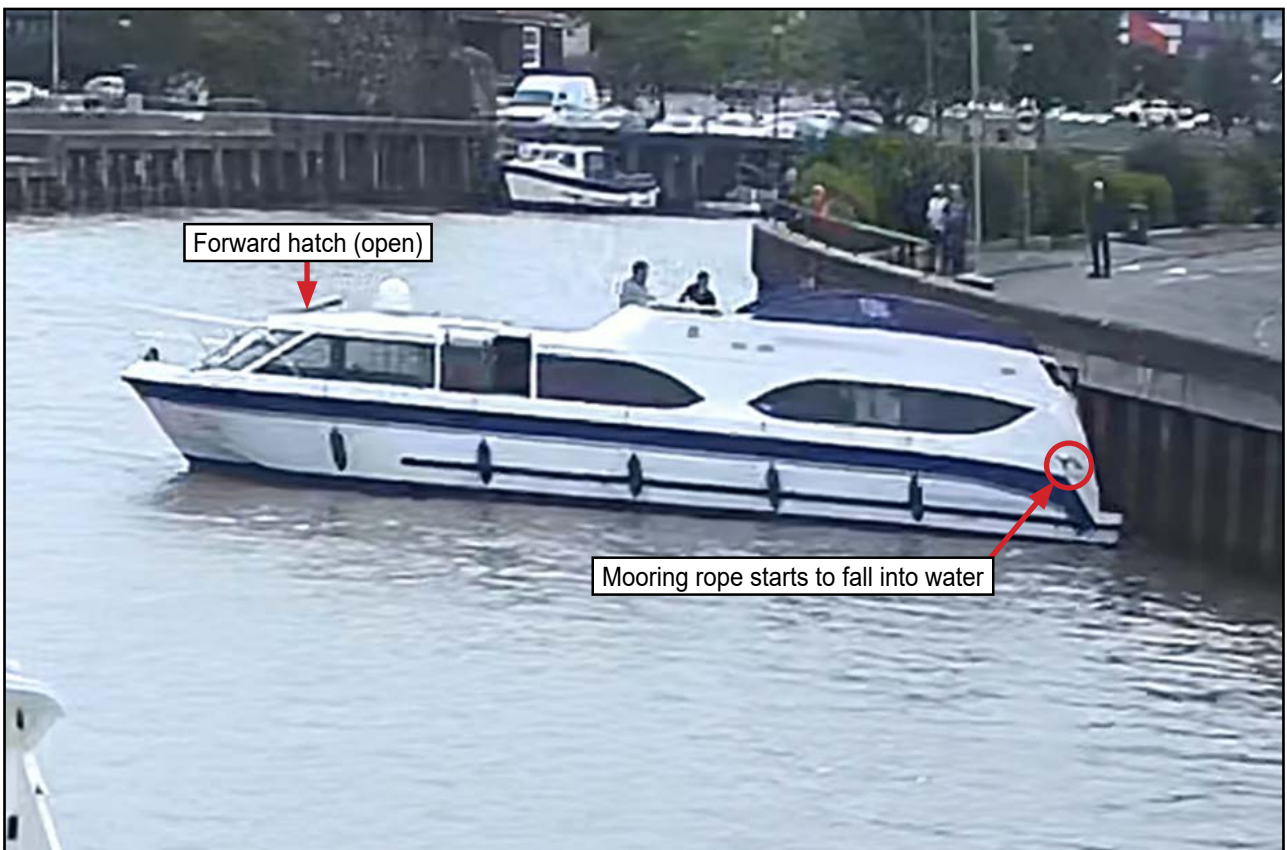
**Figure 8b:** Mooring rope on port aft deck of *Diamond Emblem 1* falling into the water at 1318:01

As the boat's propeller was rotating astern, she was drawn into it and did not resurface, having become entangled in a length of mooring rope. The rope had been loosely stowed on the boat's port aft side deck and the boat's impact with the wall provided the impetus for it to fall aft into the water. The rope was also drawn into the propeller and would have hindered the initial rescue attempts to release Laura from it. The combination of becoming entangled in the mooring rope and the rotating propeller led to Laura sustaining multiple injuries and drowning.

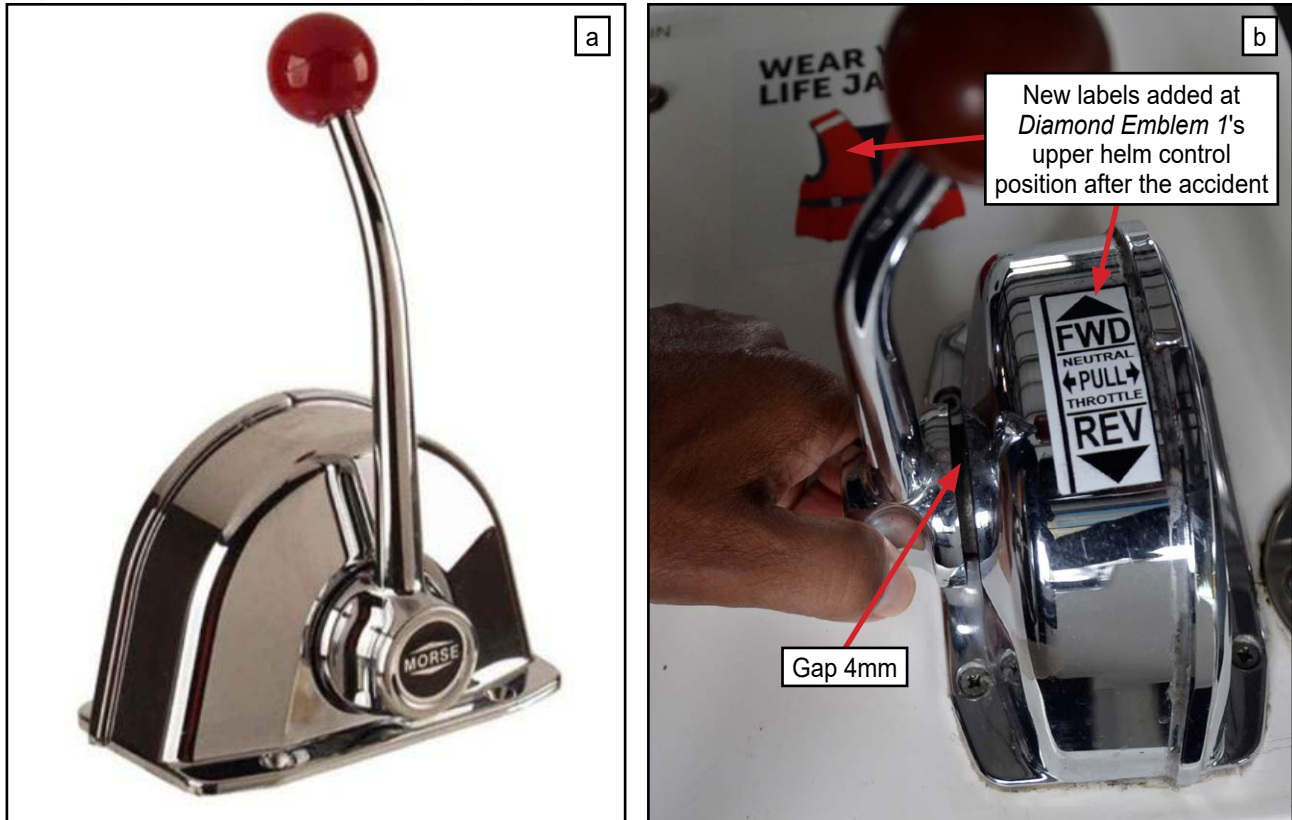
**Figure 12:** Teleflex MT-3 top mount single lever control (a) and lateral disengagement of propulsion control lever (b)

- The upper helm propulsion control lever could be pulled out of gear using one hand and holding the top of the lever. The nominated skipper had probably done this the day before the accident while attempting to put the lever into

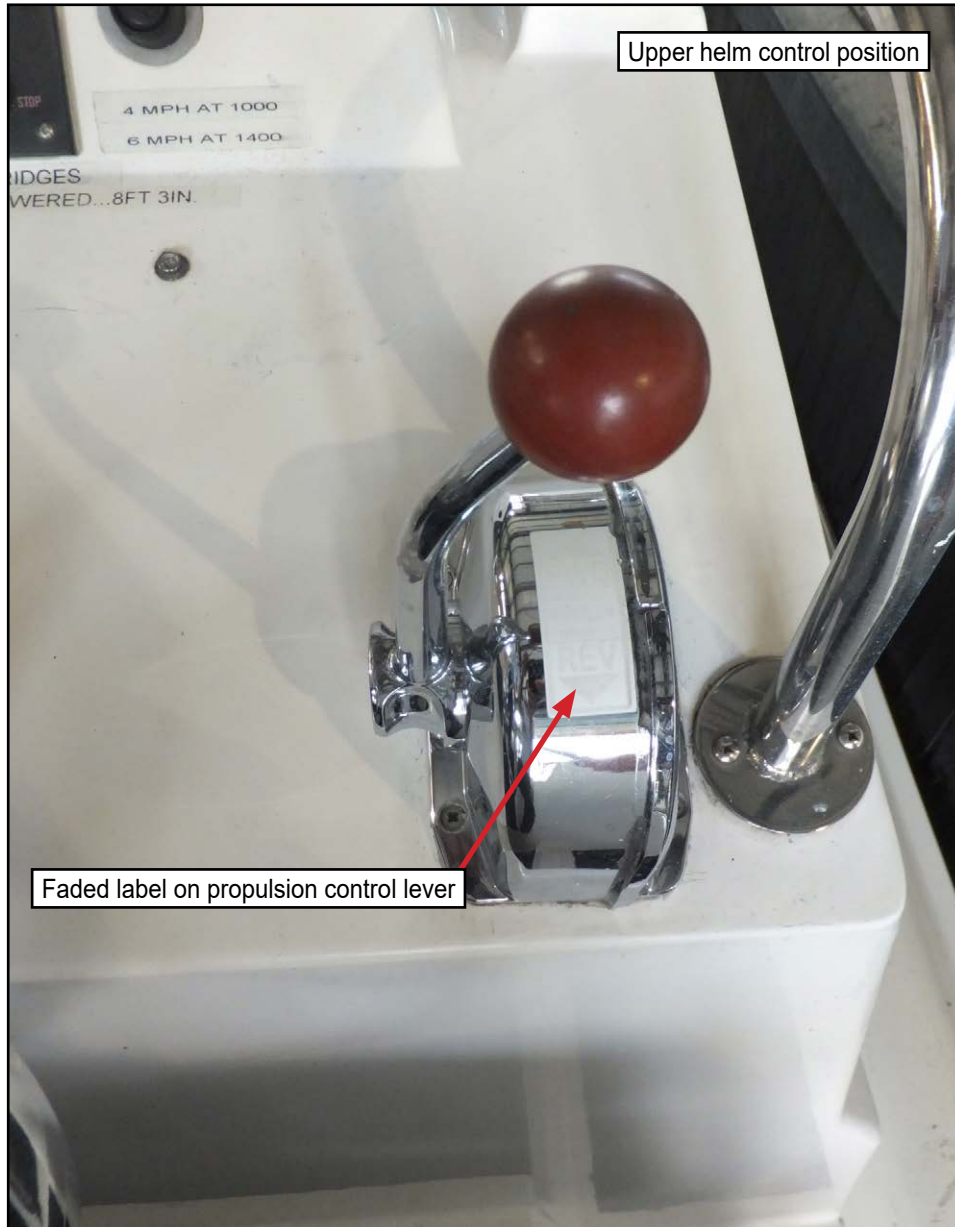
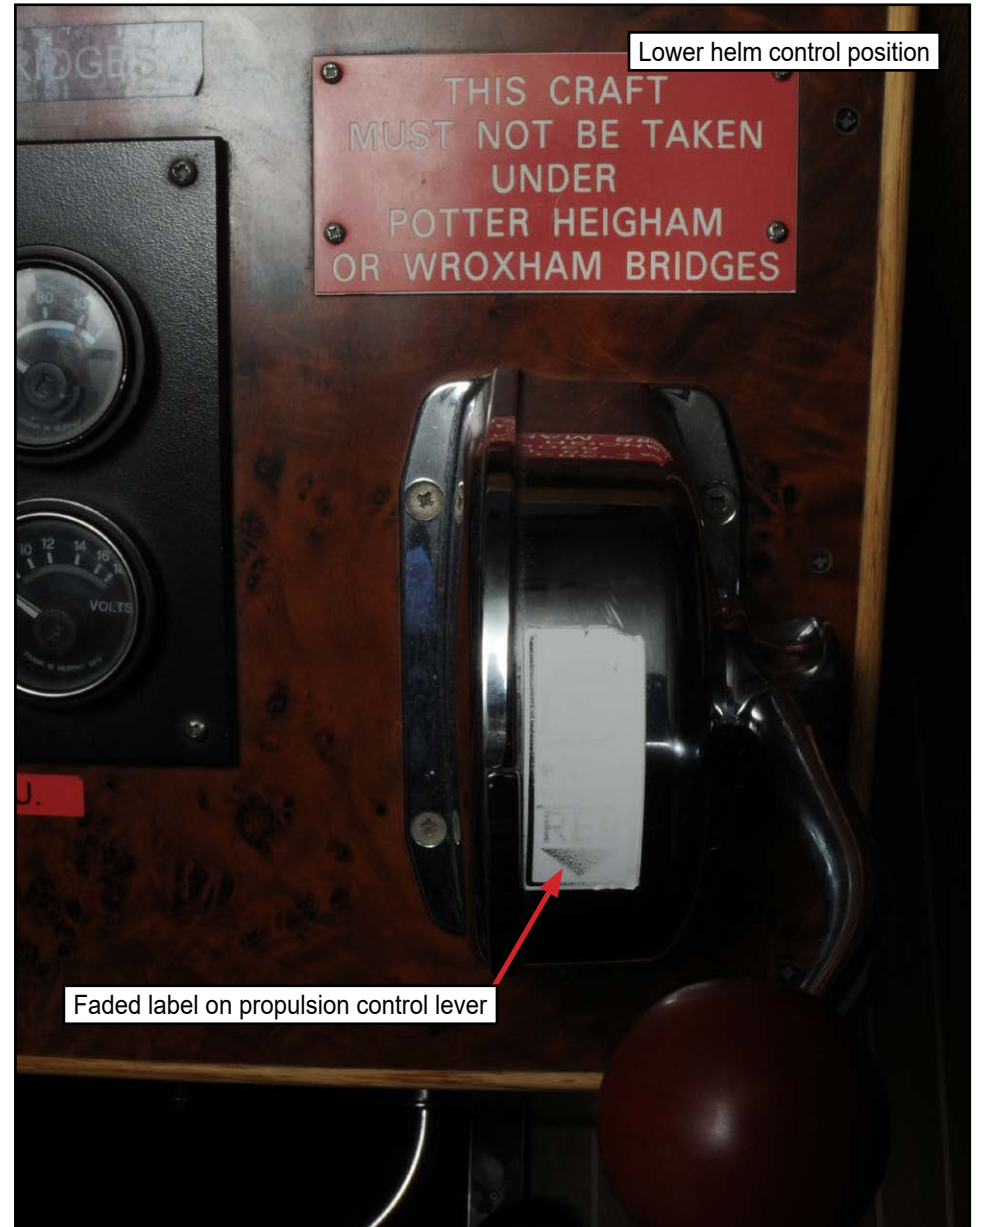
The propulsion control units were supplied with labels to indicate the forward, neutral and reverse positions. The labels on the control levers at both the upper and lower helms were almost completely faded and illegible (**Figure 14**).

Figure 14: Faded propulsion control labelling at upper and lower helm control positions at time of *Diamond Emblem 1* accident
